# **Asbestos Survey Report**

**Project Ref. No: M10538**

**1 St Peters Court**

**Full type 2 survey**

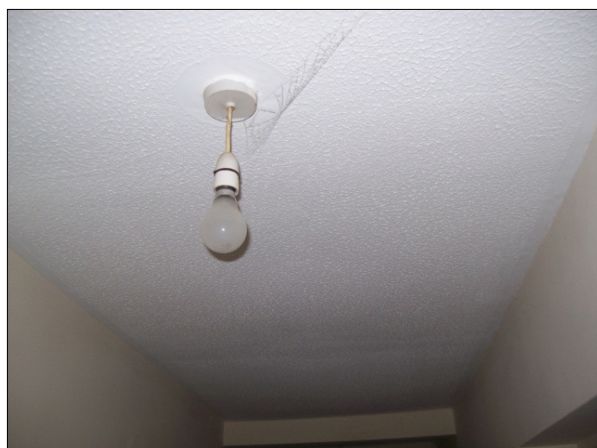
| <b>Condition:</b> | Good | <b>Accessibility:</b> | Medium |
| <b>Position:</b> | Internal | <b>RISK:</b> | <b>NONE</b> |

N.A.D.I.S textured coating to plasterboard ceiling.

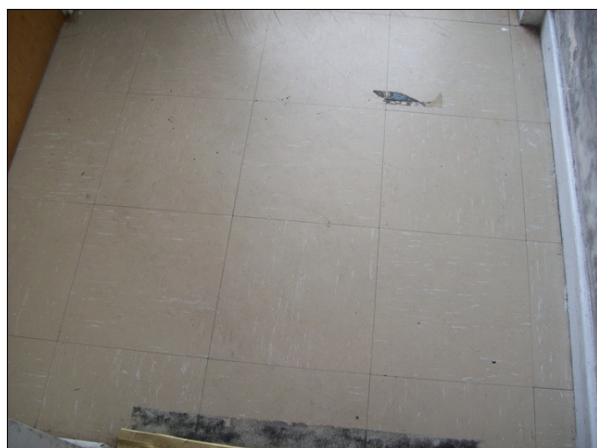
| <b>Condition:</b> | Good | <b>Accessibility:</b> | High |
| <b>Position:</b> | Internal | <b>RISK:</b> | <b>NONE</b> |

N.A.D.I.S vinyl floor tile (beige).

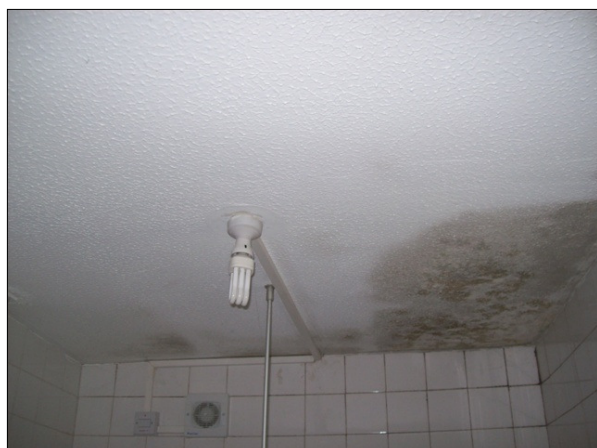
| <b>Condition:</b> | Poor | <b>Accessibility:</b> | Medium |
| <b>Position:</b> | Internal | <b>RISK:</b> | <b>NONE</b> |

N.A.D.I.S textured coating to plasterboard ceiling.

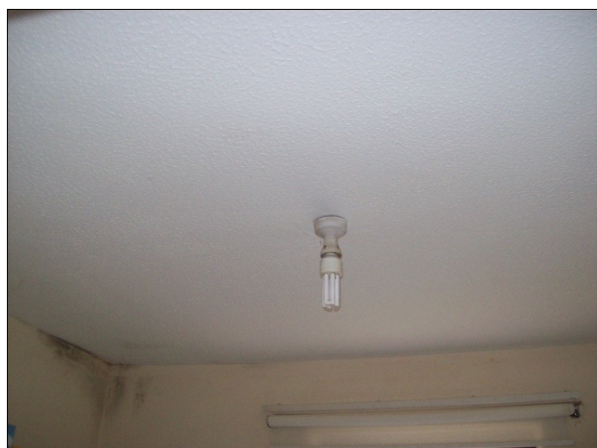
| <b>Condition:</b> | Good | <b>Accessibility:</b> | Medium |
| <b>Position:</b> | Internal | <b>RISK:</b> | <b>NONE</b> |

N.A.D.I.S textured coating to plasterboard ceiling.

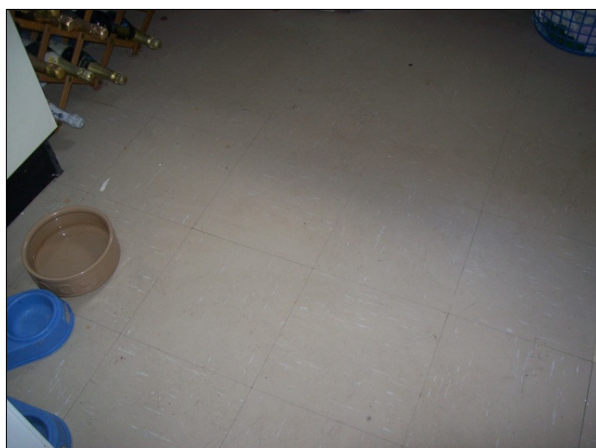
| <b>Condition:</b> | Good | <b>Accessibility:</b> | High |
| <b>Position:</b> | Internal | <b>RISK:</b> | <b>NONE</b> |

N.A.D.I.S vinyl floor tile (beige).

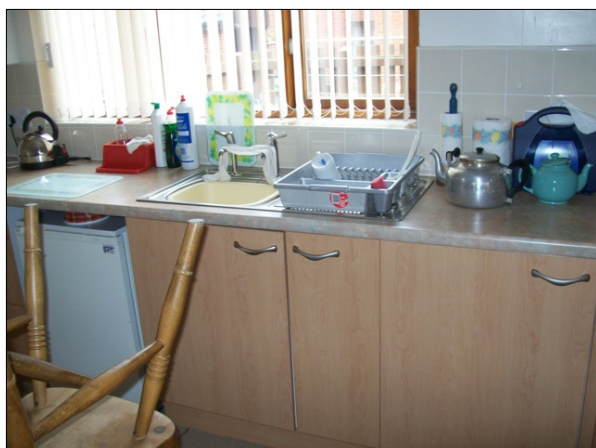
| <b>Condition:</b> | Good | <b>Accessibility:</b> | Low |
| <b>Position:</b> | Internal | <b>RISK:</b> | <b>NONE</b> |

N.A.D.I.S bitumastic sink pad under sink unit (x2).

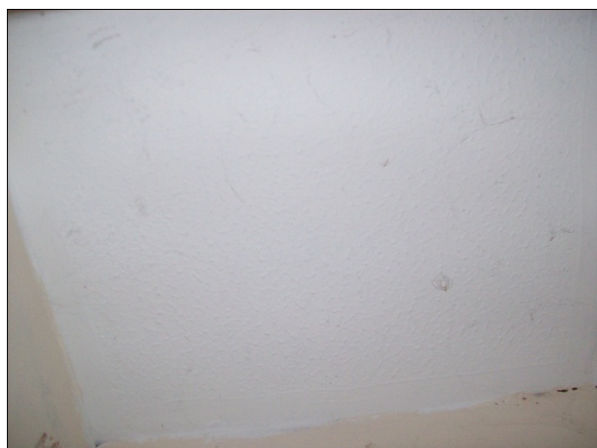
| <b>Condition:</b> | Good | <b>Accessibility:</b> | Medium |
| <b>Position:</b> | Internal | <b>RISK:</b> | <b>NONE</b> |

N.A.D.I.S textured coating to plasterboard ceiling.

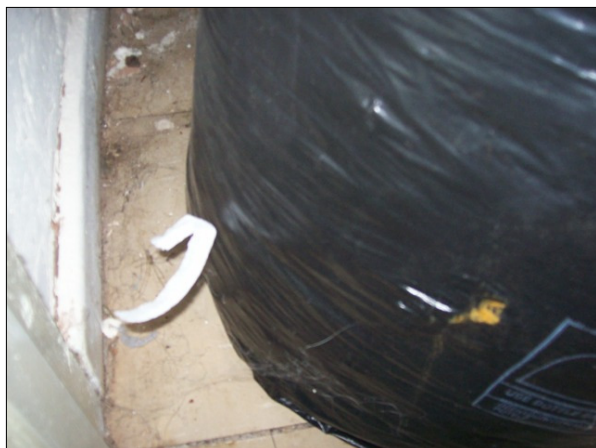
| <b>Condition:</b> | Good | <b>Accessibility:</b> | High |
| <b>Position:</b> | Internal | <b>RISK:</b> | <b>NONE</b> |

N.A.D.I.S vinyl floor tile (beige).

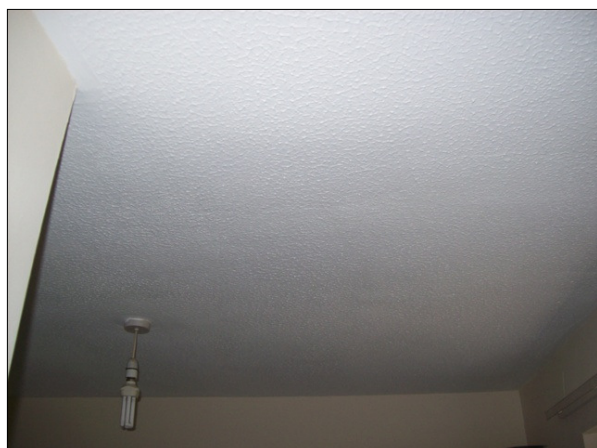
| <b>Condition:</b> | Good | <b>Accessibility:</b> | Medium |
| <b>Position:</b> | Internal | <b>RISK:</b> | <b>NONE</b> |

N.A.D.I.S textured coating to plasterboard ceiling.

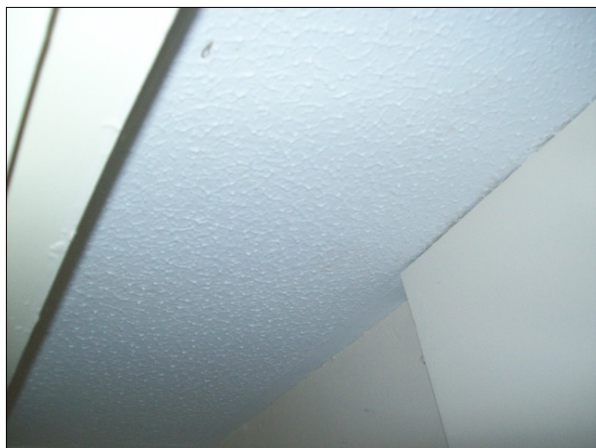
| <b>Condition:</b> | Good | <b>Accessibility:</b> | Medium |
| <b>Position:</b> | Internal | <b>RISK:</b> | <b>NONE</b> |

N.A.D.I.S textured coating to plasterboard ceiling.

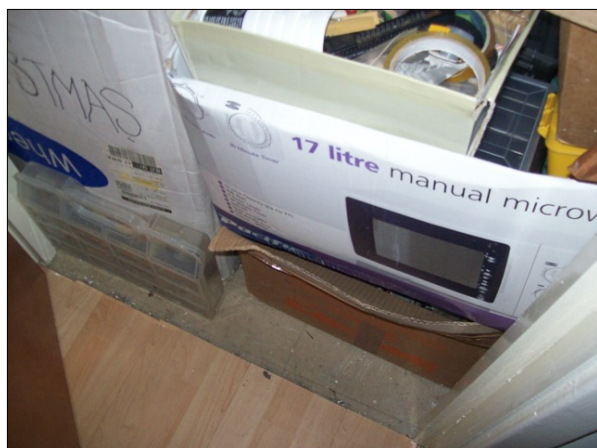
| <b>Condition:</b> | Good | <b>Accessibility:</b> | High |
| <b>Position:</b> | Internal | <b>RISK:</b> | <b>NONE</b> |

N.A.D.I.S vinyl floor tile (beige).

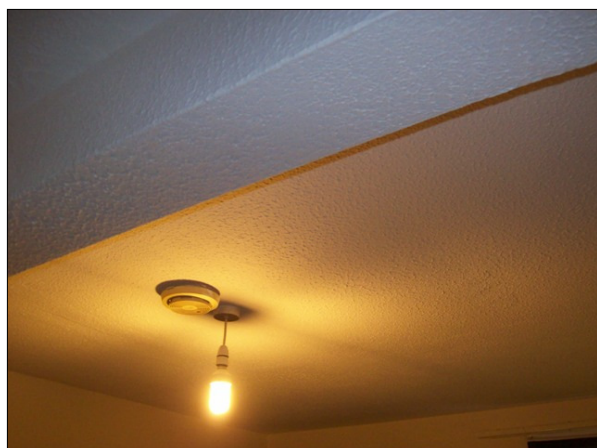
| <b>Condition:</b> | Good | <b>Accessibility:</b> | Medium |
| <b>Position:</b> | Internal | <b>RISK:</b> | <b>NONE</b> |

N.A.D.I.S textured coating to plasterboard ceiling.

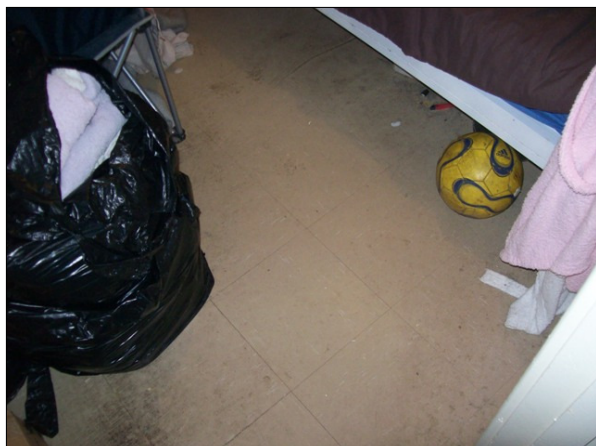
| <b>Condition:</b> | Good | <b>Accessibility:</b> | High |
| <b>Position:</b> | Internal | <b>RISK:</b> | <b>NONE</b> |

N.A.D.I.S vinyl floor tile (beige).
