## Refurbishment Survey

10 Llys Ben Bowen Thomas  
Gelligaled Road  
Ystrad  
Pentre  
CF41 7SB  
UPRN: 6447

| Type of survey: | Refurbishment Survey (with MA + PA) | | |

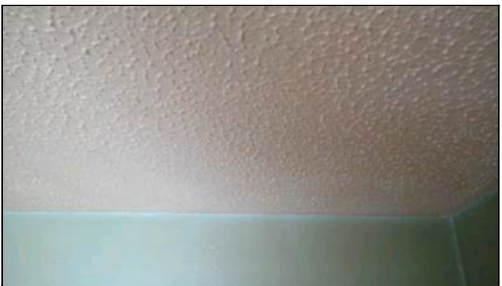
| Building | Floor | Location /Room | S,P,SP,AS<br>Sample<br>No | Product Type | Condition | Surface<br>Treatment | Asbestos Type | Quantity | Accessibility | Material<br>Score | Priority<br>Score | Total PA<br>risk<br>assessment<br>score | Recommendation |
|---|---|---|---|---|---|---|---|---|---|---|---|---|---|
| Flat 10,<br>Block 1-40 | Ground | Kitchen G01, Textured coating to plasterboard ceiling. | S<br>AE003117 | Textured Coating | Good Condition | Completely Sealed | Chrysotile | 4m <sup>2</sup> | Occasionally likely to be disturbed | 2 | 6 | 8 | Manage in-situ or remove if affected by works |

| | Survey Date: | Lead Surveyor | Survey Type | Floor | Analysis |
|---|---|---|---|---|---|
| | 12 Jun 2017 | Dave Milton | Refurbishment Survey | Ground | Chrysotile (1) |
| | AE003117 (S) | Textured Coating (1) | Completely Sealed (0) | Good Condition (0) | Occasionally likely to be disturbed (1) |

| Normal Occupancy | Score | Likelihood of disturbance | Score | Exposure Potential | Score | Maintenance Activity | Score |
|---|---|---|---|---|---|---|---|
| Recommendation | Manage in-situ or remove if affected by works | | | | | | |

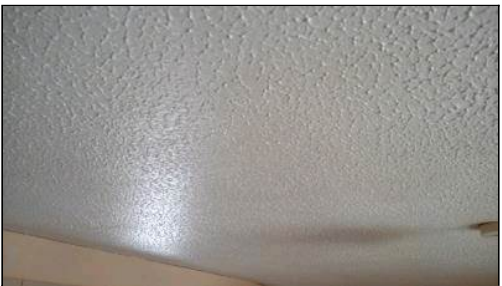
| Building | Floor | Location /Room | S,P,SP,AS<br>Sample<br>No | Product Type | Condition | Surface<br>Treatment | Asbestos Type | Quantity | Accessibility | Material<br>Score | Priority<br>Score | Total PA<br>risk<br>assessment<br>score | Recommendation |
|---|---|---|---|---|---|---|---|---|---|---|---|---|---|
| Flat 10,<br>Block 1-40 | Ground | Lounge/bedroom G02, Textured coating to plasterboard ceiling. | S<br>AE003118 | Textured Coating | Good Condition | Completely Sealed | Chrysotile | 15m <sup>2</sup> | Occasionally likely to be disturbed | 2 | 7 | 9 | Manage in-situ or remove if affected by works |

| | Survey Date: | Lead Surveyor | Survey Type | Floor | Analysis |
|---|---|---|---|---|---|
| | 12 Jun 2017 | Dave Milton | Refurbishment Survey | Ground | Chrysotile (1) |
| | AE003118 (S) | Textured Coating (1) | Completely Sealed (0) | Good Condition (0) | Occasionally likely to be disturbed (1) |

| Normal Occupancy | Score | Likelihood of disturbance | Score | Exposure Potential | Score | Maintenance Activity | Score |
|---|---|---|---|---|---|---|---|
| Recommendation | Manage in-situ or remove if affected by works | | | | | | |

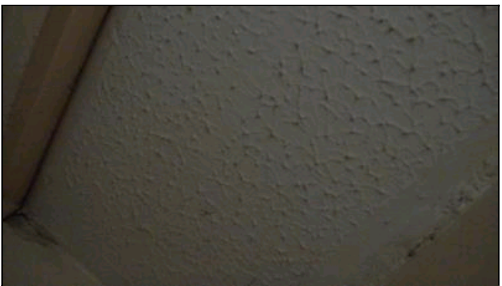
| Building | Floor | Location /Room | S,P,SP,AS<br>Sample<br>No | Product Type | Condition | Surface<br>Treatment | Asbestos Type | Quantity | Accessibility | Material<br>Score | Priority<br>Score | Total PA<br>risk<br>assessment<br>score | Recommendation |
|---|---|---|---|---|---|---|---|---|---|---|---|---|---|
| Flat 10,<br>Block 1-40 | Ground | Airing cupboard G03, Textured coating to plasterboard ceiling. | S<br>AE003119 | Textured Coating | Good Condition | Completely Sealed | Chrysotile | 1m <sup>2</sup> | Occasionally likely to be disturbed | 2 | 6 | 8 | Manage in-situ or remove if affected by works |

| | 12 Jun 2017 | Dave Milton | Refurbishment Survey | Ground | Chrysotile (1) |
| | AE003119 (S) | Textured Coating (1) | Completely Sealed (0) | Good Condition (0) | Occasionally likely to be disturbed (1) |

| Recommendation | Manage in-situ or remove if affected by works | | | | | | |

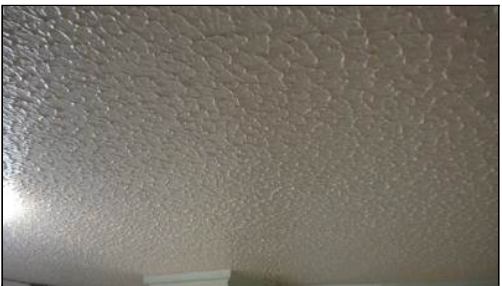
| Building | Floor | Location /Room | S,P,SP,AS<br>Sample<br>No | Product Type | Condition | Surface<br>Treatment | Asbestos Type | Quantity | Accessibility | Material<br>Score | Priority<br>Score | Total PA<br>risk<br>assessment<br>score | Recommendation |
|---|---|---|---|---|---|---|---|---|---|---|---|---|---|
| Flat 10,<br>Block 1-40 | Ground | Shower room G04, Textured coating to plasterboard ceiling. | S<br>AE003120 | Textured Coating | Good Condition | Completely Sealed | Chrysotile | 4m <sup>2</sup> | Occasionally likely to be disturbed | 2 | 6 | 8 | Manage in-situ or remove if affected by works |

| | 12 Jun 2017 | Dave Milton | Refurbishment Survey | Ground | Chrysotile (1) |
| | AE003120 (S) | Textured Coating (1) | Completely Sealed (0) | Good Condition (0) | Occasionally likely to be disturbed (1) |

| Recommendation | Manage in-situ or remove if affected by works | | | | | | |

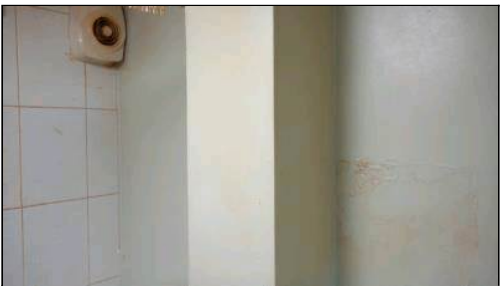
| | Survey Date: | Lead Surveyor | Survey Type | Floor | Analysis |
|---|---|---|---|---|---|
| | 12 Jun 2017 | Dave Milton | Refurbishment Survey | Ground | No Asbestos Detected (0) |
| | AE003121 (S) | Insulating Board (0) | Surface Sealed (1) | Good Condition (0) | Occasionally likely to be disturbed (1) |

| Normal Occupancy | Score | Likelihood of disturbance | Score | Exposure Potential | Score | Maintenance Activity | Score |
|---|---|---|---|---|---|---|---|
| Recommendation | No further action required | | | | | | |

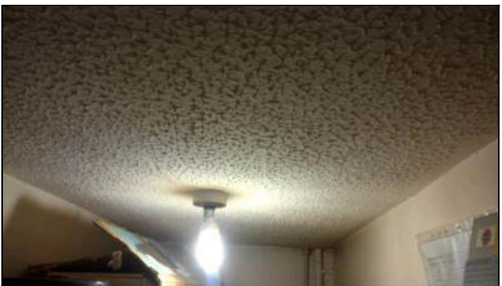
| Building | Floor | Location /Room | S,P,SP,AS<br>Sample<br>No | Product Type | Condition | Surface<br>Treatment | Asbestos Type | Quantity | Accessibility | Material<br>Score | Priority<br>Score | Total PA<br>risk<br>assessment<br>score | Recommendation |
|---|---|---|---|---|---|---|---|---|---|---|---|---|---|
| Flat 10,<br>Block 1-40 | Ground | Store G05, Textured coating to plasterboard ceiling. | S<br>AE003122 | Textured Coating | Good Condition | Completely Sealed | Chrysotile | 2m <sup>2</sup> | Occasionally likely to be disturbed | 2 | 6 | 8 | Manage in-situ or remove if affected by works |

| | Survey Date: | Lead Surveyor | Survey Type | Floor | Analysis |
|---|---|---|---|---|---|
| | 12 Jun 2017 | Dave Milton | Refurbishment Survey | Ground | Chrysotile (1) |
| | AE003122 (S) | Textured Coating (1) | Completely Sealed (0) | Good Condition (0) | Occasionally likely to be disturbed (1) |

| Normal Occupancy | Score | Likelihood of disturbance | Score | Exposure Potential | Score | Maintenance Activity | Score |
|---|---|---|---|---|---|---|---|
| Recommendation | Manage in-situ or remove if affected by works | | | | | | |

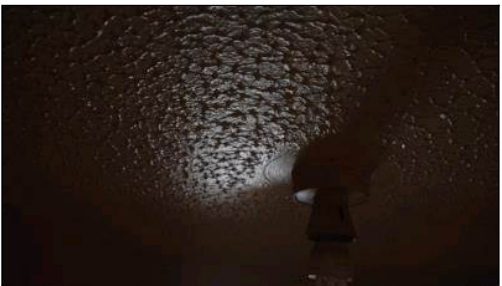
| Building | Floor | Location /Room | S,P,SP,AS<br>Sample<br>No | Product Type | Condition | Surface<br>Treatment | Asbestos Type | Quantity | Accessibility | Material<br>Score | Priority<br>Score | Total PA<br>risk<br>assessment<br>score | Recommendation |
|---|---|---|---|---|---|---|---|---|---|---|---|---|---|
| Flat 10,<br>Block 1-40 | Ground | Hall G06, Textured coating to plasterboard ceiling. | S<br>AE003123 | Textured Coating | Good Condition | Completely Sealed | Chrysotile | 2m <sup>2</sup> | Occasionally likely to be disturbed | 2 | 6 | 8 | Manage in-situ or remove if affected by works |

| | 12 Jun 2017 | Dave Milton | Refurbishment Survey | Ground | Chrysotile (1) |
| | AE003123 (S) | Textured Coating (1) | Completely Sealed (0) | Good Condition (0) | Occasionally likely to be disturbed (1) |

| Normal Occupancy | Score | Likelihood of disturbance | Score | Exposure Potential | Score | Maintenance Activity | Score |
|---|---|---|---|---|---|---|---|
| Recommendation | Manage in-situ or remove if affected by works | | | | | | |
