Asbestos Management Survey for

Steele Davis Ltd

11 Maes Trisant
Green Homes, Talbot Green
Pontyclun Rhondda
Cynon Taf
Wales
CF72 8RQ

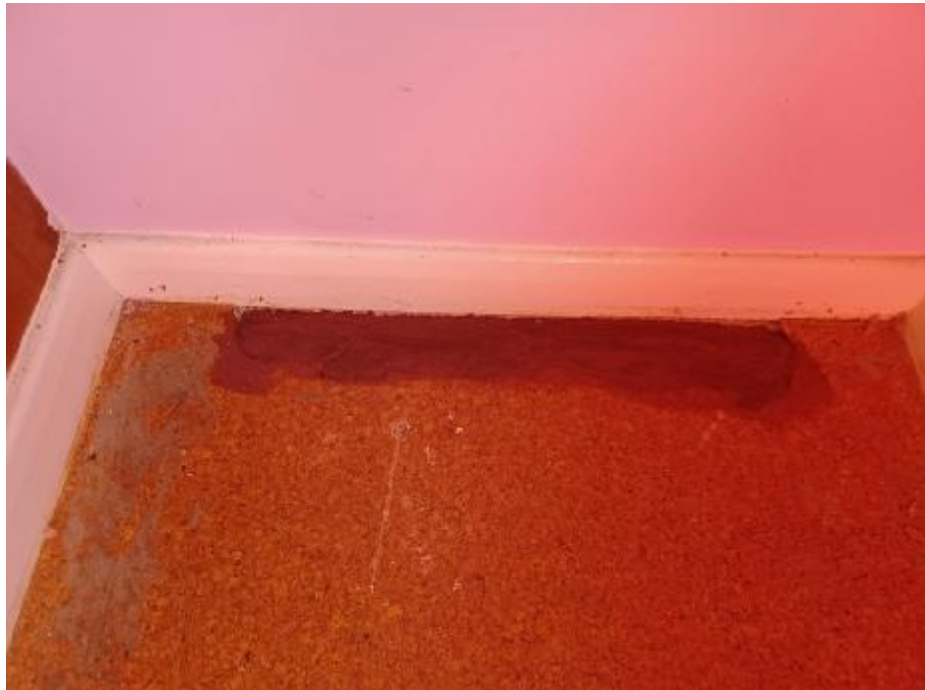
Location ID:	4845	Survey Type:	MS
Location Ref:	01	Product Type:	NADIS
Product:	Bitumen adhesive	Damage:	NADIS
Area:	Ground floor flat	Treatment:	NADIS
Floor:	Ground floor	Asbestos Type:	NADIS
Room:	Bedroom	Identification:	Identified
Surveyor Name:	Lenny Gillmore	Quantity:	1m ²
Drawing Ref:	20230314-LG01-MS		
Asbestos ?	No		
Date:	22 March 2023		
Next Inspection:	Not Applicable

Non-Asbestos Bitumen in Bedroom Alcove (on a solid floor)

No Action Required

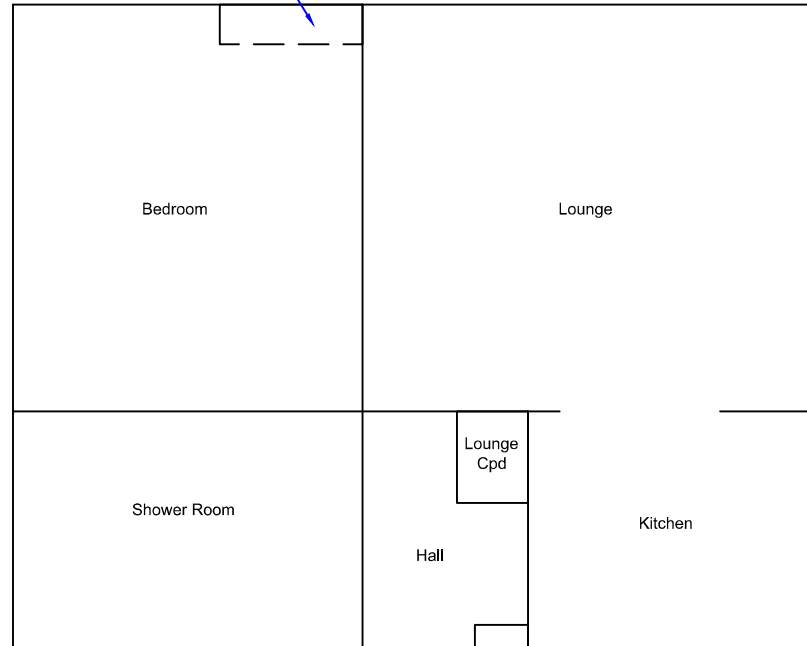
Flat Ground Floor

NON-asbestos bitumen
floor adhesive

NOTE
There was no asbestos containing materials
identified or presumed in this asbestos management
survey of the property
