## Refurbishment Survey

14 Llys Ben Bowen Thomas  
Gelligaled Road  
Ystrad  
Pentre  
CF41 7SB  
UPRN: 6450

**Building Designation:** Flat 14, Block 1-40

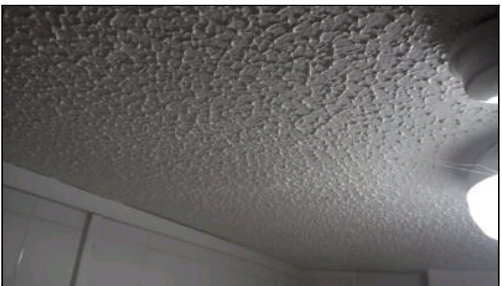
| | 12 Jun 2017 | Dave Milton | Refurbishment Survey | Ground | Chrysotile (1) |
| | AE003124 (S) | Textured Coating (1) | Completely Sealed (0) | Good Condition (0) | Occasionally likely to be disturbed (1) |

| Recommendation | Manage in-situ or remove if affected by works | | | | | | |

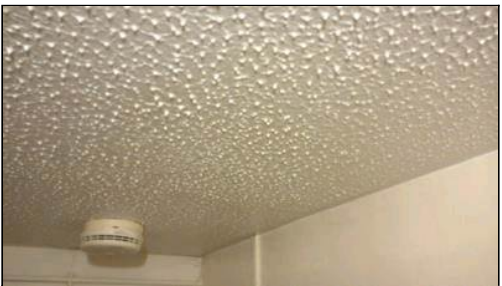
| | Survey Date: | Lead Surveyor | Survey Type | Floor | Analysis |
|---|---|---|---|---|---|
| | 12 Jun 2017 | Dave Milton | Refurbishment Survey | Ground | Chrysotile (1) |
| | AE003125 (S) | Textured Coating (1) | Completely Sealed (0) | Good Condition (0) | Occasionally likely to be disturbed (1) |

| Normal Occupancy | Score | Likelihood of disturbance | Score | Exposure Potential | Score | Maintenance Activity | Score |
|---|---|---|---|---|---|---|---|
| Recommendation | Manage in-situ or remove if affected by works | | | | | | |

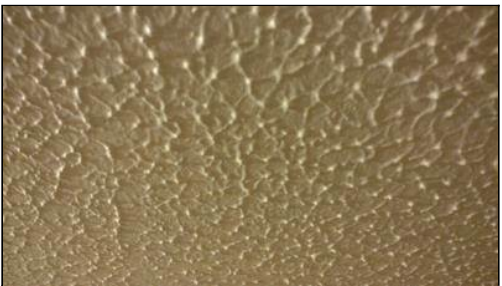
| | Survey Date: | Lead Surveyor | Survey Type | Floor | Analysis |
|---|---|---|---|---|---|
| | 12 Jun 2017 | Dave Milton | Refurbishment Survey | Ground | Chrysotile (1) |
| | AE003126 (S) | Textured Coating (1) | Completely Sealed (0) | Good Condition (0) | Occasionally likely to be disturbed (1) |

| Normal Occupancy | Score | Likelihood of disturbance | Score | Exposure Potential | Score | Maintenance Activity | Score |
|---|---|---|---|---|---|---|---|
| Recommendation | Manage in-situ or remove if affected by works | | | | | | |

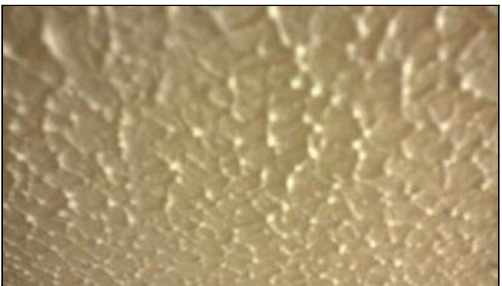
| | Survey Date: | Lead Surveyor | Survey Type | Floor | Analysis |
|---|---|---|---|---|---|
| | 12 Jun 2017 | Dave Milton | Refurbishment Survey | Ground | Chrysotile (1) |
| | AE003127 (S) | Textured Coating (1) | Completely Sealed (0) | Good Condition (0) | Occasionally likely to be disturbed (1) |

| Normal Occupancy | Score | Likelihood of disturbance | Score | Exposure Potential | Score | Maintenance Activity | Score |
|---|---|---|---|---|---|---|---|
| Recommendation | Manage in-situ or remove if affected by works | | | | | | |

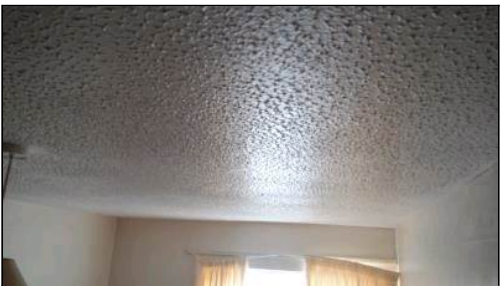
| | 12 Jun 2017 | Dave Milton | Refurbishment Survey | Ground | Chrysotile (1) |
| | AE003132 (S) | Textured Coating (1) | Completely Sealed (0) | Good Condition (0) | Occasionally likely to be disturbed (1) |

| Recommendation | Manage in-situ or remove if affected by works | | | | | | |

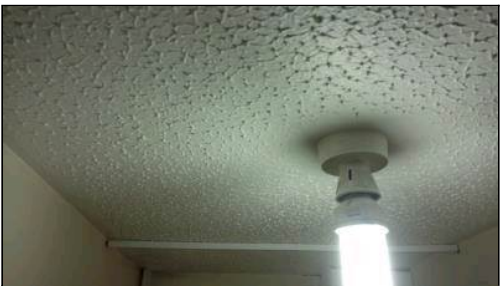
| | 12 Jun 2017 | Dave Milton | Refurbishment Survey | Ground | Chrysotile (1) |
| | AE003128 (S) | Textured Coating (1) | Completely Sealed (0) | Good Condition (0) | Occasionally likely to be disturbed (1) |

| Recommendation | Manage in-situ or remove if affected by works | | | | | | |

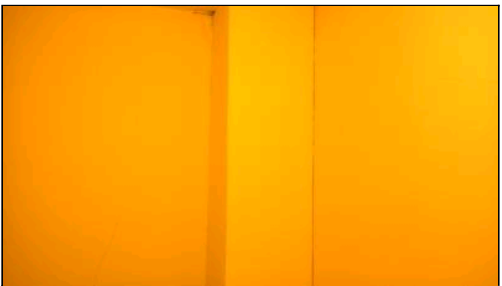
| | 12 Jun 2017 | Dave Milton | Refurbishment Survey | Ground | No Asbestos Detected (0) |
| | AE003129 (S) | Insulating Board (0) | Surface Sealed (1) | Good Condition (0) | Occasionally likely to be disturbed (1) |

| Recommendation | No further action required | | | | | | |

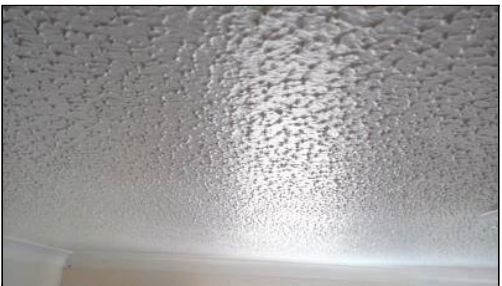
| | Survey Date: | Lead Surveyor | Survey Type | Floor | Analysis |
|---|---|---|---|---|---|
| | 12 Jun 2017 | Dave Milton | Refurbishment Survey | Ground | Chrysotile (1) |
| | AE003130 (S) | Textured Coating (1) | Completely Sealed (0) | Good Condition (0) | Occasionally likely to be disturbed (1) |

| Normal Occupancy | Score | Likelihood of disturbance | Score | Exposure Potential | Score | Maintenance Activity | Score |
|---|---|---|---|---|---|---|---|
| Recommendation | Manage in-situ or remove if affected by works | | | | | | |

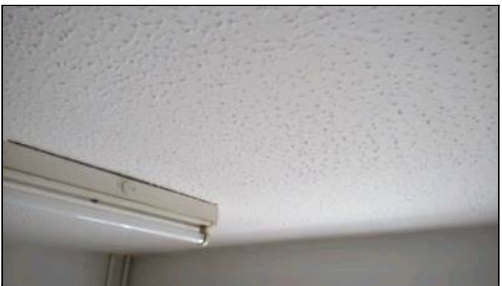
| | Survey Date: | Lead Surveyor | Survey Type | Floor | Analysis |
|---|---|---|---|---|---|
| | 12 Jun 2017 | Dave Milton | Refurbishment Survey | Ground | Chrysotile (1) |
| | AE003131 (S) | Textured Coating (1) | Completely Sealed (0) | Good Condition (0) | Occasionally likely to be disturbed (1) |

| Normal Occupancy | Score | Likelihood of disturbance | Score | Exposure Potential | Score | Maintenance Activity | Score |
|---|---|---|---|---|---|---|---|
| Recommendation | Manage in-situ or remove if affected by works | | | | | | |
