Refurbishment Survey

19 Llys Ben Bowen Thomas
Gelligaled Road
Ystrad
Pentre
CF41 7SB
UPRN: 6455

Building Designation: Flat 19, Block 1-40

Scope of Works: The Refurbishment Survey was carried out to internal areas of the flat in line with the proposed heating upgrade works.

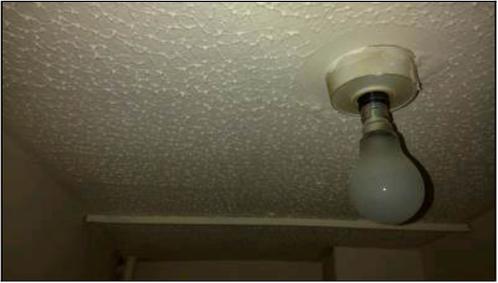
Survey Date:	Lead Surveyor	Survey Type	Floor	Analysis
	12 Jun 2017	Dave Milton	Refurbishment Survey	1st	Chrysotile (1)
	Building	Room	Item	Quantity	
	Flat 19, Block 1-40	Store 106	Textured coating to plasterboard ceiling.	2m ²	
	Sample No (S,SP,P,As)	Product Type	Surface Treatment	Condition	Accessibility
	AE003089 (S)	Textured Coating (1)	Completely Sealed (0)	Good Condition (0)	Occasionally likely to be disturbed (1)

Normal Occupancy	Score	Likelihood of disturbance	Score	Exposure Potential	Score	Maintenance Activity	Score
Main type of activity	1	Location	2	Number of occupants	1	Type of Maintenance	1
		Accessibility	1	Frequency of use	3	Frequency of maintenance	1
		Amount	1	Average Time	0		
Average Score	1	Average Score	2	Average Score	2	Average Score	1
Average of Priority	6						
Material Assessment Score	2						
Recommendation	Manage in-situ or remove if affected by works						
Surveyor comments	Please refer to Section 6.2 of this report and project desktop study (additional inspection required if going beyond suspect material).

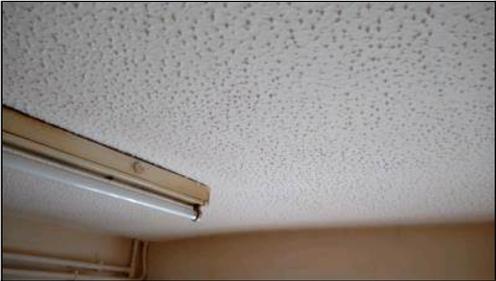
Survey Date:	Lead Surveyor	Survey Type	Floor	Analysis
	12 Jun 2017	Dave Milton	Refurbishment Survey	1st	Chrysotile (1)
	Building	Room	Item	Quantity	
	Flat 19, Block 1-40	Lounge 107	Textured coating to plasterboard ceiling.	12m ²	
	Sample No (S,SP,P,As)	Product Type	Surface Treatment	Condition	Accessibility
AE003091 (S)	Textured Coating (1)	Completely Sealed (0)	Good Condition (0)	Occasionally likely to be disturbed (1)

Normal Occupancy	Score	Likelihood of disturbance	Score	Exposure Potential	Score	Maintenance Activity	Score
Main type of activity	1	Location	2	Number of occupants	1	Type of Maintenance	1
		Accessibility	1	Frequency of use	3	Frequency of maintenance	1
		Amount	2	Average Time	2		
Average Score	1	Average Score	2	Average Score	2	Average Score	1
Average of Priority	6						
Material Assessment Score	2						
Recommendation	Manage in-situ or remove if affected by works						
Surveyor comments	Please refer to Section 6.2 of this report and project desktop study (additional inspection required if going beyond suspect material).
