Management Survey

25 Constantine Court  
Constantine Street  
Williamstown  
Penygraig  
Rhondda  
CF40 1QL  
UPRN: 6383

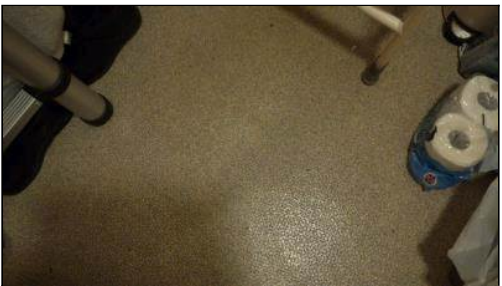
| | Survey Date: | Lead Surveyor | Survey Type | Floor | Analysis |
|---|---|---|---|---|---|
| | 6 Nov 2017 | Dave Milton | Management Survey | 1st | Crocitolite (or unknown)<br>(3) |
| | Visual (SP) | Reinforced Composite (1) | Completely Sealed (0) | Good Condition (0) | Usually inaccessible or unlikely to be disturbed (0) |

| Normal Occupancy | Score | Likelihood of disturbance | Score | Exposure Potential | Score | Maintenance Activity | Score |
|---|---|---|---|---|---|---|---|
| Surveyor comments | Unable to safely inspect at time of survey due to risk of damage to fixed flooring. | | | | | | |

| Normal Occupancy | Score | Likelihood of disturbance | Score | Exposure Potential | Score | Maintenance Activity | Score |
|---|---|---|---|---|---|---|---|
| Recommendation | Inspection required | | | | | | |

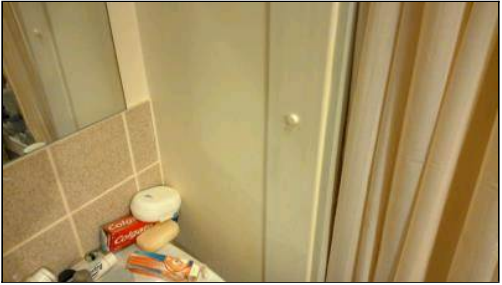
| | 6 Nov 2017 | Dave Milton | Management Survey | 1st | No Asbestos Detected (0) | |
| | AE004032 (S) | Insulation board (2) | Surface Sealed (1) | Good Condition (0) | Easily disturbed (2) | |

| Recommendation | No further action required | | | | | | |

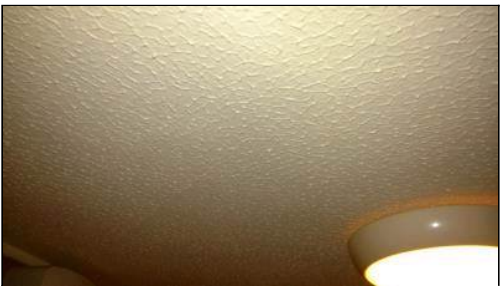
| | Survey Date: | Lead Surveyor | Survey Type | Floor | Analysis |
|---|---|---|---|---|---|
| | 6 Nov 2017 | Dave Milton | Management Survey | 1st | No Asbestos Detected (0) |
| | AE004031 (S) | Textured Coating (1) | Completely Sealed (0) | Good Condition (0) | Occasionally likely to be disturbed (1) |

| Normal Occupancy | Score | Likelihood of disturbance | Score | Exposure Potential | Score | Maintenance Activity | Score |
|---|---|---|---|---|---|---|---|
| Recommendation | No further action required | | | | | | |

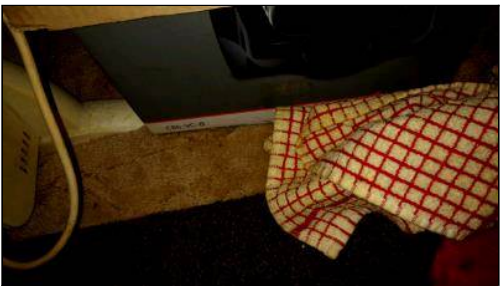
| | Survey Date: | Lead Surveyor | Survey Type | Floor | Analysis |
|---|---|---|---|---|---|
| | 6 Nov 2017 | Dave Milton | Management Survey | 1st | Crocitolite (or unknown) (3) |
| | Visual (SP) | Reinforced Composite (1) | Completely Sealed (0) | Good Condition (0) | Usually inaccessible or unlikely to be disturbed (0) |

| Normal Occupancy | Score | Likelihood of disturbance | Score | Exposure Potential | Score | Maintenance Activity | Score |
|---|---|---|---|---|---|---|---|
| Surveyor comments | Unable to safely inspect at time of survey due to risk of damage to fixed flooring. | | | | | | |

| Normal Occupancy | Score | Likelihood of disturbance | Score | Exposure Potential | Score | Maintenance Activity | Score |
|---|---|---|---|---|---|---|---|
| Recommendation | Inspection required | | | | | | |

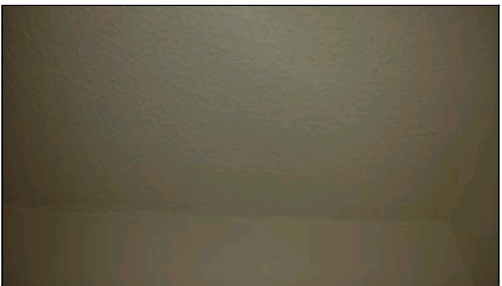
| | Survey Date: | Lead Surveyor | Survey Type | Floor | Analysis |
|---|---|---|---|---|---|
| | 6 Nov 2017 | Dave Milton | Management Survey | 1st | No Asbestos Detected (0) |
| | As AE004031 (SP) | Textured Coating (1) | Completely Sealed (0) | Good Condition (0) | Occasionally likely to be disturbed (1) |

| Normal Occupancy | Score | Likelihood of disturbance | Score | Exposure Potential | Score | Maintenance Activity | Score |
|---|---|---|---|---|---|---|---|
| Recommendation | No further action required | | | | | | |

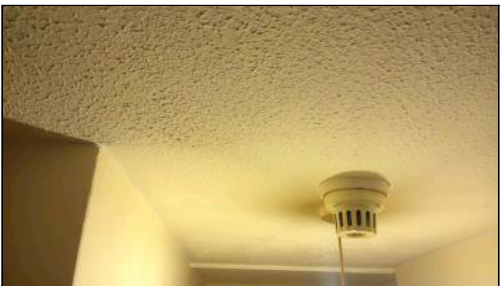
| | 6 Nov 2017 | Dave Milton | Management Survey | 1st | No Asbestos Detected (0) |
| | As AE004031 (SP) | Textured Coating (1) | Completely Sealed (0) | Good Condition (0) | Occasionally likely to be disturbed (1) |

| Recommendation | No further action required | | | | | | |

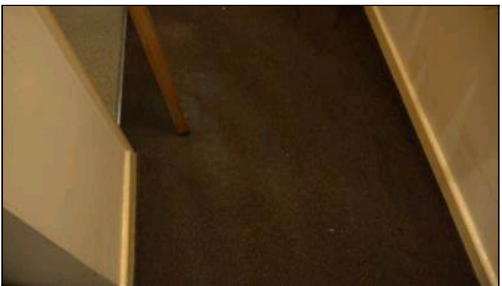
| | Survey Date: | Lead Surveyor | Survey Type | Floor | Analysis |
|---|---|---|---|---|---|
| | 6 Nov 2017 | Dave Milton | Management Survey | 1st | Crocitolite (or unknown) (3) |
| | Visual (SP) | Reinforced Composite (1) | Completely Sealed (0) | Good Condition (0) | Usually inaccessible or unlikely to be disturbed (0) |

| Normal Occupancy | Score | Likelihood of disturbance | Score | Exposure Potential | Score | Maintenance Activity | Score |
|---|---|---|---|---|---|---|---|
| Surveyor comments | Unable to safely inspect at time of survey due to risk of damage to fixed flooring. | | | | | | |

| Normal Occupancy | Score | Likelihood of disturbance | Score | Exposure Potential | Score | Maintenance Activity | Score |
|---|---|---|---|---|---|---|---|
| Recommendation | Inspection required | | | | | | |

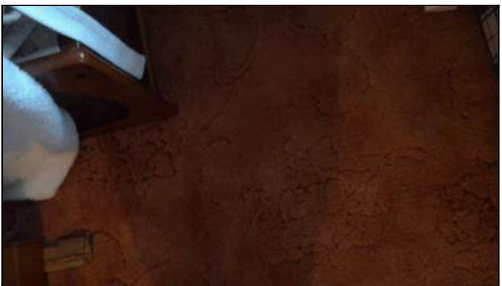
| | Survey Date: | Lead Surveyor | Survey Type | Floor | Analysis |
|---|---|---|---|---|---|
| | 6 Nov 2017 | Dave Milton | Management Survey | 1st | Crocidolite (or unknown) (3) |
| | Visual (SP) | Reinforced Composite (1) | Completely Sealed (0) | Good Condition (0) | Usually inaccessible or unlikely to be disturbed (0) |

| Normal Occupancy | Score | Likelihood of disturbance | Score | Exposure Potential | Score | Maintenance Activity | Score |
|---|---|---|---|---|---|---|---|
| Surveyor comments | Unable to safely inspect at time of survey due to risk of damage to fixed flooring. | | | | | | |

| Normal Occupancy | Score | Likelihood of disturbance | Score | Exposure Potential | Score | Maintenance Activity | Score |
|---|---|---|---|---|---|---|---|
| Recommendation | Inspection required | | | | | | |

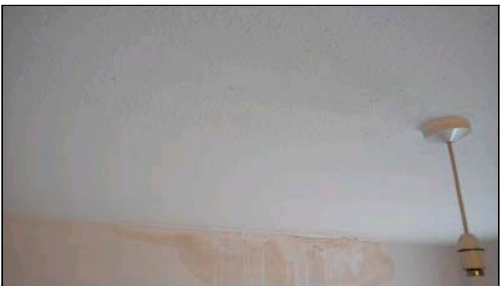
| | Survey Date: | Lead Surveyor | Survey Type | Floor | Analysis |
|---|---|---|---|---|---|
| | 6 Nov 2017 | Dave Milton | Management Survey | 1st | No Asbestos Detected (0) |
| | As AE004031 (SP) | Textured Coating (1) | Completely Sealed (0) | Good Condition (0) | Occasionally likely to be disturbed (1) |

| Normal Occupancy | Score | Likelihood of disturbance | Score | Exposure Potential | Score | Maintenance Activity | Score |
|---|---|---|---|---|---|---|---|
| Recommendation | No further action required | | | | | | |

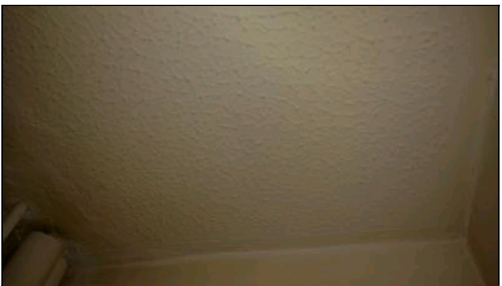
| | Survey Date: | Lead Surveyor | Survey Type | Floor | Analysis |
|---|---|---|---|---|---|
| | 6 Nov 2017 | Dave Milton | Management Survey | 1st | No Asbestos Detected (0) |
| | As AE004031 (SP) | Textured Coating (1) | Completely Sealed (0) | Good Condition (0) | Occasionally likely to be disturbed (1) |

| Normal Occupancy | Score | Likelihood of disturbance | Score | Exposure Potential | Score | Maintenance Activity | Score |
|---|---|---|---|---|---|---|---|
| Recommendation | No further action required | | | | | | |

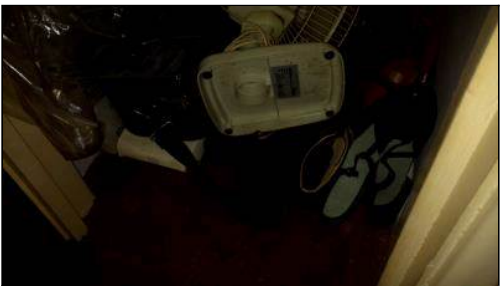
| | Survey Date: | Lead Surveyor | Survey Type | Floor | Analysis |
|---|---|---|---|---|---|
| | 6 Nov 2017 | Dave Milton | Management Survey | 1st | Crocitolite (or unknown) (3) |
| | Visual (SP) | Reinforced Composite (1) | Completely Sealed (0) | Good Condition (0) | Usually inaccessible or unlikely to be disturbed (0) |

| Normal Occupancy | Score | Likelihood of disturbance | Score | Exposure Potential | Score | Maintenance Activity | Score |
|---|---|---|---|---|---|---|---|
| Surveyor comments | Unable to safely inspect at time of survey due to risk of damage to fixed flooring. | | | | | | |

| Normal Occupancy | Score | Likelihood of disturbance | Score | Exposure Potential | Score | Maintenance Activity | Score |
|---|---|---|---|---|---|---|---|
| Recommendation | Inspection required | | | | | | |

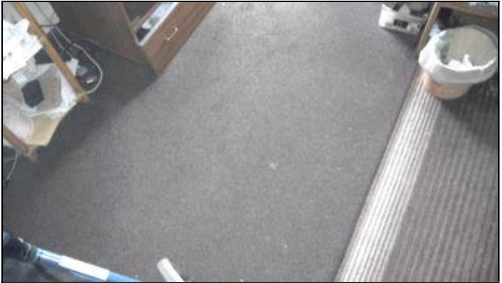
| | Survey Date: | Lead Surveyor | Survey Type | Floor | Analysis |
|---|---|---|---|---|---|
| | 6 Nov 2017 | Dave Milton | Management Survey | 1st | Crocitolite (or unknown) (3) |
| | Visual (SP) | Reinforced Composite (1) | Completely Sealed (0) | Good Condition (0) | Usually inaccessible or unlikely to be disturbed (0) |

| Normal Occupancy | Score | Likelihood of disturbance | Score | Exposure Potential | Score | Maintenance Activity | Score |
|---|---|---|---|---|---|---|---|
| Surveyor comments | Unable to safely inspect at time of survey due to risk of damage to fixed flooring. | | | | | | |

| Normal Occupancy | Score | Likelihood of disturbance | Score | Exposure Potential | Score | Maintenance Activity | Score |
|---|---|---|---|---|---|---|---|
| Recommendation | Inspection required | | | | | | |

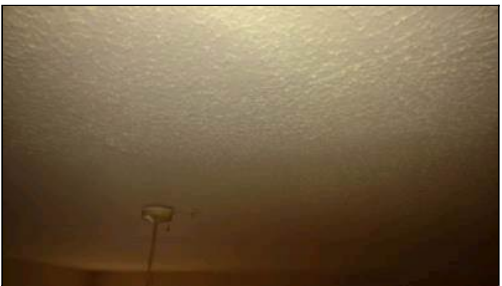
| | Survey Date: | Lead Surveyor | Survey Type | Floor | Analysis |
|---|---|---|---|---|---|
| | 6 Nov 2017 | Dave Milton | Management Survey | 1st | No Asbestos Detected (0) |
| | As AE004031 (SP) | Textured Coating (1) | Completely Sealed (0) | Good Condition (0) | Occasionally likely to be disturbed (1) |

| Normal Occupancy | Score | Likelihood of disturbance | Score | Exposure Potential | Score | Maintenance Activity | Score |
|---|---|---|---|---|---|---|---|
| Recommendation | No further action required | | | | | | |

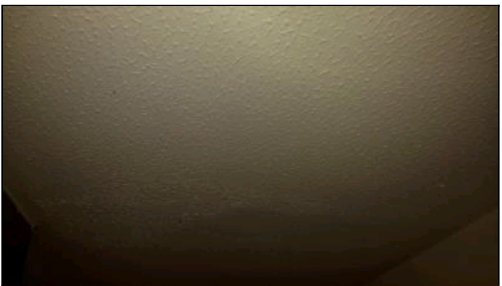
| | Survey Date: | Lead Surveyor | Survey Type | Floor | Analysis |
|---|---|---|---|---|---|
| | 6 Nov 2017 | Dave Milton | Management Survey | 1st | No Asbestos Detected (0) |
| | As AE004031 (SP) | Textured Coating (1) | Completely Sealed (0) | Good Condition (0) | Occasionally likely to be disturbed (1) |

| Normal Occupancy | Score | Likelihood of disturbance | Score | Exposure Potential | Score | Maintenance Activity | Score |
|---|---|---|---|---|---|---|---|
| Recommendation | No further action required | | | | | | |

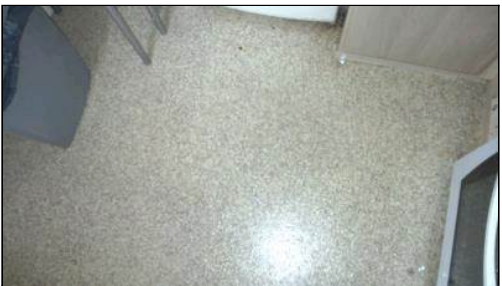
| | Survey Date: | Lead Surveyor | Survey Type | Floor | Analysis |
|---|---|---|---|---|---|
| | 6 Nov 2017 | Dave Milton | Management Survey | 1st | Crocitolite (or unknown)<br>(3) |
| | Visual (SP) | Reinforced Composite (1) | Completely Sealed (0) | Good Condition (0) | Usually inaccessible or unlikely to be disturbed (0) |

| Normal Occupancy | Score | Likelihood of disturbance | Score | Exposure Potential | Score | Maintenance Activity | Score |
|---|---|---|---|---|---|---|---|
| Surveyor comments | Unable to safely inspect at time of survey due to risk of damage to fixed flooring. | | | | | | |

| Normal Occupancy | Score | Likelihood of disturbance | Score | Exposure Potential | Score | Maintenance Activity | Score |
|---|---|---|---|---|---|---|---|
| Recommendation | Inspection required | | | | | | |

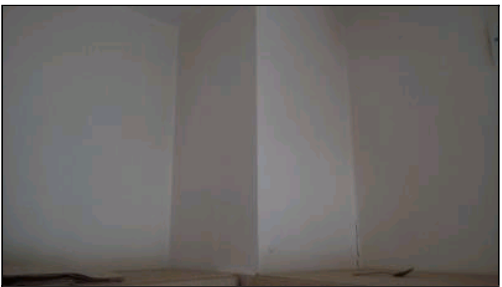
| | Survey Date: | Lead Surveyor | Survey Type | Floor | Analysis |
|---|---|---|---|---|---|
| | 6 Nov 2017 | Dave Milton | Management Survey | 1st | No Asbestos Detected (0) |
| | As AE004032 (SP) | Insulation board (2) | Surface Sealed (1) | Good Condition (0) | Easily disturbed (2) |

| Normal Occupancy | Score | Likelihood of disturbance | Score | Exposure Potential | Score | Maintenance Activity | Score |
|---|---|---|---|---|---|---|---|
| Recommendation | No further action required | | | | | | |
