## Asbestos Management Survey with Targeted Refurbishment Survey

25 Cyncoed  
Ynysybwl  
Pontypridd  
Mid Glamorgan  
CF373PL  
UPRN: 007930

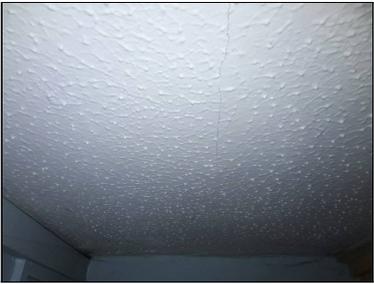
<b>Survey Date:</b>	<b>Lead Surveyor</b>	<b>Survey Type</b>	<b>Floor</b>	<b>Analysis</b>
	4 Aug 2021	Dave Milton	Refurbishment and Demolition Survey	Ground	Chrysotile (1)
	<b>Building</b>	<b>Room</b>	<b>Item</b>	<b>Quantity</b>	
	Flat 25, Block 25-28	Hall G01	Textured coating to concrete ceiling	8m <sup>2</sup>	
	<b>Sample No (S,SP,P,As)</b>	<b>Product Type</b>	<b>Surface Treatment</b>	<b>Condition</b>	<b>Accessibility</b>
BF000302 (S)	Textured Coating (1)	Completely Sealed (0)	Low Damage (1)	Occasionally likely to be disturbed (1)

Normal Occupancy	Score	Likelihood of disturbance	Score	Exposure Potential	Score	Maintenance Activity	Score
Main type of activity	1	Location	2	Number of occupants	1	Type of Maintenance	1
		Accessibility	1	Frequency of use	3	Frequency of maintenance	1
		Amount	1	Average Time	0		
Average Score	1	Average Score	2	Average Score	2	Average Score	1
Average of Priority	6						
Material Assessment Score	3						
Recommendation	Manage and re-inspect						
Surveyor comments	N/A

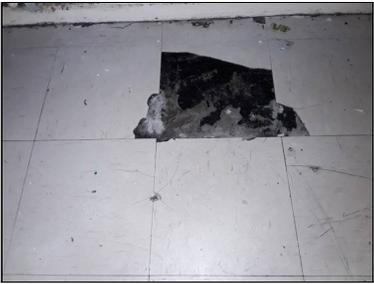
<b>Survey Date:</b>	<b>Lead Surveyor</b>	<b>Survey Type</b>	<b>Floor</b>	<b>Analysis</b>
	4 Aug 2021	Dave Milton	Refurbishment and Demolition Survey	Ground	
	<b>Building</b>	<b>Room</b>	<b>Item</b>	<b>Quantity</b>	
	Flat 25, Block 25-28	Hall G01	Beige vinyl tiles to concrete floor	7m <sup>2</sup>	
	<b>Sample No (S,SP,P,As)</b>	<b>Product Type</b>	<b>Surface Treatment</b>	<b>Condition</b>	<b>Accessibility</b>
BF000303 (S)	Well Bound Material (1)	Completely Sealed (0)	Medium Damage (2)	Routinely disturbed (3)

Normal Occupancy	Score	Likelihood of disturbance	Score	Exposure Potential	Score	Maintenance Activity	Score
Main type of activity	N/A	Location	N/A	Number of occupants	N/A	Type of Maintenance	N/A
		Accessibility	N/A	Frequency of use	N/A	Frequency of maintenance	N/A
		Amount	N/A	Average Time	N/A		
Average Score	N/A	Average Score	N/A	Average Score	N/A	Average Score	N/A
Average of Priority	N/A						
Material Assessment Score	N/A						
Recommendation	No further action required						
Surveyor comments	N/A

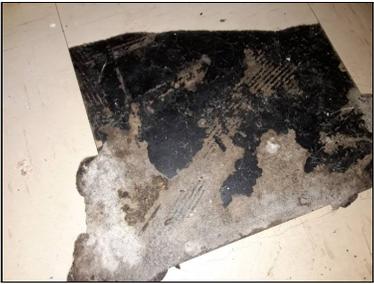
<b>Survey Date:</b>	<b>Lead Surveyor</b>	<b>Survey Type</b>	<b>Floor</b>	<b>Analysis</b>
	4 Aug 2021	Dave Milton	Refurbishment and Demolition Survey	Ground	Chrysotile (1)
	<b>Building</b>	<b>Room</b>	<b>Item</b>	<b>Quantity</b>	
	Flat 25, Block 25-28	Hall G01	Bitumen adhesive residue to concrete floor beneath beige vinyl tiles	8m <sup>2</sup>	
	<b>Sample No (S,SP,P,As)</b>	<b>Product Type</b>	<b>Surface Treatment</b>	<b>Condition</b>	<b>Accessibility</b>
BF000304 (S)	Bituminous material (1)	Completely Sealed (0)	Low Damage (1)	Easily disturbed (2)

Normal Occupancy	Score	Likelihood of disturbance	Score	Exposure Potential	Score	Maintenance Activity	Score
Main type of activity	1	Location	2	Number of occupants	1	Type of Maintenance	1
		Accessibility	2	Frequency of use	3	Frequency of maintenance	1
		Amount	1	Average Time	0		
Average Score	1	Average Score	2	Average Score	2	Average Score	1
Average of Priority	6						
Material Assessment Score	3						
Recommendation	Manage in-situ or remove if affected by works						
Surveyor comments	N/A

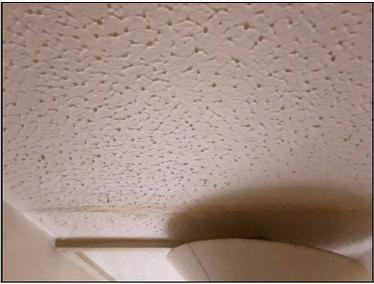
<b>Survey Date:</b>	<b>Lead Surveyor</b>	<b>Survey Type</b>	<b>Floor</b>	<b>Analysis</b>
	4 Aug 2021	Dave Milton	Refurbishment and Demolition Survey	Ground	Chrysotile (1)
	<b>Building</b>	<b>Room</b>	<b>Item</b>	<b>Quantity</b>	
	Flat 25, Block 25-28	Toilet G02	Textured coating to concrete ceiling	1.5m <sup>2</sup>	
	<b>Sample No (S,SP,P,As)</b>	<b>Product Type</b>	<b>Surface Treatment</b>	<b>Condition</b>	<b>Accessibility</b>
As BF000302 (SP)	Textured Coating (1)	Completely Sealed (0)	Low Damage (1)	Occasionally likely to be disturbed (1)

Normal Occupancy	Score	Likelihood of disturbance	Score	Exposure Potential	Score	Maintenance Activity	Score
Main type of activity	1	Location	2	Number of occupants	1	Type of Maintenance	1
		Accessibility	1	Frequency of use	3	Frequency of maintenance	1
		Amount	1	Average Time	0		
Average Score	1	Average Score	2	Average Score	2	Average Score	1
Average of Priority	6						
Material Assessment Score	3						
Recommendation	Manage and re-inspect						
Surveyor comments	N/A

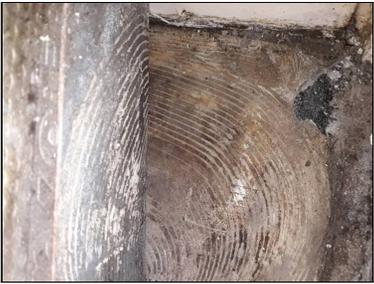
<b>Survey Date:</b>	<b>Lead Surveyor</b>	<b>Survey Type</b>	<b>Floor</b>	<b>Analysis</b>
	4 Aug 2021	Dave Milton	Refurbishment and Demolition Survey	Ground	Chrysotile (1)
	<b>Building</b>	<b>Room</b>	<b>Item</b>	<b>Quantity</b>	
	Flat 25, Block 25-28	Toilet G02	Bitumen adhesive residue to concrete floor	1.5m <sup>2</sup>	
	<b>Sample No (S,SP,P,As)</b>	<b>Product Type</b>	<b>Surface Treatment</b>	<b>Condition</b>	<b>Accessibility</b>
BF000306 (S)	Bituminous material (1)	Completely Sealed (0)	Low Damage (1)	Usually inaccessible or unlikely to be disturbed (0)

Normal Occupancy	Score	Likelihood of disturbance	Score	Exposure Potential	Score	Maintenance Activity	Score
Main type of activity	1	Location	2	Number of occupants	1	Type of Maintenance	0
		Accessibility	0	Frequency of use	3	Frequency of maintenance	0
		Amount	1	Average Time	0		
Average Score	1	Average Score	1	Average Score	2	Average Score	0
Average of Priority	4						
Material Assessment Score	3						
Recommendation	Manage in-situ or remove if affected by works						
Surveyor comments	Located beneath non-suspect screed, non-suspect red vinyl flooring and non-suspect thin beige vinyl tiles.

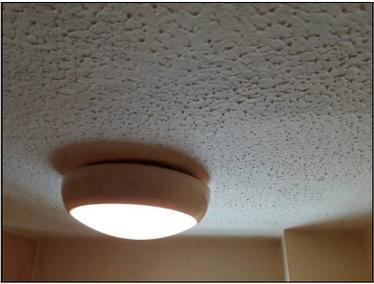
<b>Survey Date:</b>	<b>Lead Surveyor</b>	<b>Survey Type</b>	<b>Floor</b>	<b>Analysis</b>
	4 Aug 2021	Dave Milton	Refurbishment and Demolition Survey	Ground	Chrysotile (1)
	<b>Building</b>	<b>Room</b>	<b>Item</b>	<b>Quantity</b>	
	Flat 25, Block 25-28	Bathroom G03	Textured coating to concrete ceiling	3m <sup>2</sup>	
	<b>Sample No (S,SP,P,As)</b>	<b>Product Type</b>	<b>Surface Treatment</b>	<b>Condition</b>	<b>Accessibility</b>
As BF000302 (SP)	Textured Coating (1)	Completely Sealed (0)	Low Damage (1)	Occasionally likely to be disturbed (1)

Normal Occupancy	Score	Likelihood of disturbance	Score	Exposure Potential	Score	Maintenance Activity	Score
Main type of activity	1	Location	2	Number of occupants	1	Type of Maintenance	1
		Accessibility	1	Frequency of use	3	Frequency of maintenance	1
		Amount	1	Average Time	0		
Average Score	1	Average Score	2	Average Score	2	Average Score	1
Average of Priority	6						
Material Assessment Score	3						
Recommendation	Manage and re-inspect						
Surveyor comments	N/A

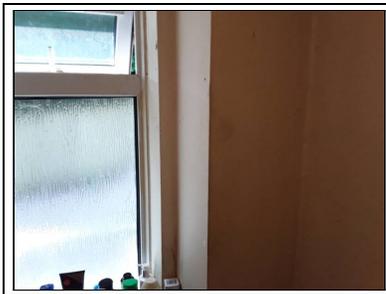
<b>Survey Date:</b>	<b>Lead Surveyor</b>	<b>Survey Type</b>	<b>Floor</b>	<b>Analysis</b>
4 Aug 2021	Dave Milton	Refurbishment and Demolition Survey	Ground	No Asbestos Detected (0)
<b>Building</b>	<b>Room</b>	<b>Item</b>	<b>Quantity</b>	
Flat 25, Block 25-28	Bathroom G03	Insulating board boxing	2m <sup>2</sup>	
<b>Sample No (S,SP,P,As)</b>	<b>Product Type</b>	<b>Surface Treatment</b>	<b>Condition</b>	<b>Accessibility</b>
BF000307 (S)	Insulating Board (0)	Surface Sealed (1)	Good Condition (0)	Easily disturbed (2)

Normal Occupancy	Score	Likelihood of disturbance	Score	Exposure Potential	Score	Maintenance Activity	Score
Main type of activity	N/A	Location	N/A	Number of occupants	N/A	Type of Maintenance	N/A
		Accessibility	N/A	Frequency of use	N/A	Frequency of maintenance	N/A
		Amount	N/A	Average Time	N/A		
Average Score	N/A	Average Score	N/A	Average Score	N/A	Average Score	N/A
Average of Priority	N/A						
Material Assessment Score	N/A						
Recommendation	No further action required						
Surveyor comments	N/A

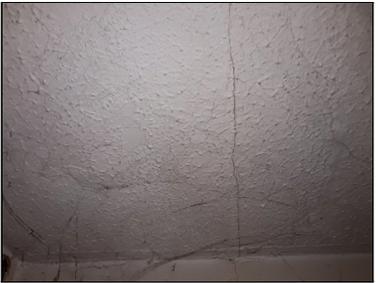
<b>Survey Date:</b>	<b>Lead Surveyor</b>	<b>Survey Type</b>	<b>Floor</b>	<b>Analysis</b>
	4 Aug 2021	Dave Milton	Management Survey	Ground	Chrysotile (1)
	<b>Building</b>	<b>Room</b>	<b>Item</b>	<b>Quantity</b>	
	Flat 25, Block 25-28	Boiler Cupboard G04	Textured coating to concrete ceiling	1m <sup>2</sup>	
	<b>Sample No (S,SP,P,As)</b>	<b>Product Type</b>	<b>Surface Treatment</b>	<b>Condition</b>	<b>Accessibility</b>
As BF000302 (SP)	Textured Coating (1)	Completely Sealed (0)	Low Damage (1)	Occasionally likely to be disturbed (1)

Normal Occupancy	Score	Likelihood of disturbance	Score	Exposure Potential	Score	Maintenance Activity	Score
Main type of activity	0	Location	2	Number of occupants	1	Type of Maintenance	1
		Accessibility	1	Frequency of use	3	Frequency of maintenance	1
		Amount	1	Average Time	0		
Average Score	0	Average Score	2	Average Score	2	Average Score	1
Average of Priority	5						
Material Assessment Score	3						
Recommendation	Manage and re-inspect						
Surveyor comments	N/A

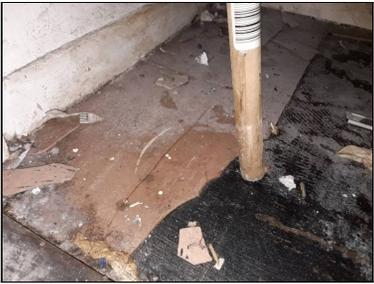
<b>Survey Date:</b>	<b>Lead Surveyor</b>	<b>Survey Type</b>	<b>Floor</b>	<b>Analysis</b>
	4 Aug 2021	Dave Milton	Management Survey	Ground	Chrysotile (1)
	<b>Building</b>	<b>Room</b>	<b>Item</b>	<b>Quantity</b>	
	Flat 25, Block 25-28	Boiler Cupboard G04	Brown vinyl tiles and bitumen adhesive to concrete floor	1m <sup>2</sup>	
	<b>Sample No (S,SP,P,As)</b>	<b>Product Type</b>	<b>Surface Treatment</b>	<b>Condition</b>	<b>Accessibility</b>
	BF000309 (S)	Well Bound Material (1)	Completely Sealed (0)	High Damage (3)	Routinely disturbed (3)

Normal Occupancy	Score	Likelihood of disturbance	Score	Exposure Potential	Score	Maintenance Activity	Score
Main type of activity	0	Location	2	Number of occupants	1	Type of Maintenance	1
		Accessibility	3	Frequency of use	3	Frequency of maintenance	1
		Amount	1	Average Time	0		
Average Score	0	Average Score	2	Average Score	2	Average Score	1
Average of Priority	5						
Material Assessment Score	5						
Recommendation	Remove						
Surveyor comments	N/A

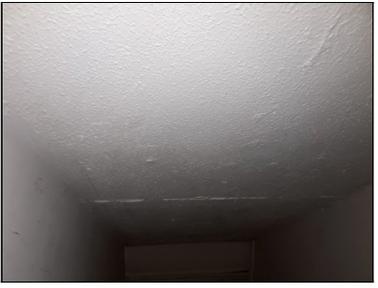
<b>Survey Date:</b>	<b>Lead Surveyor</b>	<b>Survey Type</b>	<b>Floor</b>	<b>Analysis</b>
	4 Aug 2021	Dave Milton	Management Survey	Ground	Chrysotile (1)
	<b>Building</b>	<b>Room</b>	<b>Item</b>	<b>Quantity</b>	
	Flat 25, Block 25-28	Understairs Cupboard G05	Textured coating to concrete ceiling	2m <sup>2</sup>	
	<b>Sample No (S,SP,P,As)</b>	<b>Product Type</b>	<b>Surface Treatment</b>	<b>Condition</b>	<b>Accessibility</b>
As BF000302 (SP)	Textured Coating (1)	Completely Sealed (0)	Low Damage (1)	Occasionally likely to be disturbed (1)

Normal Occupancy	Score	Likelihood of disturbance	Score	Exposure Potential	Score	Maintenance Activity	Score
Main type of activity	0	Location	2	Number of occupants	1	Type of Maintenance	1
		Accessibility	1	Frequency of use	3	Frequency of maintenance	1
		Amount	1	Average Time	0		
Average Score	0	Average Score	2	Average Score	2	Average Score	1
Average of Priority	5						
Material Assessment Score	3						
Recommendation	Manage and re-inspect						
Surveyor comments	N/A

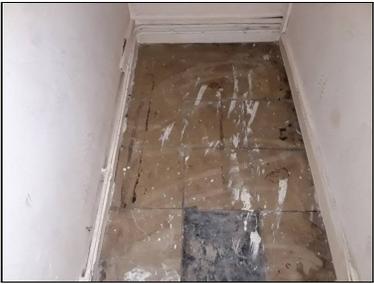
<b>Survey Date:</b>	<b>Lead Surveyor</b>	<b>Survey Type</b>	<b>Floor</b>	<b>Analysis</b>
	4 Aug 2021	Dave Milton	Management Survey	Ground	Chrysotile (1)
	<b>Building</b>	<b>Room</b>	<b>Item</b>	<b>Quantity</b>	
	Flat 25, Block 25-28	Understairs Cupboard G05	Brown vinyl tiles and bitumen adhesive to concrete floor	2m <sup>2</sup>	
	<b>Sample No (S,SP,P,As)</b>	<b>Product Type</b>	<b>Surface Treatment</b>	<b>Condition</b>	<b>Accessibility</b>
	As BF000309 (SP)	Well Bound Material (1)	Completely Sealed (0)	Low Damage (1)	Routinely disturbed (3)

Normal Occupancy	Score	Likelihood of disturbance	Score	Exposure Potential	Score	Maintenance Activity	Score
Main type of activity	0	Location	2	Number of occupants	1	Type of Maintenance	1
		Accessibility	3	Frequency of use	3	Frequency of maintenance	1
		Amount	1	Average Time	0		
Average Score	0	Average Score	2	Average Score	2	Average Score	1
Average of Priority	5						
Material Assessment Score	3						
Recommendation	Manage and re-inspect						
Surveyor comments	N/A

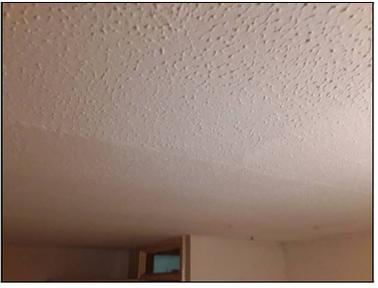
<b>Survey Date:</b>	<b>Lead Surveyor</b>	<b>Survey Type</b>	<b>Floor</b>	<b>Analysis</b>
	4 Aug 2021	Dave Milton	Management Survey	Ground	Chrysotile (1)
	<b>Building</b>	<b>Room</b>	<b>Item</b>	<b>Quantity</b>	
	Flat 25, Block 25-28	Bedroom 1 G06	Textured coating to concrete ceiling	10m <sup>2</sup>	
	<b>Sample No (S,SP,P,As)</b>	<b>Product Type</b>	<b>Surface Treatment</b>	<b>Condition</b>	<b>Accessibility</b>
	As BF000302 (SP)	Textured Coating (1)	Completely Sealed (0)	Low Damage (1)	Occasionally likely to be disturbed (1)

Normal Occupancy	Score	Likelihood of disturbance	Score	Exposure Potential	Score	Maintenance Activity	Score
Main type of activity	1	Location	2	Number of occupants	1	Type of Maintenance	1
		Accessibility	1	Frequency of use	3	Frequency of maintenance	1
		Amount	2	Average Time	3		
Average Score	1	Average Score	2	Average Score	3	Average Score	1
Average of Priority	7						
Material Assessment Score	3						
Recommendation	Manage and re-inspect						
Surveyor comments	N/A

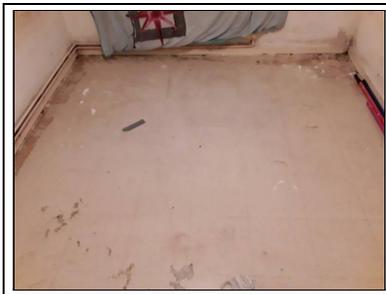
<b>Survey Date:</b>	<b>Lead Surveyor</b>	<b>Survey Type</b>	<b>Floor</b>	<b>Analysis</b>
4 Aug 2021	Dave Milton	Management Survey	Ground	
<b>Building</b>	<b>Room</b>	<b>Item</b>	<b>Quantity</b>	
Flat 25, Block 25-28	Bedroom 1 G06	Beige vinyl tiles to concrete floor	10m <sup>2</sup>	No Asbestos Detected (0)
<b>Sample No (S,SP,P,As)</b>	<b>Product Type</b>	<b>Surface Treatment</b>	<b>Condition</b>	<b>Accessibility</b>
As BF000303 (SP)	Well Bound Material (1)	Completely Sealed (0)	Medium Damage (2)	Routinely disturbed (3)

Normal Occupancy	Score	Likelihood of disturbance	Score	Exposure Potential	Score	Maintenance Activity	Score
Main type of activity	N/A	Location	N/A	Number of occupants	N/A	Type of Maintenance	N/A
		Accessibility	N/A	Frequency of use	N/A	Frequency of maintenance	N/A
		Amount	N/A	Average Time	N/A		
Average Score	N/A	Average Score	N/A	Average Score	N/A	Average Score	N/A
Average of Priority	N/A						
Material Assessment Score	N/A						
Recommendation	No further action required						
Surveyor comments	N/A

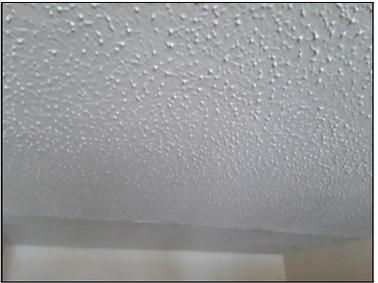
<b>Survey Date:</b>	<b>Lead Surveyor</b>	<b>Survey Type</b>	<b>Floor</b>	<b>Analysis</b>
	4 Aug 2021	Dave Milton	Management Survey	Ground	Chrysotile (1)
	<b>Building</b>	<b>Room</b>	<b>Item</b>	<b>Quantity</b>	
	Flat 25, Block 25-28	Bedroom 2 G07	Textured coating to concrete ceiling	12m <sup>2</sup>	
	<b>Sample No (S,SP,P,As)</b>	<b>Product Type</b>	<b>Surface Treatment</b>	<b>Condition</b>	<b>Accessibility</b>
As BF000302 (SP)	Textured Coating (1)	Completely Sealed (0)	Low Damage (1)	Occasionally likely to be disturbed (1)

Normal Occupancy	Score	Likelihood of disturbance	Score	Exposure Potential	Score	Maintenance Activity	Score
Main type of activity	1	Location	2	Number of occupants	1	Type of Maintenance	1
		Accessibility	1	Frequency of use	3	Frequency of maintenance	1
		Amount	2	Average Time	3		
Average Score	1	Average Score	2	Average Score	3	Average Score	1
Average of Priority	7						
Material Assessment Score	3						
Recommendation	Manage and re-inspect						
Surveyor comments	N/A

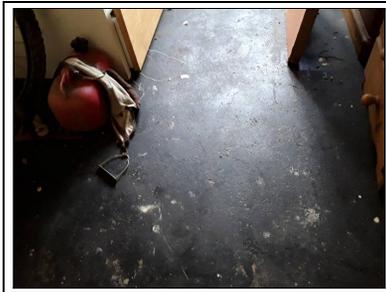
<b>Survey Date:</b>	<b>Lead Surveyor</b>	<b>Survey Type</b>	<b>Floor</b>	<b>Analysis</b>
4 Aug 2021	Dave Milton	Management Survey	Ground	Chrysotile (1)
<b>Building</b>	<b>Room</b>	<b>Item</b>	<b>Quantity</b>	
Flat 25, Block 25-28	Bedroom 2 G07	Bitumen adhesive residue to concrete floor	12m <sup>2</sup>	
<b>Sample No (S,SP,P,As)</b>	<b>Product Type</b>	<b>Surface Treatment</b>	<b>Condition</b>	<b>Accessibility</b>
As BF000304 (SP)	Bituminous material (1)	Completely Sealed (0)	Low Damage (1)	Routinely disturbed (3)

Normal Occupancy	Score	Likelihood of disturbance	Score	Exposure Potential	Score	Maintenance Activity	Score
Main type of activity	1	Location	2	Number of occupants	1	Type of Maintenance	1
		Accessibility	3	Frequency of use	3	Frequency of maintenance	1
		Amount	2	Average Time	3		
Average Score	1	Average Score	3	Average Score	3	Average Score	1
Average of Priority	<b>8</b>						
Material Assessment Score	<b>3</b>						
Recommendation	Encapsulate or repair						
Surveyor comments	N/A

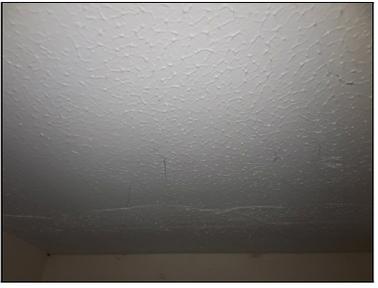
<b>Survey Date:</b>	<b>Lead Surveyor</b>	<b>Survey Type</b>	<b>Floor</b>	<b>Analysis</b>
	4 Aug 2021	Dave Milton	Management Survey	Ground	Chrysotile (1)
	<b>Building</b>	<b>Room</b>	<b>Item</b>	<b>Quantity</b>	
	Flat 25, Block 25-28	Cupboard G08	Textured coating to concrete ceiling	1.5	
	<b>Sample No (S,SP,P,As)</b>	<b>Product Type</b>	<b>Surface Treatment</b>	<b>Condition</b>	<b>Accessibility</b>
	As BF000302 (SP)	Textured Coating (1)	Completely Sealed (0)	Good Condition (0)	Occasionally likely to be disturbed (1)

Normal Occupancy	Score	Likelihood of disturbance	Score	Exposure Potential	Score	Maintenance Activity	Score
Main type of activity	0	Location	2	Number of occupants	1	Type of Maintenance	1
		Accessibility	1	Frequency of use	3	Frequency of maintenance	1
		Amount	1	Average Time	0		
Average Score	0	Average Score	2	Average Score	2	Average Score	1
Average of Priority	5						
Material Assessment Score	2						
Recommendation	Manage and re-inspect						
Surveyor comments	N/A

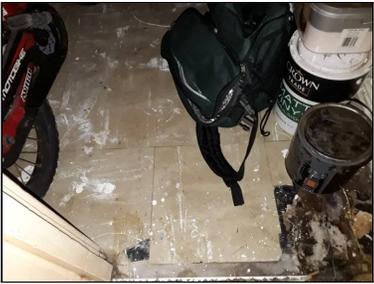
<b>Survey Date:</b>	<b>Lead Surveyor</b>	<b>Survey Type</b>	<b>Floor</b>	<b>Analysis</b>
	4 Aug 2021	Dave Milton	Management Survey	Ground	Chrysotile (1)
	<b>Building</b>	<b>Room</b>	<b>Item</b>	<b>Quantity</b>	
	Flat 25, Block 25-28	Cupboard G08	Brown vinyl tiles and bitumen adhesive to concrete floor	1.5m <sup>2</sup>	
	<b>Sample No (S,SP,P,As)</b>	<b>Product Type</b>	<b>Surface Treatment</b>	<b>Condition</b>	<b>Accessibility</b>
	As BF000309 (SP)	Well Bound Material (1)	Completely Sealed (0)	Low Damage (1)	Routinely disturbed (3)

Normal Occupancy	Score	Likelihood of disturbance	Score	Exposure Potential	Score	Maintenance Activity	Score
Main type of activity	0	Location	2	Number of occupants	1	Type of Maintenance	1
		Accessibility	3	Frequency of use	3	Frequency of maintenance	1
		Amount	1	Average Time	0		
Average Score	0	Average Score	2	Average Score	2	Average Score	1
Average of Priority	5						
Material Assessment Score	3						
Recommendation	Manage and re-inspect						
Surveyor comments	N/A

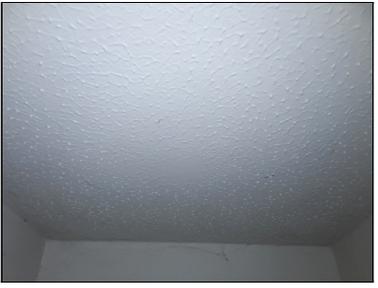
<b>Survey Date:</b>	<b>Lead Surveyor</b>	<b>Survey Type</b>	<b>Floor</b>	<b>Analysis</b>
	4 Aug 2021	Dave Milton	Management Survey	Ground	Chrysotile (1)
	<b>Building</b>	<b>Room</b>	<b>Item</b>	<b>Quantity</b>	
	Flat 25, Block 25-28	Cupboard G09	Textured coating to concrete ceiling	1m <sup>2</sup>	
	<b>Sample No (S,SP,P,As)</b>	<b>Product Type</b>	<b>Surface Treatment</b>	<b>Condition</b>	<b>Accessibility</b>
	As BF000302 (SP)	Textured Coating (1)	Completely Sealed (0)	Good Condition (0)	Occasionally likely to be disturbed (1)

Normal Occupancy	Score	Likelihood of disturbance	Score	Exposure Potential	Score	Maintenance Activity	Score
Main type of activity	0	Location	2	Number of occupants	1	Type of Maintenance	1
		Accessibility	1	Frequency of use	3	Frequency of maintenance	1
		Amount	1	Average Time	0		
Average Score	0	Average Score	2	Average Score	2	Average Score	1
Average of Priority	5						
Material Assessment Score	2						
Recommendation	Manage and re-inspect						
Surveyor comments	N/A

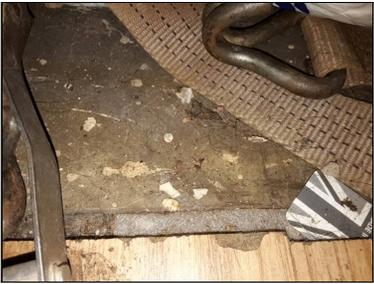
<b>Survey Date:</b>	<b>Lead Surveyor</b>	<b>Survey Type</b>	<b>Floor</b>	<b>Analysis</b>
	4 Aug 2021	Dave Milton	Management Survey	Ground	Chrysotile (1)
	<b>Building</b>	<b>Room</b>	<b>Item</b>	<b>Quantity</b>	
	Flat 25, Block 25-28	Cupboard G09	Brown vinyl tiles and bitumen adhesive to concrete floor	1m <sup>2</sup>	
	<b>Sample No (S,SP,P,As)</b>	<b>Product Type</b>	<b>Surface Treatment</b>	<b>Condition</b>	<b>Accessibility</b>
	As BF000309 (SP)	Well Bound Material (1)	Completely Sealed (0)	Good Condition (0)	Routinely disturbed (3)

Normal Occupancy	Score	Likelihood of disturbance	Score	Exposure Potential	Score	Maintenance Activity	Score
Main type of activity	0	Location	2	Number of occupants	1	Type of Maintenance	1
		Accessibility	3	Frequency of use	3	Frequency of maintenance	1
		Amount	1	Average Time	0		
Average Score	0	Average Score	2	Average Score	2	Average Score	1
Average of Priority	5						
Material Assessment Score	2						
Recommendation	Manage and re-inspect						
Surveyor comments	N/A

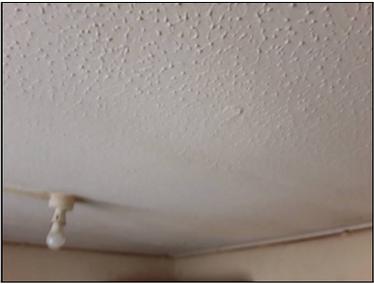
<b>Survey Date:</b>	<b>Lead Surveyor</b>	<b>Survey Type</b>	<b>Floor</b>	<b>Analysis</b>
	4 Aug 2021	Dave Milton	Management Survey	Ground	Chrysotile (1)
	<b>Building</b>	<b>Room</b>	<b>Item</b>	<b>Quantity</b>	
	Flat 25, Block 25-28	Kitchen G10	Textured coating to concrete ceiling	6m <sup>2</sup>	
	<b>Sample No (S,SP,P,As)</b>	<b>Product Type</b>	<b>Surface Treatment</b>	<b>Condition</b>	<b>Accessibility</b>
	As BF000302 (SP)	Textured Coating (1)	Completely Sealed (0)	Low Damage (1)	Occasionally likely to be disturbed (1)

Normal Occupancy	Score	Likelihood of disturbance	Score	Exposure Potential	Score	Maintenance Activity	Score
Main type of activity	1	Location	2	Number of occupants	1	Type of Maintenance	1
		Accessibility	1	Frequency of use	3	Frequency of maintenance	1
		Amount	1	Average Time	1		
Average Score	1	Average Score	2	Average Score	2	Average Score	1
Average of Priority	6						
Material Assessment Score	3						
Recommendation	Manage and re-inspect						
Surveyor comments	N/A

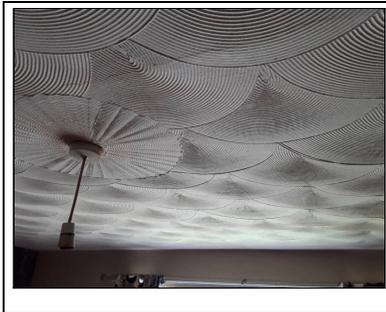
<b>Survey Date:</b>	<b>Lead Surveyor</b>	<b>Survey Type</b>	<b>Floor</b>	<b>Analysis</b>
4 Aug 2021	Dave Milton	Management Survey	Ground	Chrysotile (1)
<b>Building</b>	<b>Room</b>	<b>Item</b>	<b>Quantity</b>	
Flat 25, Block 25-28	Lounge G11	Textured coating to concrete ceiling	18m <sup>2</sup>	
<b>Sample No (S,SP,P,As)</b>	<b>Product Type</b>	<b>Surface Treatment</b>	<b>Condition</b>	<b>Accessibility</b>
BF000310 (S)	Textured Coating (1)	Completely Sealed (0)	Good Condition (0)	Occasionally likely to be disturbed (1)

Normal Occupancy	Score	Likelihood of disturbance	Score	Exposure Potential	Score	Maintenance Activity	Score
Main type of activity	1	Location	2	Number of occupants	1	Type of Maintenance	1
		Accessibility	1	Frequency of use	3	Frequency of maintenance	1
		Amount	2	Average Time	2		
Average Score	1	Average Score	2	Average Score	2	Average Score	1
Average of Priority	6						
Material Assessment Score	2						
Recommendation	Manage and re-inspect						
Surveyor comments	N/A

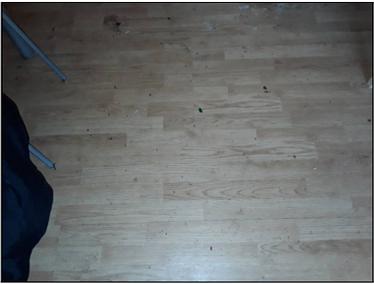
Survey Date:	Lead Surveyor	Survey Type	Floor	Analysis
	4 Aug 2021	Dave Milton	Management Survey	Ground	Chrysotile (1)
	Building	Room	Item	Quantity	
	Flat 25, Block 25-28	Lounge G11	Presumed vinyl tiles to concrete floor beneath fixed laminate flooring	18m <sup>2</sup>	
	Sample No (S,SP,P,As)	Product Type	Surface Treatment	Condition	Accessibility
	Visual (P)	Reinforced Composite (1)	Completely Sealed (0)	Low Damage (1)	Usually inaccessible or unlikely to be disturbed (0)

Normal Occupancy	Score	Likelihood of disturbance	Score	Exposure Potential	Score	Maintenance Activity	Score
Main type of activity	1	Location	2	Number of occupants	1	Type of Maintenance	0
		Accessibility	0	Frequency of use	3	Frequency of maintenance	0
		Amount	2	Average Time	2		
Average Score	1	Average Score	2	Average Score	2	Average Score	0
Average of Priority	5						
Material Assessment Score	3						
Recommendation	Inspection required						
Surveyor comments	No access at time of survey due to potential to cause significant damage to fixtures and fittings.
