## Asbestos Refurbishment Survey

28 Constantine Court  
William Street  
Penygraig  
Rhondda  
CF40 1QL  
UPRN: 6386

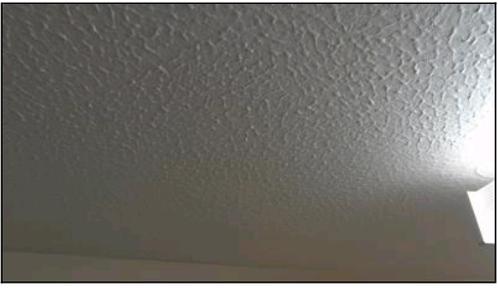
Survey Date:	Lead Surveyor	Survey Type	Floor	Analysis
	8 Nov 2019	Dave Milton	Refurbishment Survey	2nd	No Asbestos Detected (0)
	Building	Room	Item	Quantity	
	Flat 28, Block 1-35	Kitchen 201	Textured coating to plasterboard ceiling	4m <sup>2</sup>	
	Sample No (S,SP,P,As)	Product Type	Surface Treatment	Condition	Accessibility
	AI007888 (S)	Textured Coating (1)	Completely Sealed (0)	Good Condition (0)	Occasionally likely to be disturbed (1)

Normal Occupancy	Score	Likelihood of disturbance	Score	Exposure Potential	Score	Maintenance Activity	Score
Main type of activity	N/A	Location	N/A	Number of occupants	N/A	Type of Maintenance	N/A
		Accessibility	N/A	Frequency of use	N/A	Frequency of maintenance	N/A
		Amount	N/A	Average Time	N/A		
Average Score	N/A	Average Score	N/A	Average Score	N/A	Average Score	N/A
Average of Priority	N/A						
Material Assessment Score	N/A						
Recommendation	No further action required						
Surveyor comments	Non-suspect void above.
