## Refurbishment Survey

3 Llys Ben Bowen Thomas  
Gelligaled Road  
Ystrad  
Pentre  
CF41 7SB  
UPRN: 6440

| Type of survey: | Refurbishment Survey (with MA + PA) | | |
| Date of survey: | 12 Jun 2017 | | |

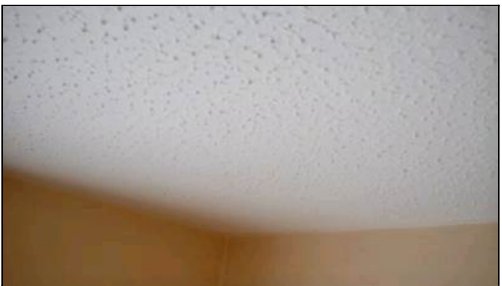
| | Survey Date: | Lead Surveyor | Survey Type | Floor | Analysis |
| | 12 Jun 2017 | Dave Milton | Refurbishment Survey | Ground | Chrysotile (1) |
| | AE003110 (S) | Textured Coating (1) | Completely Sealed (0) | Good Condition (0) | Occasionally likely to be disturbed (1) |

| Normal Occupancy | Score | Likelihood of disturbance | Score | Exposure Potential | Score | Maintenance Activity | Score |
|---|---|---|---|---|---|---|---|
| Recommendation | Manage in-situ or remove if affected by works | | | | | | |

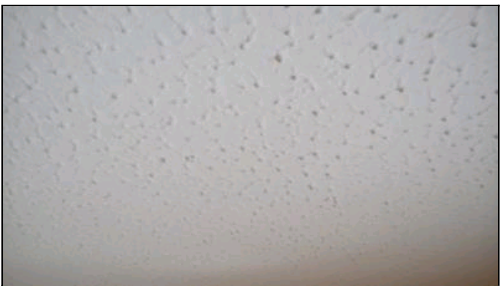
| | Survey Date: | Lead Surveyor | Survey Type | Floor | Analysis |
| | 12 Jun 2017 | Dave Milton | Refurbishment Survey | Ground | Chrysotile (1) |
| | AE003111 (S) | Textured Coating (1) | Completely Sealed (0) | Good Condition (0) | Occasionally likely to be disturbed (1) |

| Normal Occupancy | Score | Likelihood of disturbance | Score | Exposure Potential | Score | Maintenance Activity | Score |
|---|---|---|---|---|---|---|---|
| Recommendation | Manage in-situ or remove if affected by works | | | | | | |

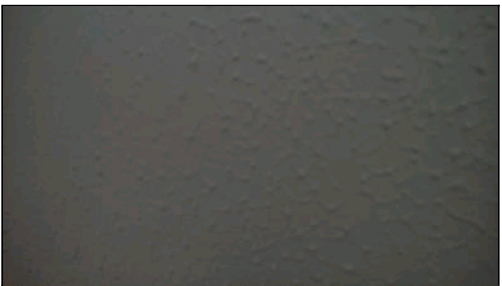
| | Survey Date: | Lead Surveyor | Survey Type | Floor | Analysis |
| | 12 Jun 2017 | Dave Milton | Refurbishment Survey | Ground | Chrysotile (1) |
| | AE003112 (S) | Textured Coating (1) | Completely Sealed (0) | Good Condition (0) | Occasionally likely to be disturbed (1) |

| Recommendation | Manage in-situ or remove if affected by works | | | | | | |

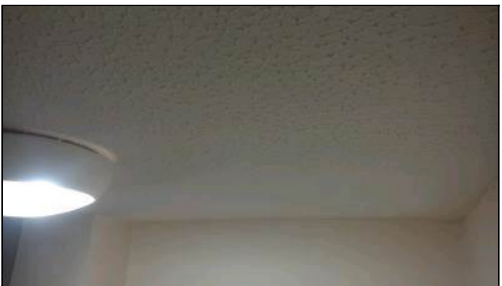
| | Survey Date: | Lead Surveyor | Survey Type | Floor | Analysis |
| | 12 Jun 2017 | Dave Milton | Refurbishment Survey | Ground | Chrysotile (1) |
| | AE003113 (S) | Textured Coating (1) | Completely Sealed (0) | Good Condition (0) | Occasionally likely to be disturbed (1) |

| Recommendation | Manage in-situ or remove if affected by works | | | | | | |

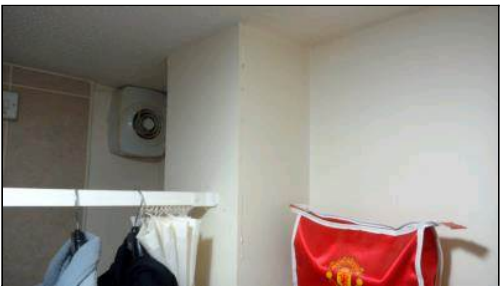
| | Survey Date: | Lead Surveyor | Survey Type | Floor | Analysis |
| | 12 Jun 2017 | Dave Milton | Refurbishment Survey | Ground | No Asbestos Detected (0) |
| | AE003114 (S) | Insulating Board (0) | Surface Sealed (1) | Good Condition (0) | Occasionally likely to be disturbed (1) |

| Normal Occupancy | Score | Likelihood of disturbance | Score | Exposure Potential | Score | Maintenance Activity | Score |
|---|---|---|---|---|---|---|---|
| Recommendation | No further action required | | | | | | |

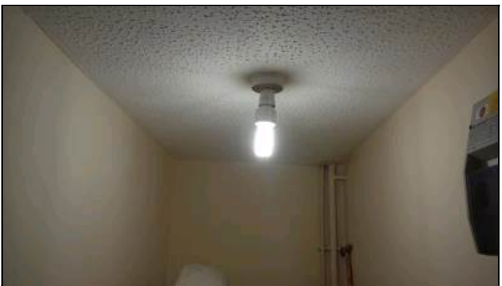
| | Survey Date: | Lead Surveyor | Survey Type | Floor | Analysis |
| | 12 Jun 2017 | Dave Milton | Refurbishment Survey | Ground | Chrysotile (1) |
| | AE003115 (S) | Textured Coating (1) | Completely Sealed (0) | Good Condition (0) | Occasionally likely to be disturbed (1) |

| Normal Occupancy | Score | Likelihood of disturbance | Score | Exposure Potential | Score | Maintenance Activity | Score |
|---|---|---|---|---|---|---|---|
| Recommendation | Manage in-situ or remove if affected by works | | | | | | |

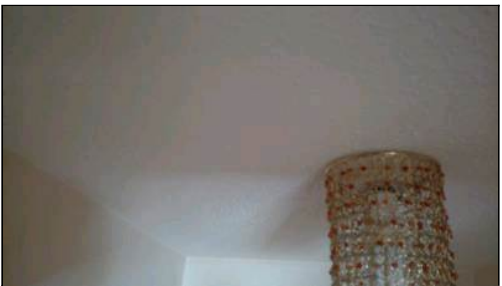
| | Survey Date: | Lead Surveyor | Survey Type | Floor | Analysis |
| | 12 Jun 2017 | Dave Milton | Refurbishment Survey | Ground | Chrysotile (1) |
| | AE003116 (S) | Textured Coating (1) | Completely Sealed (0) | Good Condition (0) | Occasionally likely to be disturbed (1) |

| Normal Occupancy | Score | Likelihood of disturbance | Score | Exposure Potential | Score | Maintenance Activity | Score |
|---|---|---|---|---|---|---|---|
| Recommendation | Manage in-situ or remove if affected by works | | | | | | |
