# **Asbestos Survey Report**

**Project Ref. No: M10538**

**3 St Peters Court**

**Full type 2 survey**

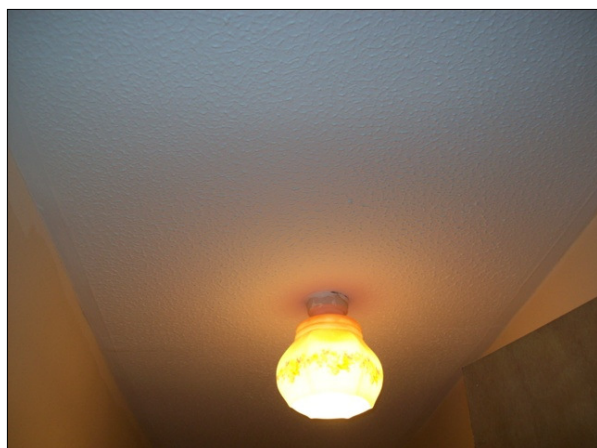
### Asbestos Sample Record - 01a

| <b>Position:</b> | Internal | <b>RISK:</b> | <b>NONE</b> |

N.A.D.I.S textured coating to plasterboard ceiling.

| <b>Action required:</b> | None | | |

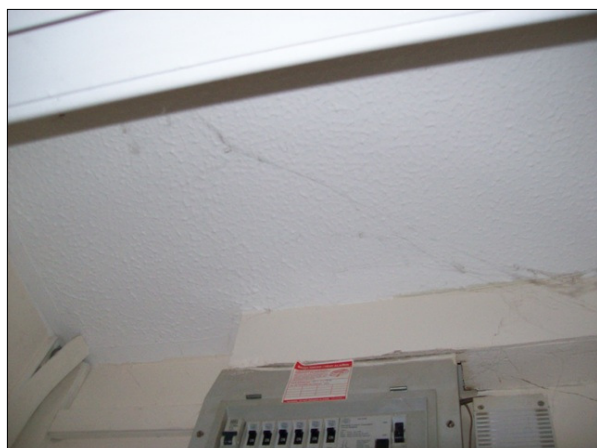
### Asbestos Sample Record - 01m01

| <b>Position:</b> | Internal | <b>RISK:</b> | <b>NONE</b> |

N.A.D.I.S textured coating to plasterboard ceiling.

| <b>Action required:</b> | None | | |

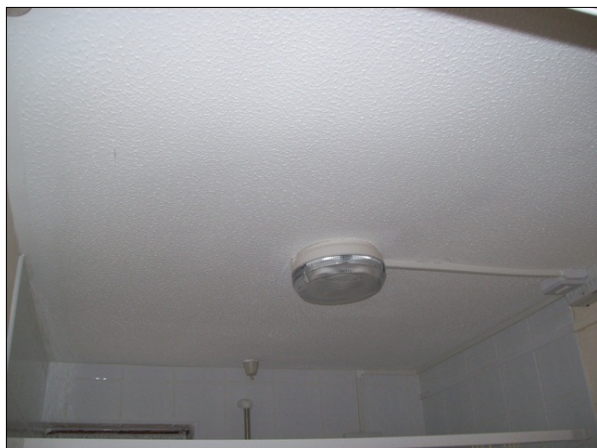
### Asbestos Sample Record - 01m02

| <b>Position:</b> | Internal | <b>RISK:</b> | <b>NONE</b> |

N.A.D.I.S textured coating to plasterboard ceiling.

| <b>Action required:</b> | None | | |

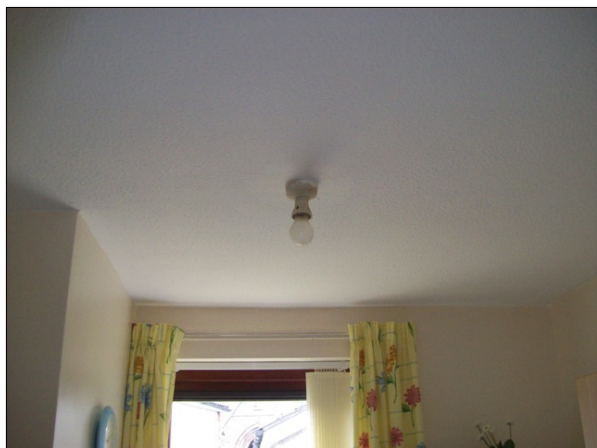
### Asbestos Sample Record - 01m03

| <b>Position:</b> | Internal | <b>RISK:</b> | <b>NONE</b> |

N.A.D.I.S textured coating to plasterboard ceiling.

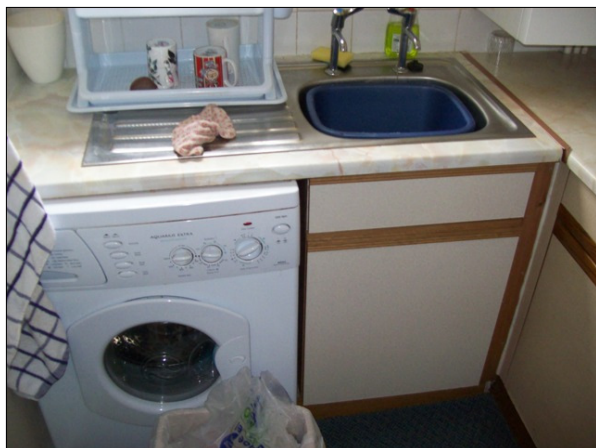
| <b>Position:</b> | Internal | <b>RISK:</b> | <b>NONE</b> |

N.A.D.I.S bitumastic sink pad under sink unit (x2).

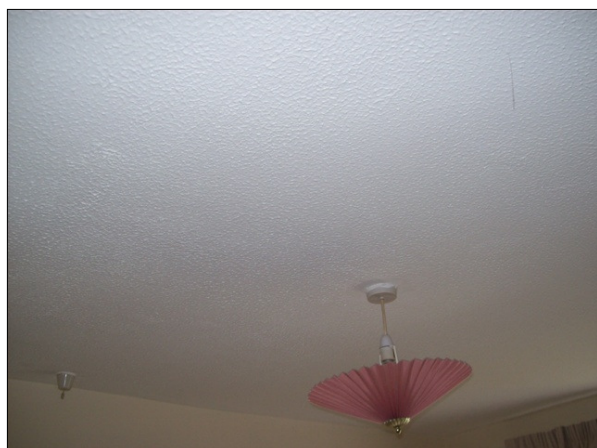
| <b>Position:</b> | Internal | <b>RISK:</b> | <b>NONE</b> |

N.A.D.I.S textured coating to plasterboard ceiling.

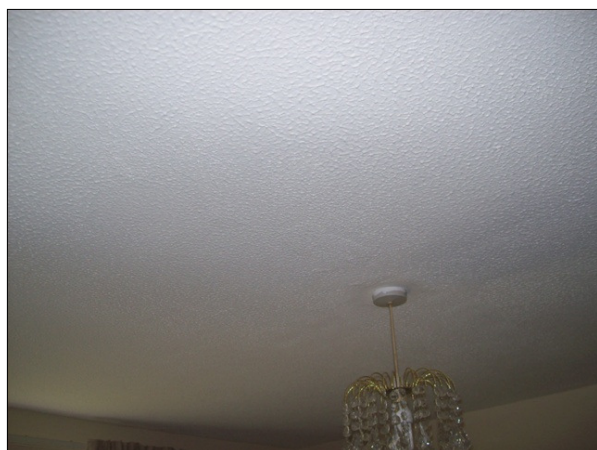
| <b>Position:</b> | Internal | <b>RISK:</b> | <b>NONE</b> |

N.A.D.I.S textured coating to plasterboard ceiling.
