Management Survey

35 Constantine Court  
Constantine Street  
Williamstown  
Penygraig  
Rhondda  
CF40 1QL  
UPRN: 6393

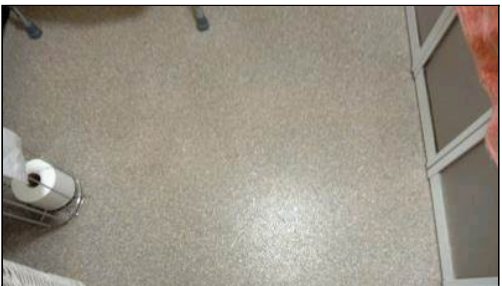
| | Survey Date: | Lead Surveyor | Survey Type | Floor | Analysis |
|---|---|---|---|---|---|
| | 6 Nov 2017 | Dave Milton | Management Survey | 2nd | Crocidolite (or unknown) (3) |
| | Visual (SP) | Reinforced Composite (1) | Completely Sealed (0) | Good Condition (0) | Usually inaccessible or unlikely to be disturbed (0) |

| Normal Occupancy | Score | Likelihood of disturbance | Score | Exposure Potential | Score | Maintenance Activity | Score |
|---|---|---|---|---|---|---|---|
| Surveyor comments | Unable to safely inspect at time of survey due to risk of damage to fixed flooring. | | | | | | |

| Normal Occupancy | Score | Likelihood of disturbance | Score | Exposure Potential | Score | Maintenance Activity | Score |
|---|---|---|---|---|---|---|---|
| Recommendation | Inspection required | | | | | | |

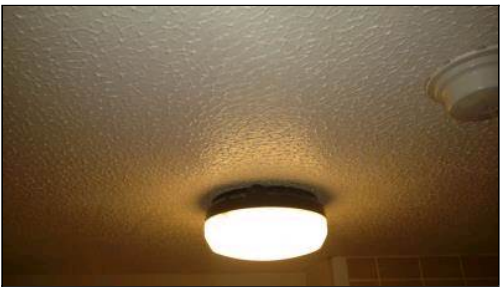
| | Survey Date: | Lead Surveyor | Survey Type | Floor | Analysis |
|---|---|---|---|---|---|
| | 6 Nov 2017 | Dave Milton | Management Survey | 2nd | No Asbestos Detected (0) |
| | AE004029 (S) | Textured Coating (1) | Completely Sealed (0) | Good Condition (0) | Occasionally likely to be disturbed (1) |

| Normal Occupancy | Score | Likelihood of disturbance | Score | Exposure Potential | Score | Maintenance Activity | Score |
|---|---|---|---|---|---|---|---|
| Recommendation | No further action required | | | | | | |

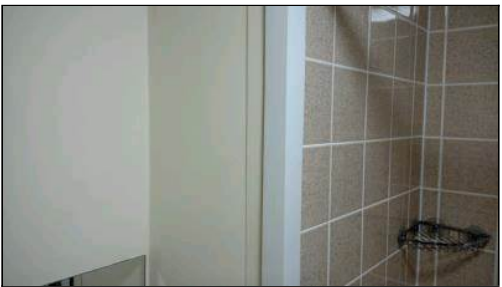
| | Survey Date: | Lead Surveyor | Survey Type | Floor | Analysis |
|---|---|---|---|---|---|
| | 6 Nov 2017 | Dave Milton | Management Survey | 2nd | No Asbestos Detected (0) |
| | AE004030 (S) | Insulation board (2) | Surface Sealed (1) | Good Condition (0) | Occasionally likely to be disturbed (1) |

| Normal Occupancy | Score | Likelihood of disturbance | Score | Exposure Potential | Score | Maintenance Activity | Score |
|---|---|---|---|---|---|---|---|
| Recommendation | No further action required | | | | | | |

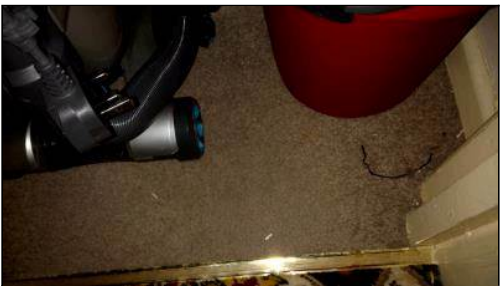
| | Survey Date: | Lead Surveyor | Survey Type | Floor | Analysis |
|---|---|---|---|---|---|
| | 6 Nov 2017 | Dave Milton | Management Survey | 2nd | Crocidolite (or unknown) (3) |
| | Visual (SP) | Reinforced Composite (1) | Completely Sealed (0) | Good Condition (0) | Usually inaccessible or unlikely to be disturbed (0) |

| Normal Occupancy | Score | Likelihood of disturbance | Score | Exposure Potential | Score | Maintenance Activity | Score |
|---|---|---|---|---|---|---|---|
| Surveyor comments | Unable to safely inspect at time of survey due to risk of damage to fixed flooring. | | | | | | |

| Normal Occupancy | Score | Likelihood of disturbance | Score | Exposure Potential | Score | Maintenance Activity | Score |
|---|---|---|---|---|---|---|---|
| Recommendation | Inspection required | | | | | | |

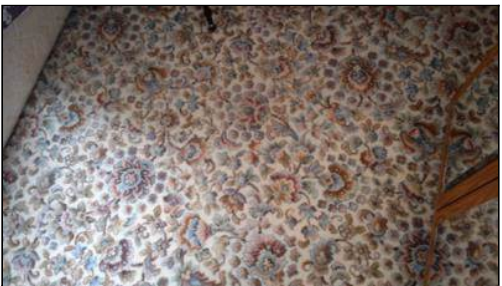
| | Survey Date: | Lead Surveyor | Survey Type | Floor | Analysis |
|---|---|---|---|---|---|
| | 6 Nov 2017 | Dave Milton | Management Survey | 2nd | Crocidolite (or unknown) (3) |
| | Visual (SP) | Reinforced Composite (1) | Completely Sealed (0) | Good Condition (0) | Usually inaccessible or unlikely to be disturbed (0) |

| Normal Occupancy | Score | Likelihood of disturbance | Score | Exposure Potential | Score | Maintenance Activity | Score |
|---|---|---|---|---|---|---|---|
| Surveyor comments | Unable to safely inspect at time of survey due to risk of damage to fixed flooring. | | | | | | |

| Normal Occupancy | Score | Likelihood of disturbance | Score | Exposure Potential | Score | Maintenance Activity | Score |
|---|---|---|---|---|---|---|---|
| Recommendation | Inspection required | | | | | | |

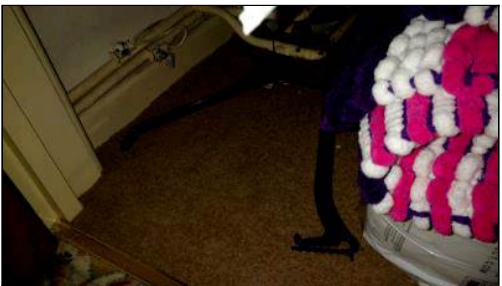
| | Survey Date: | Lead Surveyor | Survey Type | Floor | Analysis |
|---|---|---|---|---|---|
| | 6 Nov 2017 | Dave Milton | Management Survey | 2nd | Crocitolite (or unknown)<br>(3) |
| | Visual (SP) | Reinforced Composite (1) | Completely Sealed (0) | Good Condition (0) | Usually inaccessible or unlikely to be disturbed (0) |

| Normal Occupancy | Score | Likelihood of disturbance | Score | Exposure Potential | Score | Maintenance Activity | Score |
|---|---|---|---|---|---|---|---|
| Surveyor comments | Unable to safely inspect at time of survey due to risk of damage to fixed flooring. | | | | | | |

| Normal Occupancy | Score | Likelihood of disturbance | Score | Exposure Potential | Score | Maintenance Activity | Score |
|---|---|---|---|---|---|---|---|
| Recommendation | Inspection required | | | | | | |

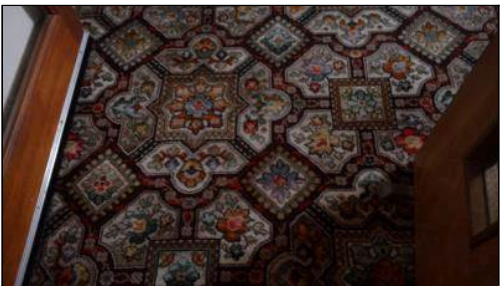
| | Survey Date: | Lead Surveyor | Survey Type | Floor | Analysis |
|---|---|---|---|---|---|
| | 6 Nov 2017 | Dave Milton | Management Survey | 2nd | Crocitolite (or unknown) (3) |
| | Visual (SP) | Reinforced Composite (1) | Completely Sealed (0) | Good Condition (0) | Usually inaccessible or unlikely to be disturbed (0) |

| Normal Occupancy | Score | Likelihood of disturbance | Score | Exposure Potential | Score | Maintenance Activity | Score |
|---|---|---|---|---|---|---|---|
| Surveyor comments | Unable to safely inspect at time of survey due to risk of damage to fixed flooring. | | | | | | |

| Normal Occupancy | Score | Likelihood of disturbance | Score | Exposure Potential | Score | Maintenance Activity | Score |
|---|---|---|---|---|---|---|---|
| Recommendation | Inspection required | | | | | | |

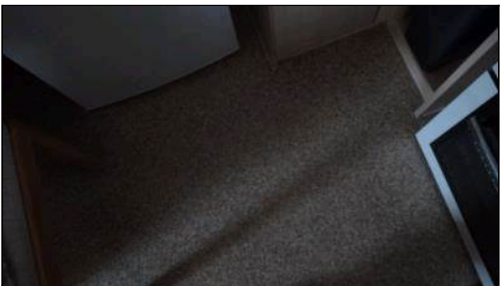
| | 6 Nov 2017 | Dave Milton | Management Survey | 2nd | Crocidolite (or unknown) (3) |
| | Visual (SP) | Reinforced Composite (1) | Completely Sealed (0) | Good Condition (0) | Usually inaccessible or unlikely to be disturbed (0) |

| Surveyor comments | Unable to safely inspect at time of survey due to risk of damage to fixed flooring. | | | | | | |

| Recommendation | Inspection required | | | | | | |
