Refurbishment Survey

37 Llys Ben Bowen Thomas
Gelligaled Road
Ystrad
Pentre
CF41 7SB
UPRN: 6473

Report issue date:	16 Jun 2017

Building Designation: Flat 37, Block 1-40

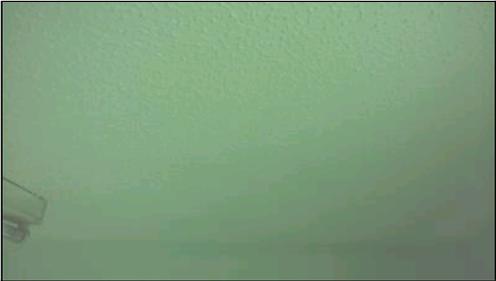
Survey Date:	Lead Surveyor	Survey Type	Floor	Analysis
	12 Jun 2017	Dave Milton	Refurbishment Survey	2nd	Chrysotile (1)
	Building	Room	Item	Quantity	
	Flat 37, Block 1-40	Kitchen 201	Textured coating to plasterboard ceiling.	4m ²	
	Sample No (S,SP,P,As)	Product Type	Surface Treatment	Condition	Accessibility
AE003103 (S)	Textured Coating (1)	Completely Sealed (0)	Good Condition (0)	Occasionally likely to be disturbed (1)

Normal Occupancy	Score	Likelihood of disturbance	Score	Exposure Potential	Score	Maintenance Activity	Score
Main type of activity	1	Location	2	Number of occupants	1	Type of Maintenance	1
		Accessibility	1	Frequency of use	3	Frequency of maintenance	1
		Amount	1	Average Time	0		
Average Score	1	Average Score	2	Average Score	2	Average Score	1
Average of Priority	6						
Material Assessment Score	2						
Recommendation	Manage in-situ or remove if affected by works						
Surveyor comments	Please refer to Section 6.2 of this report and project desktop study (additional inspection required if going beyond suspect material).

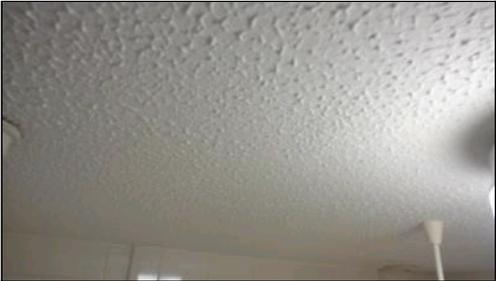
Survey Date:	Lead Surveyor	Survey Type	Floor	Analysis
	12 Jun 2017	Dave Milton	Refurbishment Survey	2nd	Chrysotile (1)
	Building	Room	Item	Quantity	
	Flat 37, Block 1-40	Shower room 204	Textured coating to plasterboard ceiling.	4m ²	
	Sample No (S,SP,P,As)	Product Type	Surface Treatment	Condition	Accessibility
AE003106 (S)	Textured Coating (1)	Completely Sealed (0)	Good Condition (0)	Occasionally likely to be disturbed (1)

Normal Occupancy	Score	Likelihood of disturbance	Score	Exposure Potential	Score	Maintenance Activity	Score
Main type of activity	1	Location	2	Number of occupants	1	Type of Maintenance	1
		Accessibility	1	Frequency of use	3	Frequency of maintenance	1
		Amount	1	Average Time	0		
Average Score	1	Average Score	2	Average Score	2	Average Score	1
Average of Priority	6						
Material Assessment Score	2						
Recommendation	Manage in-situ or remove if affected by works						
Surveyor comments	Please refer to Section 6.2 of this report and project desktop study (additional inspection required if going beyond suspect material).

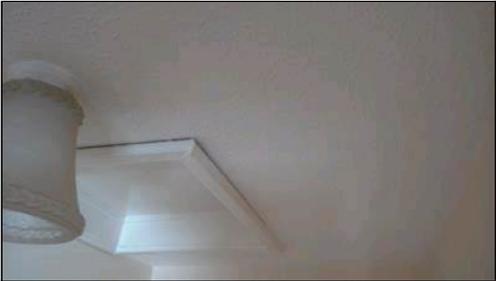
Survey Date:	Lead Surveyor	Survey Type	Floor	Analysis
	12 Jun 2017	Dave Milton	Refurbishment Survey	2nd	Chrysotile (1)
	Building	Room	Item	Quantity	
	Flat 37, Block 1-40	Hall 206	Textured coating to plasterboard ceiling.	2m ²	
	Sample No (S,SP,P,As)	Product Type	Surface Treatment	Condition	Accessibility
AE003109 (S)	Textured Coating (1)	Completely Sealed (0)	Good Condition (0)	Occasionally likely to be disturbed (1)

Normal Occupancy	Score	Likelihood of disturbance	Score	Exposure Potential	Score	Maintenance Activity	Score
Main type of activity	1	Location	2	Number of occupants	1	Type of Maintenance	1
		Accessibility	1	Frequency of use	3	Frequency of maintenance	1
		Amount	1	Average Time	0		
Average Score	1	Average Score	2	Average Score	2	Average Score	1
Average of Priority	6						
Material Assessment Score	2						
Recommendation	Manage in-situ or remove if affected by works						
Surveyor comments	Please refer to Section 6.2 of this report and project desktop study (additional inspection required if going beyond suspect material).
