# Management Survey

4 Constantine Court  
 Constantine Street  
 Williamstown  
 Penygraig  
 CF40 1QL  
 UPRN: 6362

4 Constantine Court  
Constantine Street  
Williamstown  
Penygraig  
CF40 1QL

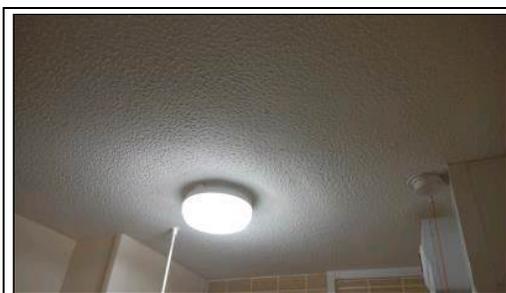
Survey Date:	Lead Surveyor	Survey Type	Floor	Analysis
30 Sep 2016 to 3 Oct 2016	Sebastian Lawniczak	Management Survey	Ground	No Asbestos Detected (0)
Building	Room	Item	Quantity	
Block 1-35. Flat 4.	Wet Room G01	Textured coating to fixed plasterboard ceiling	4m <sup>2</sup>	
Sample No (S,SP,P,As)	Product Type	Surface Treatment	Condition	Accessibility
AE001934 (S)	Textured Coating (1)	Completely Sealed (0)	Good Condition (0)	Occasionally likely to be disturbed (1)

Normal Occupancy	Score	Likelihood of disturbance	Score	Exposure Potential	Score	Maintenance Activity	Score
Main type of activity	N/A	Location	N/A	Number of occupants	N/A	Type of Maintenance	N/A
		Accessibility	N/A	Frequency of use	N/A	Frequency of maintenance	N/A
		Amount	N/A	Average Time	N/A		
Average Score	N/A	Average Score	N/A	Average Score	N/A	Average Score	N/A
Average of Priority	N/A						
Material Assessment Score	N/A						
Recommendation	No further action required						
Surveyor comments	N/A

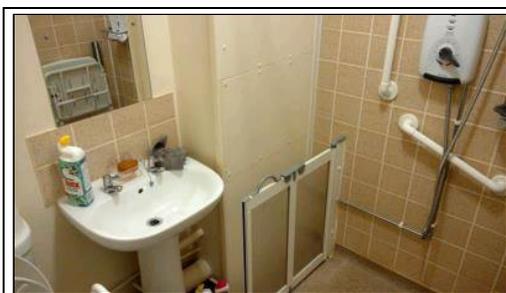
Survey Date:	Lead Surveyor	Survey Type	Floor	Analysis
30 Sep 2016 to 3 Oct 2016	Sebastian Lawniczak	Management Survey	Ground	No Asbestos Detected (0)
Building	Room	Item	Quantity	
Block 1-35. Flat 4.	Wet Room G01	Insulating board panels forming fixed riser boxing	3m <sup>2</sup>	
Sample No (S,SP,P,As)	Product Type	Surface Treatment	Condition	Accessibility
AE001935 (S)	Insulating Board (0)	Surface Sealed (1)	Good Condition (0)	Easily disturbed (2)

Normal Occupancy	Score	Likelihood of disturbance	Score	Exposure Potential	Score	Maintenance Activity	Score
Main type of activity	N/A	Location	N/A	Number of occupants	N/A	Type of Maintenance	N/A
		Accessibility	N/A	Frequency of use	N/A	Frequency of maintenance	N/A
		Amount	N/A	Average Time	N/A		
Average Score	N/A	Average Score	N/A	Average Score	N/A	Average Score	N/A
Average of Priority	N/A						
Material Assessment Score	N/A						
Recommendation	No further action required						
Surveyor comments	N/A

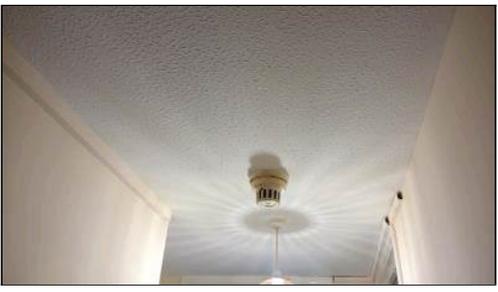
<b>Survey Date:</b>	<b>Lead Surveyor</b>	<b>Survey Type</b>	<b>Floor</b>	<b>Analysis</b>
	30 Sep 2016 to 3 Oct 2016	Sebastian Lawniczak	Management Survey	Ground	No Asbestos Detected (0)
	<b>Building</b>	<b>Room</b>	<b>Item</b>	<b>Quantity</b>	
	Block 1-35. Flat 4.	Hallway G02	Textured coating to fixed plasterboard ceiling	3m <sup>2</sup>	
	<b>Sample No (S,SP,P,As)</b>	<b>Product Type</b>	<b>Surface Treatment</b>	<b>Condition</b>	<b>Accessibility</b>
As AE001934 (SP)	Textured Coating (1)	Completely Sealed (0)	Good Condition (0)	Occasionally likely to be disturbed (1)

<b>Normal Occupancy</b>	<b>Score</b>	<b>Likelihood of disturbance</b>	<b>Score</b>	<b>Exposure Potential</b>	<b>Score</b>	<b>Maintenance Activity</b>	<b>Score</b>
Main type of activity	N/A	Location	N/A	Number of occupants	N/A	Type of Maintenance	N/A
		Accessibility	N/A	Frequency of use	N/A	Frequency of maintenance	N/A
		Amount	N/A	Average Time	N/A		
Average Score	N/A	Average Score	N/A	Average Score	N/A	Average Score	N/A
Average of Priority	N/A						
Material Assessment Score	N/A						
Recommendation	No further action required						
Surveyor comments	N/A

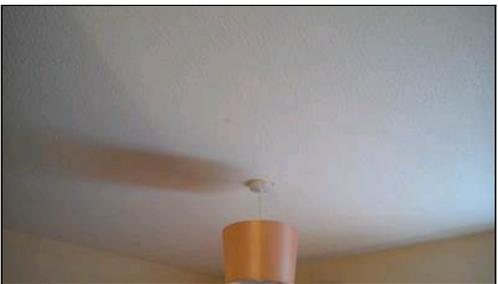
<b>Survey Date:</b>	<b>Lead Surveyor</b>	<b>Survey Type</b>	<b>Floor</b>	<b>Analysis</b>
	30 Sep 2016 to 3 Oct 2016	Sebastian Lawniczak	Management Survey	Ground	No Asbestos Detected (0)
	<b>Building</b>	<b>Room</b>	<b>Item</b>	<b>Quantity</b>	
	Block 1-35. Flat 4.	Bedroom G04	Textured coating to fixed plasterboard ceiling	8m <sup>2</sup>	
	<b>Sample No (S,SP,P,As)</b>	<b>Product Type</b>	<b>Surface Treatment</b>	<b>Condition</b>	<b>Accessibility</b>
As AE001934 (SP)	Textured Coating (1)	Completely Sealed (0)	Good Condition (0)	Occasionally likely to be disturbed (1)

<b>Normal Occupancy</b>	<b>Score</b>	<b>Likelihood of disturbance</b>	<b>Score</b>	<b>Exposure Potential</b>	<b>Score</b>	<b>Maintenance Activity</b>	<b>Score</b>
Main type of activity	N/A	Location	N/A	Number of occupants	N/A	Type of Maintenance	N/A
		Accessibility	N/A	Frequency of use	N/A	Frequency of maintenance	N/A
		Amount	N/A	Average Time	N/A		
Average Score	N/A	Average Score	N/A	Average Score	N/A	Average Score	N/A
Average of Priority	N/A						
Material Assessment Score	N/A						
Recommendation	No further action required						
Surveyor comments	N/A

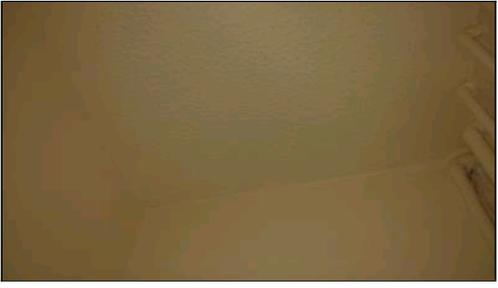
<b>Survey Date:</b>	<b>Lead Surveyor</b>	<b>Survey Type</b>	<b>Floor</b>	<b>Analysis</b>
	30 Sep 2016 to 3 Oct 2016	Sebastian Lawniczak	Management Survey	Ground	No Asbestos Detected (0)
	<b>Building</b>	<b>Room</b>	<b>Item</b>	<b>Quantity</b>	
	Block 1-35. Flat 4.	Bedroom Cupboard G05	Textured coating to fixed plasterboard ceiling	<1m <sup>2</sup>	
	<b>Sample No (S,SP,P,As)</b>	<b>Product Type</b>	<b>Surface Treatment</b>	<b>Condition</b>	<b>Accessibility</b>
As AE001934 (SP)	Textured Coating (1)	Completely Sealed (0)	Good Condition (0)	Occasionally likely to be disturbed (1)

<b>Normal Occupancy</b>	<b>Score</b>	<b>Likelihood of disturbance</b>	<b>Score</b>	<b>Exposure Potential</b>	<b>Score</b>	<b>Maintenance Activity</b>	<b>Score</b>
Main type of activity	N/A	Location	N/A	Number of occupants	N/A	Type of Maintenance	N/A
		Accessibility	N/A	Frequency of use	N/A	Frequency of maintenance	N/A
		Amount	N/A	Average Time	N/A		
Average Score	N/A	Average Score	N/A	Average Score	N/A	Average Score	N/A
Average of Priority	N/A						
Material Assessment Score	N/A						
Recommendation	No further action required						
Surveyor comments	N/A

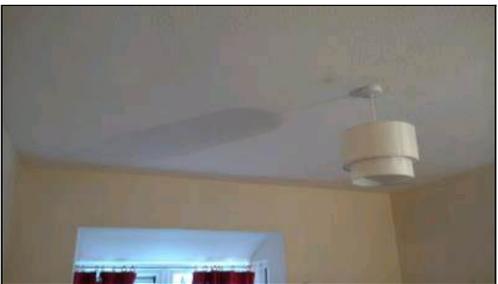
<b>Survey Date:</b>	<b>Lead Surveyor</b>	<b>Survey Type</b>	<b>Floor</b>	<b>Analysis</b>
	30 Sep 2016 to 3 Oct 2016	Sebastian Lawniczak	Management Survey	Ground	No Asbestos Detected (0)
	<b>Building</b>	<b>Room</b>	<b>Item</b>	<b>Quantity</b>	
	Block 1-35. Flat 4.	Living Room G06	Textured coating to fixed plasterboard ceiling and bay window soffit	10m <sup>2</sup>	
	<b>Sample No (S,SP,P,As)</b>	<b>Product Type</b>	<b>Surface Treatment</b>	<b>Condition</b>	<b>Accessibility</b>
As AE001934 (SP)	Textured Coating (1)	Completely Sealed (0)	Good Condition (0)	Occasionally likely to be disturbed (1)

<b>Normal Occupancy</b>	<b>Score</b>	<b>Likelihood of disturbance</b>	<b>Score</b>	<b>Exposure Potential</b>	<b>Score</b>	<b>Maintenance Activity</b>	<b>Score</b>
Main type of activity	N/A	Location	N/A	Number of occupants	N/A	Type of Maintenance	N/A
		Accessibility	N/A	Frequency of use	N/A	Frequency of maintenance	N/A
		Amount	N/A	Average Time	N/A		
Average Score	N/A	Average Score	N/A	Average Score	N/A	Average Score	N/A
Average of Priority	N/A						
Material Assessment Score	N/A						
Recommendation	No further action required						
Surveyor comments	N/A

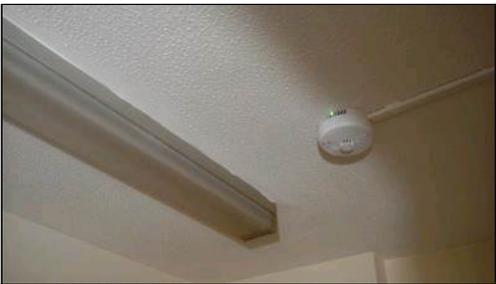
<b>Survey Date:</b>	<b>Lead Surveyor</b>	<b>Survey Type</b>	<b>Floor</b>	<b>Analysis</b>
	30 Sep 2016 to 3 Oct 2016	Sebastian Lawniczak	Management Survey	Ground	No Asbestos Detected (0)
	<b>Building</b>	<b>Room</b>	<b>Item</b>	<b>Quantity</b>	
	Block 1-35. Flat 4.	Kitchen G07	Textured coating to fixed plasterboard ceiling	5m <sup>2</sup>	
	<b>Sample No (S,SP,P,As)</b>	<b>Product Type</b>	<b>Surface Treatment</b>	<b>Condition</b>	<b>Accessibility</b>
As AE001934 (SP)	Textured Coating (1)	Completely Sealed (0)	Good Condition (0)	Occasionally likely to be disturbed (1)

<b>Normal Occupancy</b>	<b>Score</b>	<b>Likelihood of disturbance</b>	<b>Score</b>	<b>Exposure Potential</b>	<b>Score</b>	<b>Maintenance Activity</b>	<b>Score</b>
Main type of activity	N/A	Location	N/A	Number of occupants	N/A	Type of Maintenance	N/A
		Accessibility	N/A	Frequency of use	N/A	Frequency of maintenance	N/A
		Amount	N/A	Average Time	N/A		
Average Score	N/A	Average Score	N/A	Average Score	N/A	Average Score	N/A
Average of Priority	N/A						
Material Assessment Score	N/A						
Recommendation	No further action required						
Surveyor comments	N/A
