# Management Survey

5 Constantine Court  
 Constantine Street  
 Williamstown  
 Penygraig  
 CF40 1QL  
 UPRN: 6363

5 Constantine Court  
Constantine Street  
Williamstown  
Penygraig  
CF40 1QL

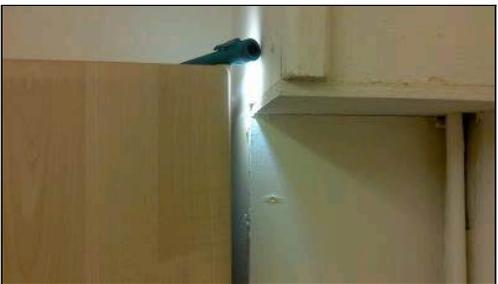
<b>Survey Date:</b>	<b>Lead Surveyor</b>	<b>Survey Type</b>	<b>Floor</b>	<b>Analysis</b>
	21 Apr 2016	John Hunter	Management Survey	Ground	
	<b>Building</b>	<b>Room</b>	<b>Item</b>	<b>Quantity</b>	
	Main Flat	Kitchen G01	Insulating board panel to side of timber boxing adj. to wall unit.	<1m <sup>2</sup>	
	<b>Sample No (S,SP,P,As)</b>	<b>Product Type</b>	<b>Surface Treatment</b>	<b>Condition</b>	<b>Accessibility</b>
AI000412 (S)	Insulating Board (0)	Surface Sealed (1)	Low Damage (1)	Occasionally likely to be disturbed (1)

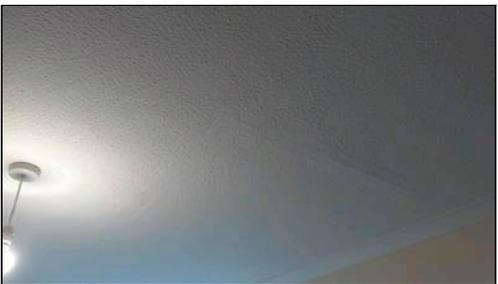
Survey Date:	Lead Surveyor	Survey Type	Floor	Analysis
	21 Apr 2016	John Hunter	Management Survey	Ground	No Asbestos Detected (0)
	Building	Room	Item	Quantity	
	Main Flat	Living Room G02	Textured coating to plasterboard ceiling.	10m <sup>2</sup>	
	Sample No (S,SP,P,As)	Product Type	Surface Treatment	Condition	Accessibility
As AI000411 (SP)	Textured Coating (1)	Completely Sealed (0)	Low Damage (1)	Occasionally likely to be disturbed (1)

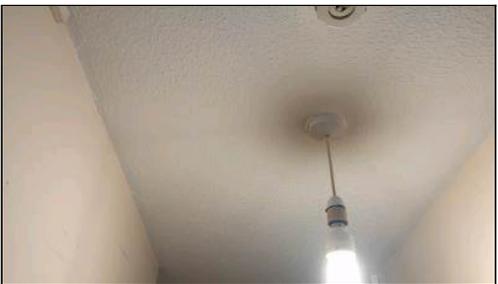
<b>Survey Date:</b>	<b>Lead Surveyor</b>	<b>Survey Type</b>	<b>Floor</b>	<b>Analysis</b>
	21 Apr 2016	John Hunter	Management Survey	Ground	
	<b>Building</b>	<b>Room</b>	<b>Item</b>	<b>Quantity</b>	
	Main Flat	Lobby G03	Textured coating to plasterboard ceiling.	3m <sup>2</sup>	
	<b>Sample No (S,SP,P,As)</b>	<b>Product Type</b>	<b>Surface Treatment</b>	<b>Condition</b>	<b>Accessibility</b>
As AI000411 (SP)	Textured Coating (1)	Completely Sealed (0)	Low Damage (1)	Occasionally likely to be disturbed (1)

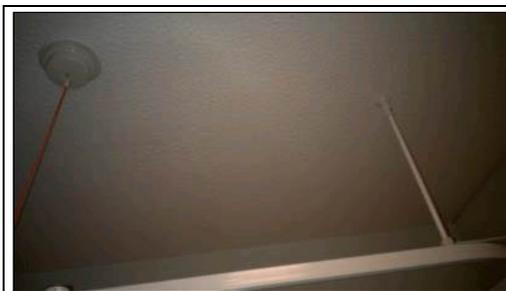
Survey Date:	Lead Surveyor	Survey Type	Floor	Analysis
21 Apr 2016	John Hunter	Management Survey	Ground	No Asbestos Detected (0)
Building	Room	Item	Quantity	
Main Flat	Bathroom G04	Textured coating to plasterboard ceiling.	<4m <sup>2</sup>	
Sample No (S,SP,P,As)	Product Type	Surface Treatment	Condition	Accessibility
As AI000411 (SP)	Textured Coating (1)	Completely Sealed (0)	Low Damage (1)	Occasionally likely to be disturbed (1)

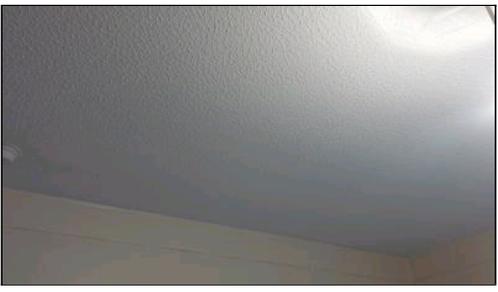
<b>Survey Date:</b>	<b>Lead Surveyor</b>	<b>Survey Type</b>	<b>Floor</b>	<b>Analysis</b>
	21 Apr 2016	John Hunter	Management Survey	Ground	No Asbestos Detected (0)
	<b>Building</b>	<b>Room</b>	<b>Item</b>	<b>Quantity</b>	
	Main Flat	Bedroom G06	Textured coating to plasterboard ceiling.	8m <sup>2</sup>	
	<b>Sample No (S,SP,P,As)</b>	<b>Product Type</b>	<b>Surface Treatment</b>	<b>Condition</b>	<b>Accessibility</b>
As AI000411 (SP)	Textured Coating (1)	Completely Sealed (0)	Low Damage (1)	Occasionally likely to be disturbed (1)

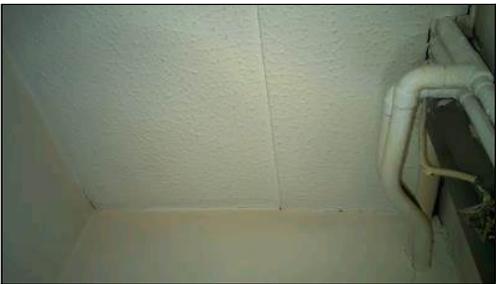
Survey Date:	Lead Surveyor	Survey Type	Floor	Analysis
	21 Apr 2016	John Hunter	Management Survey	Ground	No Asbestos Detected (0)
	Building	Room	Item	Quantity	
	Main Flat	Airing Cupboard G07	Textured coating to plasterboard ceiling.	1m <sup>2</sup>	
	Sample No (S,SP,P,As)	Product Type	Surface Treatment	Condition	Accessibility
	As AI000411 (SP)	Textured Coating (1)	Completely Sealed (0)	Low Damage (1)	Occasionally likely to be disturbed (1)
