## Refurbishment Survey

5 Llys Ben Bowen Thomas  
Gelligaled Road  
Ystrad  
Pentre  
CF41 7SB  
UPRN: 6442

**Kovia**

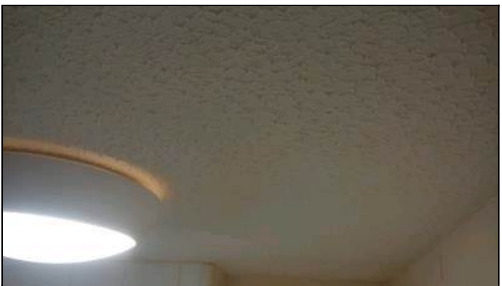
| | 12 Jun 2017 | Dave Milton | Refurbishment Survey | Ground | Chrysotile (1) |
| | AE003093 (S) | Textured Coating (1) | Completely Sealed (0) | Good Condition (0) | Occasionally likely to be disturbed (1) |

| Recommendation | Manage in-situ or remove if affected by works | | | | | | |

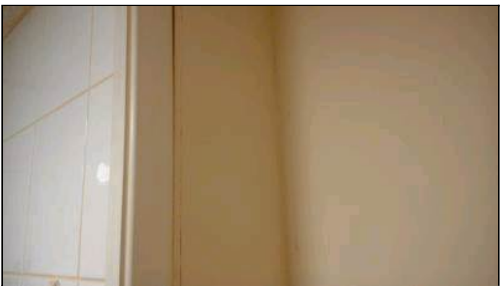
| | Survey Date: | Lead Surveyor | Survey Type | Floor | Analysis |
|---|---|---|---|---|---|
| | 12 Jun 2017 | Dave Milton | Refurbishment Survey | Ground | No Asbestos Detected (0) |
| | AE003094 (S) | Insulating Board (0) | Surface Sealed (1) | Good Condition (0) | Occasionally likely to be disturbed (1) |

| Normal Occupancy | Score | Likelihood of disturbance | Score | Exposure Potential | Score | Maintenance Activity | Score |
|---|---|---|---|---|---|---|---|
| Recommendation | No further action required | | | | | | |

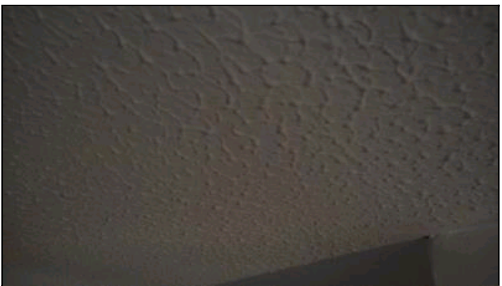
| | Survey Date: | Lead Surveyor | Survey Type | Floor | Analysis |
|---|---|---|---|---|---|
| | 12 Jun 2017 | Dave Milton | Refurbishment Survey | Ground | Chrysotile (1) |
| | AE003095 (S) | Textured Coating (1) | Completely Sealed (0) | Good Condition (0) | Occasionally likely to be disturbed (1) |

| Normal Occupancy | Score | Likelihood of disturbance | Score | Exposure Potential | Score | Maintenance Activity | Score |
|---|---|---|---|---|---|---|---|
| Recommendation | Manage in-situ or remove if affected by works | | | | | | |

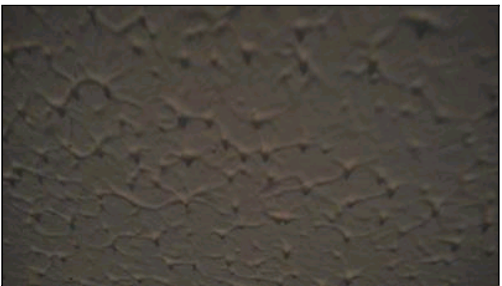
| | 12 Jun 2017 | Dave Milton | Refurbishment Survey | Ground | Chrysotile (1) |
| | AE003096 (S) | Textured Coating (1) | Completely Sealed (0) | Good Condition (0) | Occasionally likely to be disturbed (1) |

| Recommendation | Manage in-situ or remove if affected by works | | | | | | |

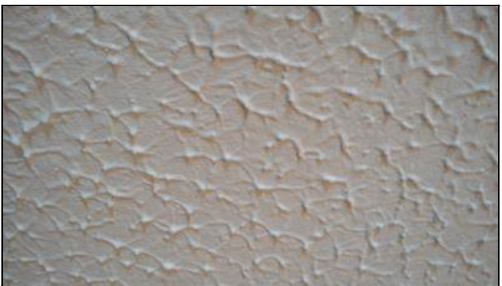
| | 12 Jun 2017 | Dave Milton | Refurbishment Survey | Ground | Chrysotile (1) |
| | AE003097 (S) | Textured Coating (1) | Completely Sealed (0) | Good Condition (0) | Occasionally likely to be disturbed (1) |

| Normal Occupancy | Score | Likelihood of disturbance | Score | Exposure Potential | Score | Maintenance Activity | Score |
|---|---|---|---|---|---|---|---|
| Recommendation | Manage in-situ or remove if affected by works | | | | | | |

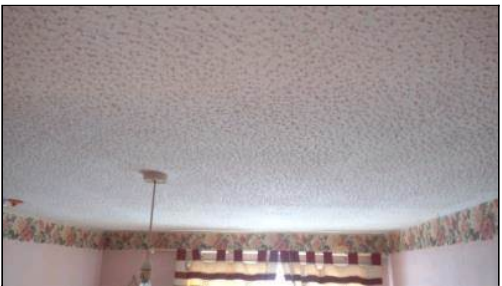
| | 12 Jun 2017 | Dave Milton | Refurbishment Survey | Ground | Chrysotile (1) |
| | AE003098 (S) | Textured Coating (1) | Completely Sealed (0) | Good Condition (0) | Occasionally likely to be disturbed (1) |

| Recommendation | Manage in-situ or remove if affected by works | | | | | | |

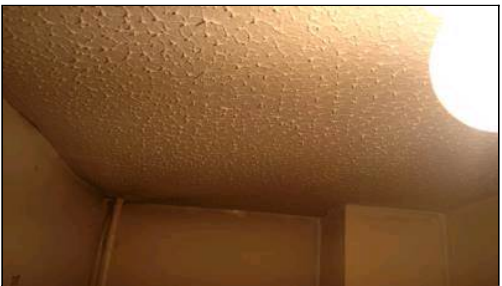
| | Survey Date: | Lead Surveyor | Survey Type | Floor | Analysis |
|---|---|---|---|---|---|
| | 12 Jun 2017 | Dave Milton | Refurbishment Survey | Ground | Chrysotile (1) |
| | AE003099 (S) | Textured Coating (1) | Completely Sealed (0) | Good Condition (0) | Occasionally likely to be disturbed (1) |

| Normal Occupancy | Score | Likelihood of disturbance | Score | Exposure Potential | Score | Maintenance Activity | Score |
|---|---|---|---|---|---|---|---|
| Recommendation | Manage in-situ or remove if affected by works | | | | | | |

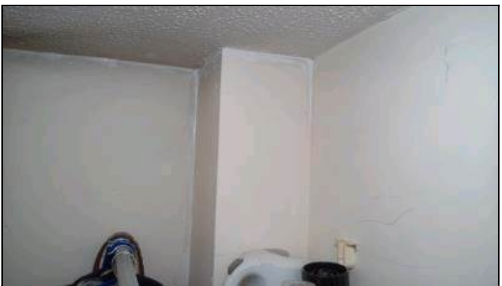
| | 12 Jun 2017 | Dave Milton | Refurbishment Survey | Ground | No Asbestos Detected (0) |
| | AE003100 (S) | Insulating Board (0) | Surface Sealed (1) | Good Condition (0) | Occasionally likely to be disturbed (1) |

| Recommendation | No further action required | | | | | | |

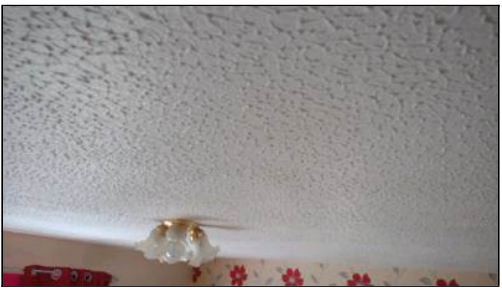
| | Survey Date: | Lead Surveyor | Survey Type | Floor | Analysis |
|---|---|---|---|---|---|
| | 12 Jun 2017 | Dave Milton | Refurbishment Survey | Ground | Chrysotile (1) |
| | AE003101 (S) | Textured Coating (1) | Completely Sealed (0) | Good Condition (0) | Occasionally likely to be disturbed (1) |

| Normal Occupancy | Score | Likelihood of disturbance | Score | Exposure Potential | Score | Maintenance Activity | Score |
|---|---|---|---|---|---|---|---|
| Recommendation | Manage in-situ or remove if affected by works | | | | | | |

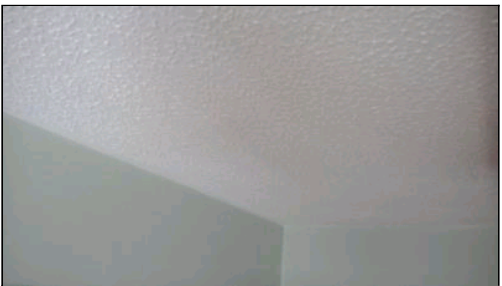
| | 12 Jun 2017 | Dave Milton | Refurbishment Survey | Ground | Chrysotile (1) |
| | AE003102 (S) | Textured Coating (1) | Completely Sealed (0) | Good Condition (0) | Occasionally likely to be disturbed (1) |

| Recommendation | Manage in-situ or remove if affected by works | | | | | | |
