**51 Penpisgah Road,  
Tonypandy, Mid Glamorgan,  
CF40 1EY**

**EMI Construction Limited**

September 2019

<b>Report Type:</b>		Refurbishment Survey Report
<b>Report Issue:</b>		FINAL
<b>Job/File Ref. No's:</b>		J023166
<b>Survey Date:</b>		15th August 2019
<b>Report Issue Date:</b>		11th September 2019
<b>Report by:</b>	<b>Name:</b>	Jon Trimble
	<b>Signature:</b>

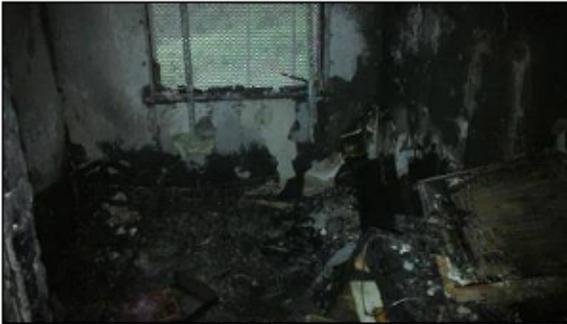
Inspection Number	Location/Description	Comments	Advised Action	Photograph
Inspection 2 Presumed	1st Floor, Throughout, Limited access to 1st floor	Due to the fire damage on the first floor it was only possible to survey the area from the landing as the structural integrity of other areas could not be ascertained.	Survey prior to works

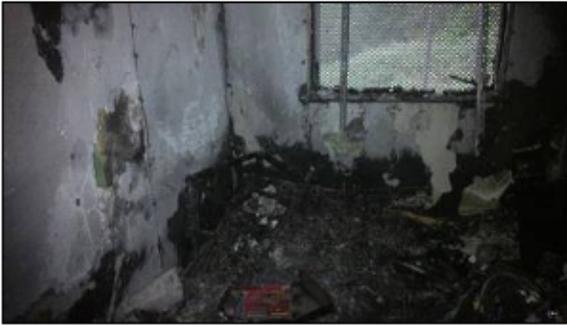
Inspection 5 Presumed	1st Floor, Rear left Bedroom, Inaccessible	Due to fire damage	Survey prior to works

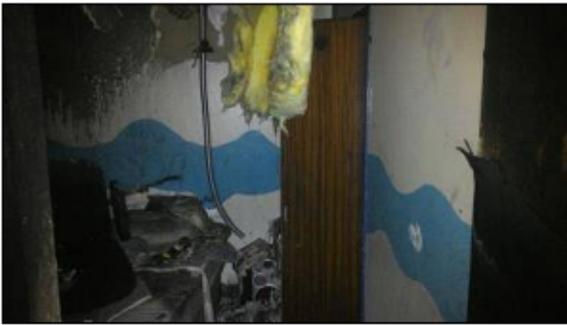
Inspection 14 Presumed	1st Floor, Rear right Bedroom Cupboard, Limited access	Due to fire damage	Survey prior to works

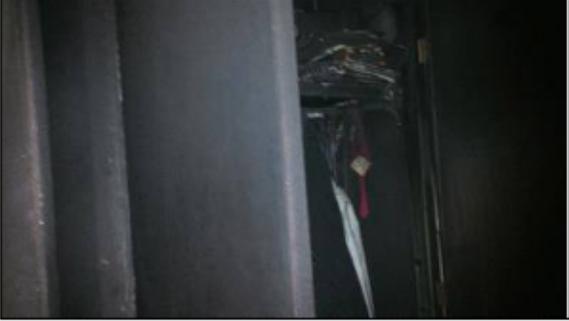
Inspection Number	Location/Description	Comments	Advised Action	Photograph
Inspection 15 Presumed	1st Floor, Front Bedroom Cupboard, Limited access	Due to fire damage	Survey prior to works

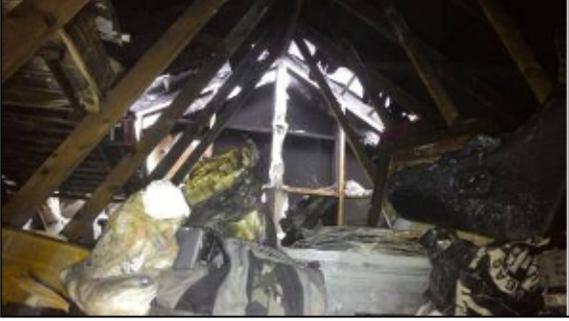
Inspection 17 Presumed	1st Floor, Loft, Limited access to loft	Due to fire damage	Survey prior to works

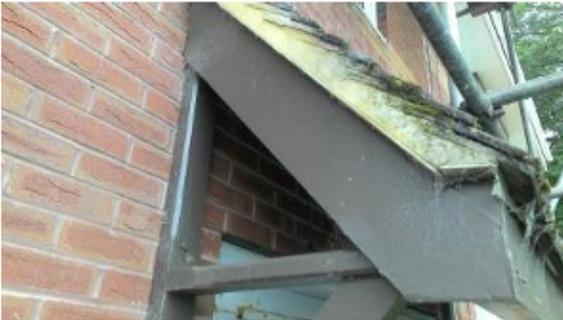
Inspection Number	Location/Position/Description	Product	Comments	Photograph
Inspection 1 BY000507	Ground Floor, External, Insulating board edging to porch roof	Insulating board	Approximately 4m Good Condition Unsealed

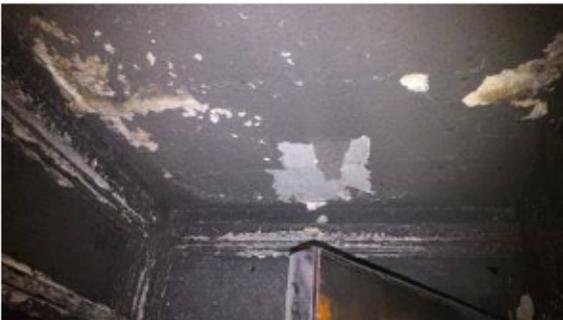
Inspection 3 BY000508	1st Floor, Landing, Textured coating to plasterboard ceiling and associated debris	Textured Coating	Approximately 4m <sup>2</sup> High Damage Reinforced composite material Due to the extent of damage from the fire in the area it should be presumed that debris from this material is present throughout

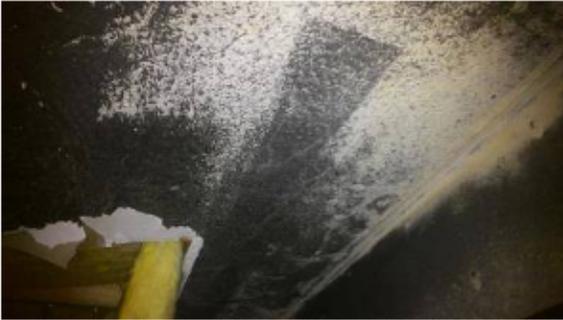
Inspection 6 BY000509	1st Floor, Rear right Bedroom, Textured coating to plasterboard ceiling and associated debris	Textured Coating	Approximately 15m <sup>2</sup> High Damage Reinforced composite material Due to the extent of damage from the fire in the area it should be presumed that debris from this material is present throughout

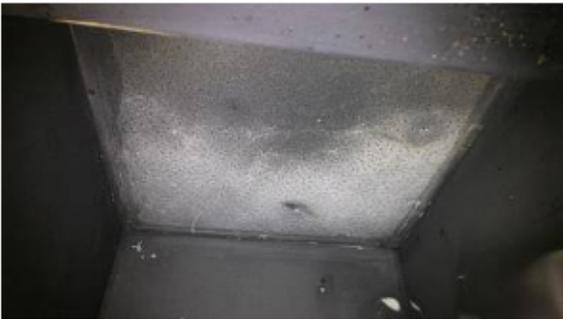
Inspection Number	Location/Position/Description	Product	Comments	Photograph
Inspection 8 BY000510	1st Floor, Airing Cupboard, Textured coating to plasterboard ceiling	Textured Coating	Approximately 1m <sup>2</sup> Low Damage Reinforced composite material

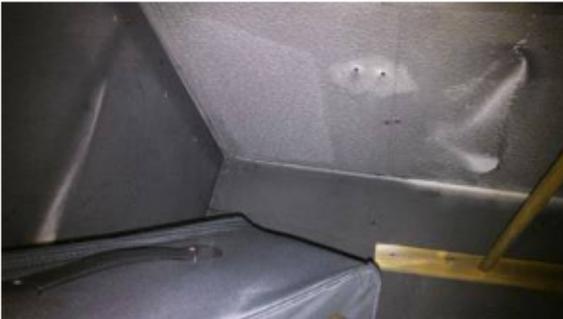
Inspection 9 Strongly Presumed Same As BY000510	1st Floor, Cupboard above stairs, Textured coating to plasterboard ceiling	Textured Coating	Approximately 1m <sup>2</sup> Good Condition Reinforced composite material

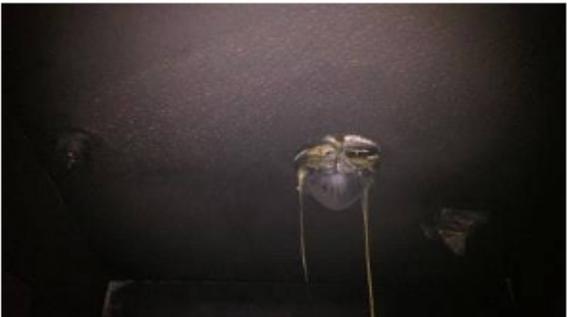
Inspection Number	Location/Position/Description	Product	Comments	Photograph
Inspection 12 BY000511	1st Floor, Bathroom, Textured coating to plasterboard ceiling and associated debris	Textured Coating	Approximately 4m <sup>2</sup> High Damage Reinforced composite material Due to the extent of damage from the fire in the area it should be presumed that debris from this material is present throughout

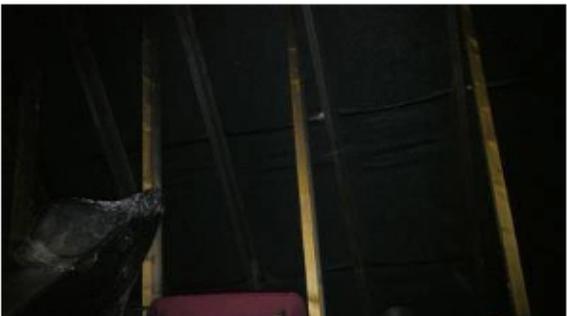
Inspection 16 BY000513	1st Floor, Loft, Bitumen felt to roof	Bitumen	Approximately 45m <sup>2</sup> Low Damage Reinforced composite material

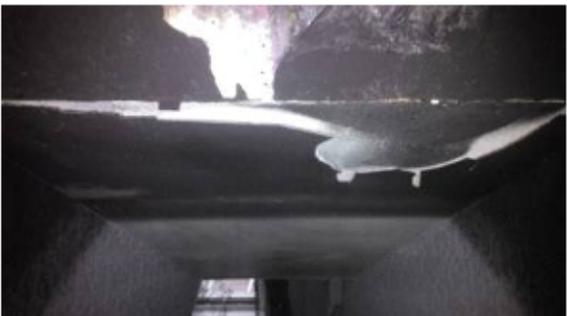
Inspection 18 BY000514	Ground Floor, Stairs, Textured coating to plasterboard ceiling behind plaster	Textured Coating	Approximately 3m <sup>2</sup> Low Damage Reinforced composite material

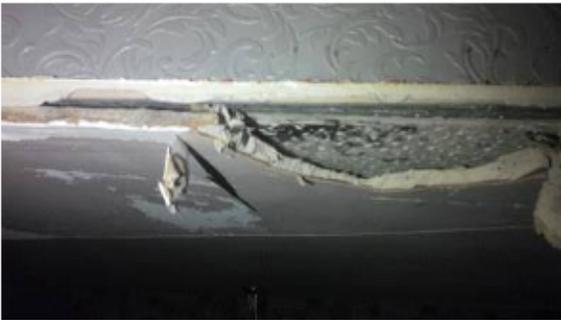
Inspection Number	Location/Position/Description	Product	Comments	Photograph
Inspection 19 BY000515	Ground Floor, Lounge, Textured coating to plasterboard ceiling above secondary layer of plasterboard	Textured Coating	Approximately 28m <sup>2</sup> Good Condition Reinforced composite material Has been overlaid with a second layer of plasterboard

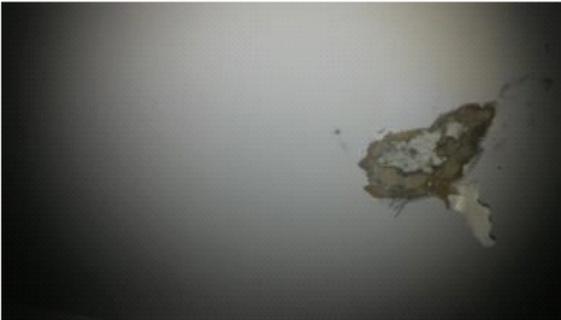
Inspection 20 BY000516	Ground Floor, Kitchen, Textured coating to plasterboard ceiling above secondary layer of plasterboard	Textured Coating	Approximately 20m <sup>2</sup> Good Condition Reinforced composite material Has been overlaid with a second layer of plasterboard

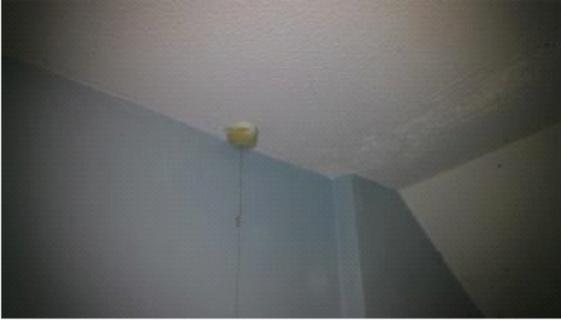
Inspection 22 BY000517	Ground Floor, Utility Room, Textured coating to plasterboard ceiling	Textured Coating	Approximately 3m <sup>2</sup> Good Condition Reinforced composite material

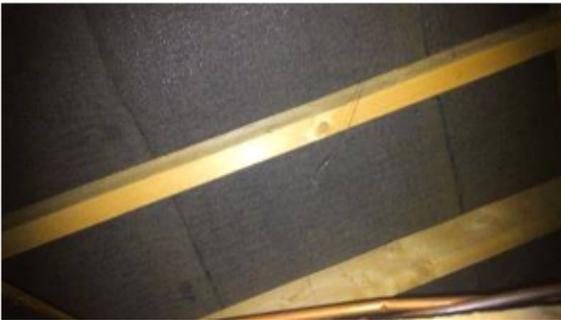
<b>Inspection Number</b>	<b>Location/Position/Description</b>	<b>Product</b>	<b>Comments</b>	<b>Photograph</b>
Inspection 24 BY000519	Ground Floor, Loft above Rear Bedroom, Bitumen felt to roof	Bitumen	Approximately 25m <sup>2</sup> Good Condition Reinforced composite material
