**WALES & WEST HOUSING
ASSOCIATION
3 ALEXANDRA GATE
FFORDD PENGAM
TREMORFA
CARDIFF
CF24 2UD**

PROJECT NO: J138685

DATE: NOVEMBER 2013

**ASBESTOS MANAGEMENT SURVEY
TO TARGETED AREAS OF
CONSTANTINE COURT, CONSTANTINE STREET, WILLIAMSTOWN, PENYGRAIG,
CF40 1QL**

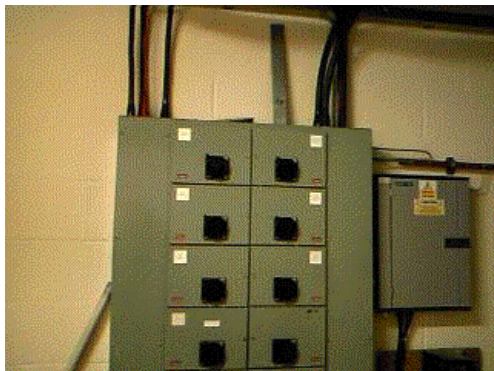
FLOOR/LOCATION: Ground Floor Electrical supply room (019)	
DESCRIPTION: Strongly presumed asbestos textile within fuse boxes - unable to inspect due to live status at the time of survey	
RECOMMENDATIONS: Conduct further investigation prior to relevant maintenance / refurbishment works	
EXTENT:	Minor amounts, String, Gaskets
SAMPLE REF:	Presumed
RESULT:	Presumed Crocidolite (or unknown)
