## Management with Targeted Refurbishment Survey to Ceilings

5 Cyncoed  
Ynysybwl  
Pontypridd  
CF37 3PL  
UPRN: 7910

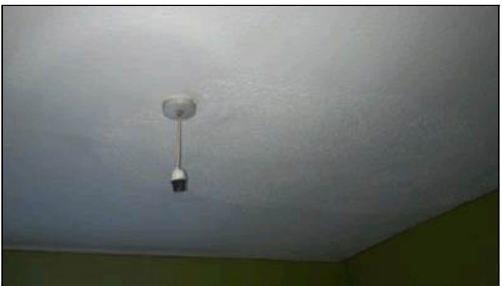
| | Survey Date: | Lead Surveyor | Survey Type | Floor | Analysis |
|---|---|---|---|---|---|
| | 17 Jan 2017 to 18 Jan 2017 | Ben Coleman | Management Survey | 1st | No Asbestos Detected (0) |
| | As AI002226 (SP) | Textured Coating (1) | Completely Sealed (0) | Low Damage (1) | Occasionally likely to be disturbed (1) |

| Normal Occupancy | Score | Likelihood of disturbance | Score | Exposure Potential | Score | Maintenance Activity | Score |
|---|---|---|---|---|---|---|---|
| Recommendation | No further action required | | | | | | |

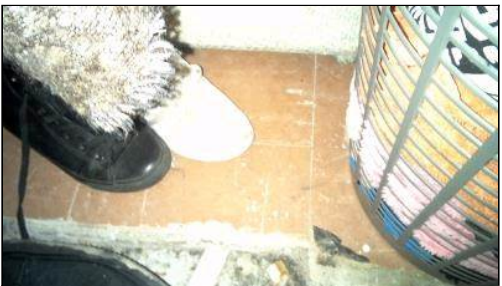
| | Survey Date: | Lead Surveyor | Survey Type | Floor | Analysis |
|---|---|---|---|---|---|
| | 17 Jan 2017 to 18 Jan 2017 | Ben Coleman | Management Survey | Ground | Chrysotile (1) |
| | AI002228 (S) | Well Bound Material (1) | Completely Sealed (0) | Low Damage (1) | Easily disturbed (2) |

| Normal Occupancy | Score | Likelihood of disturbance | Score | Exposure Potential | Score | Maintenance Activity | Score |
|---|---|---|---|---|---|---|---|
| Recommendation | Manage and re-inspect | | | | | | |

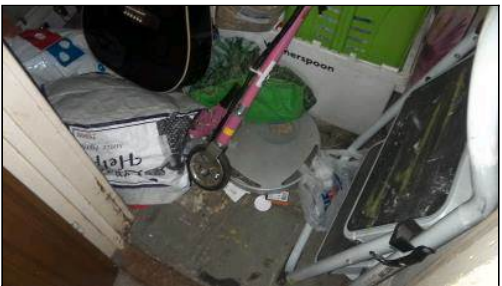
| | Survey Date: | Lead Surveyor | Survey Type | Floor | Analysis |
|---|---|---|---|---|---|
| | 17 Jan 2017 to 18 Jan 2017 | Ben Coleman | Management Survey | Ground | Chrysotile (1) |
| | AI002229 (S) | Well Bound Material (1) | Completely Sealed (0) | Low Damage (1) | Easily disturbed (2) |

| Normal Occupancy | Score | Likelihood of disturbance | Score | Exposure Potential | Score | Maintenance Activity | Score |
|---|---|---|---|---|---|---|---|
| Recommendation | Manage and re-inspect | | | | | | |

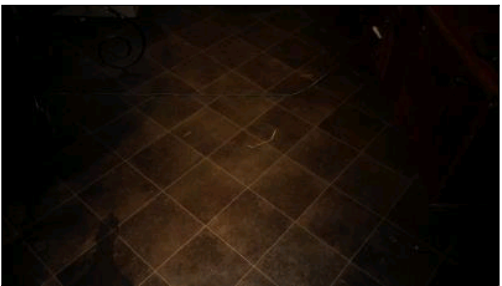
| | Survey Date: | Lead Surveyor | Survey Type | Floor | Analysis |
|---|---|---|---|---|---|
| | 17 Jan 2017 to 18 Jan 2017 | Ben Coleman | Management Survey | Ground | Chrysotile (1) |
| | AI002230 (S) | Well Bound Material (1) | Completely Sealed (0) | Low Damage (1) | Easily disturbed (2) |

| Normal Occupancy | Score | Likelihood of disturbance | Score | Exposure Potential | Score | Maintenance Activity | Score |
|---|---|---|---|---|---|---|---|
| Recommendation | Manage and re-inspect | | | | | | |

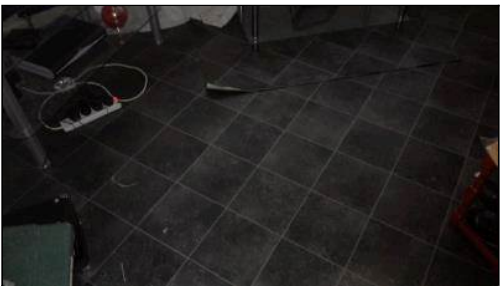
| | Survey Date: | Lead Surveyor | Survey Type | Floor | Analysis |
|---|---|---|---|---|---|
| | 17 Jan 2017 to 18 Jan 2017 | Ben Coleman | Management Survey | Ground | Chrysotile (1) |

| Normal Occupancy | Score | Likelihood of disturbance | Score | Exposure Potential | Score | Maintenance Activity | Score |
|---|---|---|---|---|---|---|---|
| Recommendation | Manage and re-inspect | | | | | | |
