Asbestos Management Consultancy

Management Survey

12 Cyncoed
Ynysybwll
CF37 3PL
UPRN: 7917

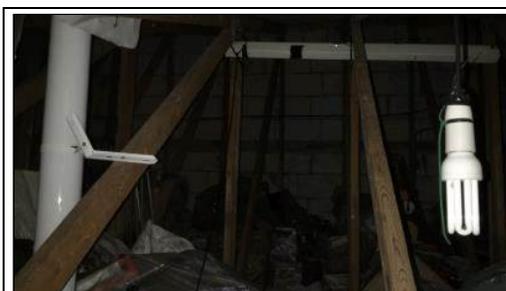
Survey Date:	Lead Surveyor	Survey Type	Floor	Analysis
3 Jun 2016 to 4 Jun 2016	Sebastian Lawniczak	Management Survey	Roof	N/A
Building	Room	Item	Quantity	
Main House	Loft Space R01	No suspect materials identified	N/A	
Sample No (S,SP,P,As)	Product Type	Surface Treatment	Condition	Accessibility
Visual (P)	N/A	N/A	N/A	N/A

Normal Occupancy	Score	Likelihood of disturbance	Score	Exposure Potential	Score	Maintenance Activity	Score
Main type of activity	N/A	Location	N/A	Number of occupants	N/A	Type of Maintenance	N/A
		Accessibility	N/A	Frequency of use	N/A	Frequency of maintenance	N/A
		Amount	N/A	Average Time	N/A		
Average Score	N/A	Average Score	N/A	Average Score	N/A	Average Score	N/A
Average of Priority	N/A						
Material Assessment Score	N/A						
Recommendation	No further action required						
Surveyor comments	N/A

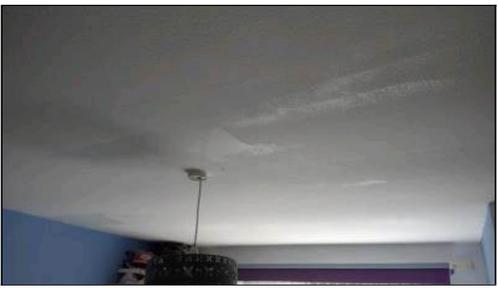
Survey Date:	Lead Surveyor	Survey Type	Floor	Analysis
	3 Jun 2016 to 4 Jun 2016	Sebastian Lawniczak	Management Survey	1st	No Asbestos Detected (0)
	Building	Room	Item	Quantity	
	Main House	Bedroom 2 102	Textured coating to plasterboard ceiling	10m ²	
	Sample No (S,SP,P,As)	Product Type	Surface Treatment	Condition	Accessibility
AE001378 (S)	Textured Coating (1)	Completely Sealed (0)	Good Condition (0)	Occasionally likely to be disturbed (1)

Normal Occupancy	Score	Likelihood of disturbance	Score	Exposure Potential	Score	Maintenance Activity	Score
Main type of activity	N/A	Location	N/A	Number of occupants	N/A	Type of Maintenance	N/A
		Accessibility	N/A	Frequency of use	N/A	Frequency of maintenance	N/A
		Amount	N/A	Average Time	N/A		
Average Score	N/A	Average Score	N/A	Average Score	N/A	Average Score	N/A
Average of Priority	N/A						
Material Assessment Score	N/A						
Recommendation	No further action required						
Surveyor comments	N/A

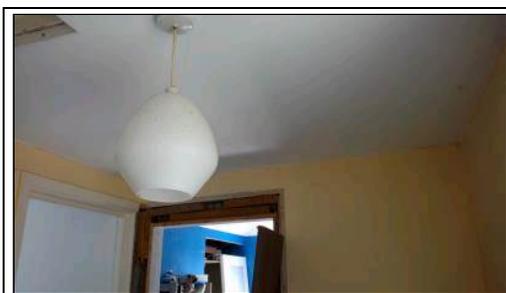
Survey Date:	Lead Surveyor	Survey Type	Floor	Analysis
3 Jun 2016 to 4 Jun 2016	Sebastian Lawniczak	Management Survey	1st	N/A
Building	Room	Item	Quantity	
Main House	Landing 104	No suspect materials identified	N/A	
Sample No (S,SP,P,As)	Product Type	Surface Treatment	Condition	Accessibility
Visual (P)	N/A	N/A	N/A	N/A

Normal Occupancy	Score	Likelihood of disturbance	Score	Exposure Potential	Score	Maintenance Activity	Score
Main type of activity	N/A	Location	N/A	Number of occupants	N/A	Type of Maintenance	N/A
		Accessibility	N/A	Frequency of use	N/A	Frequency of maintenance	N/A
		Amount	N/A	Average Time	N/A		
Average Score	N/A	Average Score	N/A	Average Score	N/A	Average Score	N/A
Average of Priority	N/A						
Material Assessment Score	N/A						
Recommendation	No further action required						
Surveyor comments	N/A

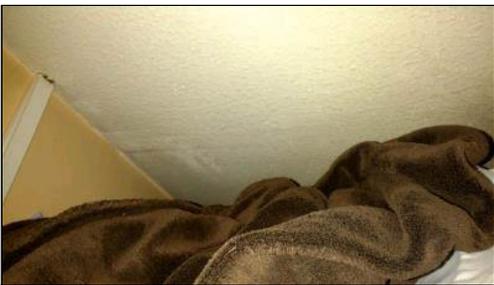
Survey Date:	Lead Surveyor	Survey Type	Floor	Analysis
	3 Jun 2016 to 4 Jun 2016	Sebastian Lawniczak	Management Survey	1st	No Asbestos Detected (0)
	Building	Room	Item	Quantity	
	Main House	Airing Cupboard 105	Textured coating to plasterboard ceiling	1m ²	
	Sample No (S,SP,P,As)	Product Type	Surface Treatment	Condition	Accessibility
As AE001378 (SP)	Textured Coating (1)	Completely Sealed (0)	Low Damage (1)	Occasionally likely to be disturbed (1)

Normal Occupancy	Score	Likelihood of disturbance	Score	Exposure Potential	Score	Maintenance Activity	Score
Main type of activity	N/A	Location	N/A	Number of occupants	N/A	Type of Maintenance	N/A
		Accessibility	N/A	Frequency of use	N/A	Frequency of maintenance	N/A
		Amount	N/A	Average Time	N/A		
Average Score	N/A	Average Score	N/A	Average Score	N/A	Average Score	N/A
Average of Priority	N/A						
Material Assessment Score	N/A						
Recommendation	No further action required						
Surveyor comments	N/A

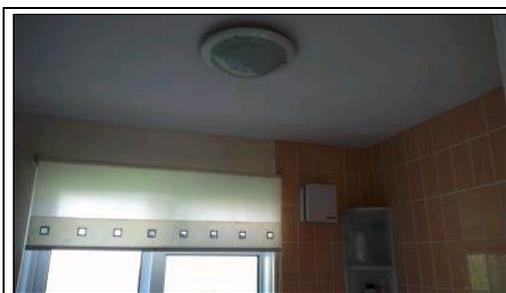
Survey Date:	Lead Surveyor	Survey Type	Floor	Analysis
3 Jun 2016 to 4 Jun 2016	Sebastian Lawniczak	Management Survey	1st	N/A
Building	Room	Item	Quantity	
Main House	Bathroom 106	No suspect materials identified	N/A	
Sample No (S,SP,P,As)	Product Type	Surface Treatment	Condition	Accessibility
Visual (P)	N/A	N/A	N/A	N/A

Normal Occupancy	Score	Likelihood of disturbance	Score	Exposure Potential	Score	Maintenance Activity	Score
Main type of activity	N/A	Location	N/A	Number of occupants	N/A	Type of Maintenance	N/A
		Accessibility	N/A	Frequency of use	N/A	Frequency of maintenance	N/A
		Amount	N/A	Average Time	N/A		
Average Score	N/A	Average Score	N/A	Average Score	N/A	Average Score	N/A
Average of Priority	N/A						
Material Assessment Score	N/A						
Recommendation	No further action required						
Surveyor comments	N/A

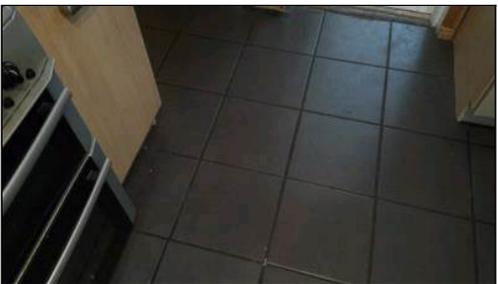
Survey Date:	Lead Surveyor	Survey Type	Floor	Analysis
	3 Jun 2016 to 4 Jun 2016	Sebastian Lawniczak	Management Survey	Ground	Chrysotile (1)
	Building	Room	Item	Quantity	
	Main House	Kitchen G01	Strongly presumed vinyl tiles to concrete floor beneath fixed ceramic floor tiles	9m ²	
	Sample No (S,SP,P,As)	Product Type	Surface Treatment	Condition	Accessibility
	Visual (SP)	Reinforced Composite (1)	Completely Sealed (0)	Good Condition (0)	Usually inaccessible or unlikely to be disturbed (0)

Normal Occupancy	Score	Likelihood of disturbance	Score	Exposure Potential	Score	Maintenance Activity	Score
Main type of activity	1	Location	2	Number of occupants	1	Type of Maintenance	0
		Accessibility	0	Frequency of use	3	Frequency of maintenance	0
		Amount	1	Average Time	1		
Average Score	1	Average Score	1	Average Score	2	Average Score	0
Average of Priority	4						
Material Assessment Score	2						
Recommendation	Inspection required						
Surveyor comments	Unable to safely sample at time of survey due to the potential to damage fixtures and fittings.

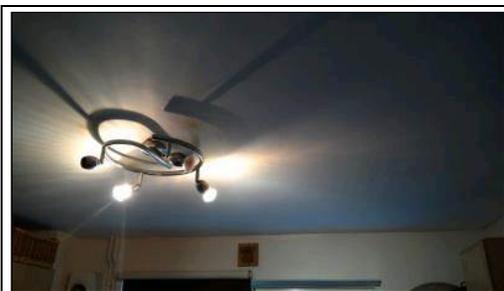
Survey Date:	Lead Surveyor	Survey Type	Floor	Analysis
3 Jun 2016 to 4 Jun 2016	Sebastian Lawniczak	Management Survey	Ground	No Asbestos Detected (0)
Building	Room	Item	Quantity	
Main House	Kitchen G01	Coating to plasterboard ceiling	9m ²	
Sample No (S,SP,P,As)	Product Type	Surface Treatment	Condition	Accessibility
AE001374 (S)	Textured Coating (1)	Completely Sealed (0)	Good Condition (0)	Occasionally likely to be disturbed (1)

Normal Occupancy	Score	Likelihood of disturbance	Score	Exposure Potential	Score	Maintenance Activity	Score
Main type of activity	N/A	Location	N/A	Number of occupants	N/A	Type of Maintenance	N/A
		Accessibility	N/A	Frequency of use	N/A	Frequency of maintenance	N/A
		Amount	N/A	Average Time	N/A		
Average Score	N/A	Average Score	N/A	Average Score	N/A	Average Score	N/A
Average of Priority	N/A						
Material Assessment Score	N/A						
Recommendation	No further action required						
Surveyor comments	N/A

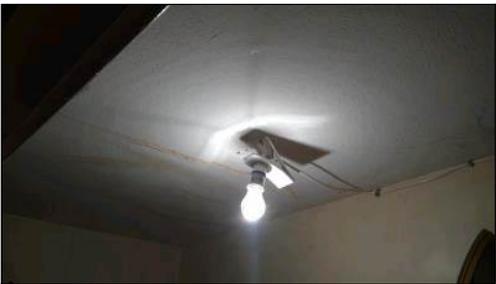
Survey Date:	Lead Surveyor	Survey Type	Floor	Analysis
	3 Jun 2016 to 4 Jun 2016	Sebastian Lawniczak	Management Survey	Ground	No Asbestos Detected (0)
	Building	Room	Item	Quantity	
	Main House	Larder G02	Textured coating to fixed plasterboard ceiling	<2m ²	
	Sample No (S,SP,P,As)	Product Type	Surface Treatment	Condition	Accessibility
AE001375 (S)	Textured Coating (1)	Completely Sealed (0)	Good Condition (0)	Occasionally likely to be disturbed (1)

Normal Occupancy	Score	Likelihood of disturbance	Score	Exposure Potential	Score	Maintenance Activity	Score
Main type of activity	N/A	Location	N/A	Number of occupants	N/A	Type of Maintenance	N/A
		Accessibility	N/A	Frequency of use	N/A	Frequency of maintenance	N/A
		Amount	N/A	Average Time	N/A		
Average Score	N/A	Average Score	N/A	Average Score	N/A	Average Score	N/A
Average of Priority	N/A						
Material Assessment Score	N/A						
Recommendation	No further action required						
Surveyor comments	N/A

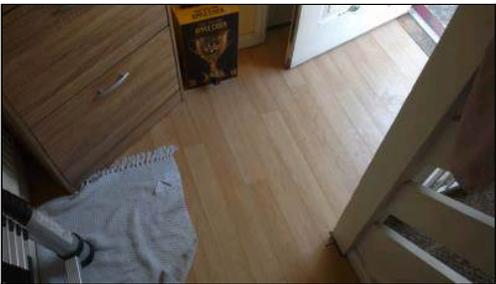
Survey Date:	Lead Surveyor	Survey Type	Floor	Analysis
	3 Jun 2016 to 4 Jun 2016	Sebastian Lawniczak	Management Survey	Ground	Chrysotile (1)
	Building	Room	Item	Quantity	
	Main House	Hallway G03	Strongly presumed vinyl tiles to concrete floor beneath fixed laminate covering	4m ²	
	Sample No (S,SP,P,As)	Product Type	Surface Treatment	Condition	Accessibility
Visual (SP)	Reinforced Composite (1)	Completely Sealed (0)	Good Condition (0)	Usually inaccessible or unlikely to be disturbed (0)

Normal Occupancy	Score	Likelihood of disturbance	Score	Exposure Potential	Score	Maintenance Activity	Score
Main type of activity	1	Location	2	Number of occupants	1	Type of Maintenance	0
		Accessibility	0	Frequency of use	3	Frequency of maintenance	0
		Amount	1	Average Time	0		
Average Score	1	Average Score	1	Average Score	2	Average Score	0
Average of Priority	4						
Material Assessment Score	2						
Recommendation	Inspection required						
Surveyor comments	Unable to safely sample at time of survey due to the potential to damage fixtures and fittings.

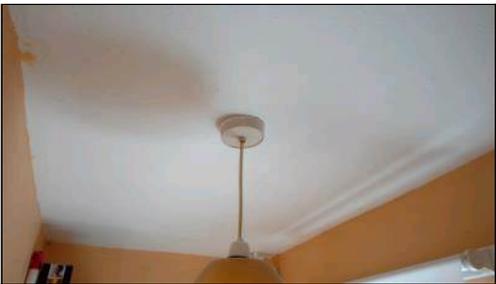
Survey Date:	Lead Surveyor	Survey Type	Floor	Analysis
	3 Jun 2016 to 4 Jun 2016	Sebastian Lawniczak	Management Survey	Ground	No Asbestos Detected (0)
	Building	Room	Item	Quantity	
	Main House	WC G05	Textured coating to fixed plasterboard ceiling	2m ²	
	Sample No (S,SP,P,As)	Product Type	Surface Treatment	Condition	Accessibility
	As AE001375 (SP)	Textured Coating (1)	Completely Sealed (0)	Good Condition (0)	Occasionally likely to be disturbed (1)

Normal Occupancy	Score	Likelihood of disturbance	Score	Exposure Potential	Score	Maintenance Activity	Score
Main type of activity	N/A	Location	N/A	Number of occupants	N/A	Type of Maintenance	N/A
		Accessibility	N/A	Frequency of use	N/A	Frequency of maintenance	N/A
		Amount	N/A	Average Time	N/A		
Average Score	N/A	Average Score	N/A	Average Score	N/A	Average Score	N/A
Average of Priority	N/A						
Material Assessment Score	N/A						
Recommendation	No further action required						
Surveyor comments	N/A

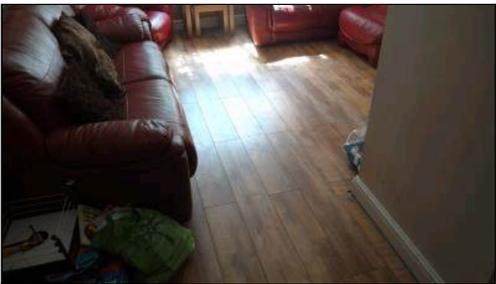
Survey Date:	Lead Surveyor	Survey Type	Floor	Analysis
	3 Jun 2016 to 4 Jun 2016	Sebastian Lawniczak	Management Survey	Ground	Chrysotile (1)
	Building	Room	Item	Quantity	
	Main House	Lounge / Diner G06	Strongly presumed vinyl tiles to concrete floor beneath fixed laminate covering	22m ²	
	Sample No (S,SP,P,As)	Product Type	Surface Treatment	Condition	Accessibility
Visual (SP)	Reinforced Composite (1)	Completely Sealed (0)	Good Condition (0)	Usually inaccessible or unlikely to be disturbed (0)

Normal Occupancy	Score	Likelihood of disturbance	Score	Exposure Potential	Score	Maintenance Activity	Score
Main type of activity	1	Location	2	Number of occupants	1	Type of Maintenance	0
		Accessibility	0	Frequency of use	3	Frequency of maintenance	0
		Amount	2	Average Time	2		
Average Score	1	Average Score	2	Average Score	2	Average Score	0
Average of Priority	5						
Material Assessment Score	2						
Recommendation	Inspection required						
Surveyor comments	Unable to safely sample at time of survey due to the potential to damage fixtures and fittings.

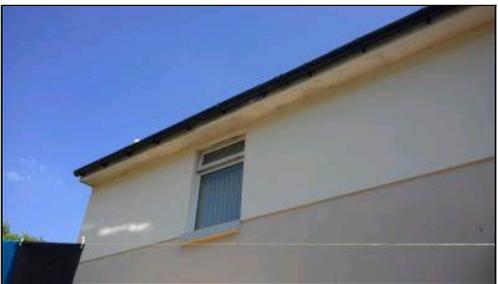
Survey Date:	Lead Surveyor	Survey Type	Floor	Analysis
	3 Jun 2016 to 4 Jun 2016	Sebastian Lawniczak	Management Survey	External	Crocidolite (or unknown) (3)
	Building	Room	Item	Quantity	
	Main House	Throughout E01	Strongly presumed cement soffit boards to high level roofline	8lm	
	Sample No (S,SP,P,As)	Product Type	Surface Treatment	Condition	Accessibility
Visual (SP)	Asbestos Cement (1)	Surface Sealed (1)	Good Condition (0)	Usually inaccessible or unlikely to be disturbed (0)

Normal Occupancy	Score	Likelihood of disturbance	Score	Exposure Potential	Score	Maintenance Activity	Score
Main type of activity	0	Location	0	Number of occupants	0	Type of Maintenance	0
		Accessibility	0	Frequency of use	0	Frequency of maintenance	0
		Amount	1	Average Time	0		
Average Score	0	Average Score	1	Average Score	0	Average Score	0
Average of Priority	1						
Material Assessment Score	5						
Recommendation	Inspection required						
Surveyor comments	Unable to safely sample due to height restrictions.

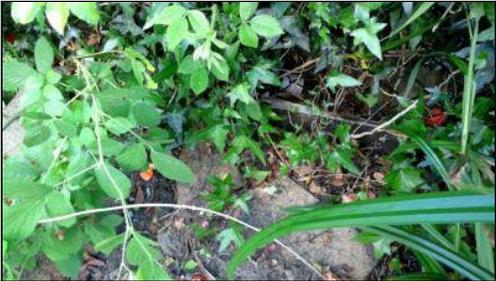
Survey Date:	Lead Surveyor	Survey Type	Floor	Analysis
	3 Jun 2016 to 4 Jun 2016	Sebastian Lawniczak	Management Survey	External	Chrysotile (1)
	Building	Room	Item	Quantity	
	Main House	Throughout E01	Redundant cement panels to RHS garden edges	1m ²	
	Sample No (S,SP,P,As)	Product Type	Surface Treatment	Condition	Accessibility
AE001379 (S)	Cement (1)	Surface Sealed (1)	Medium Damage (2)	Occasionally likely to be disturbed (1)

Normal Occupancy	Score	Likelihood of disturbance	Score	Exposure Potential	Score	Maintenance Activity	Score
Main type of activity	0	Location	0	Number of occupants	0	Type of Maintenance	0
		Accessibility	1	Frequency of use	0	Frequency of maintenance	0
		Amount	1	Average Time	0		
Average Score	0	Average Score	1	Average Score	0	Average Score	0
Average of Priority	1						
Material Assessment Score	5						
Recommendation	Remove						
Surveyor comments	Unable to provide full extent - garden overgrown.

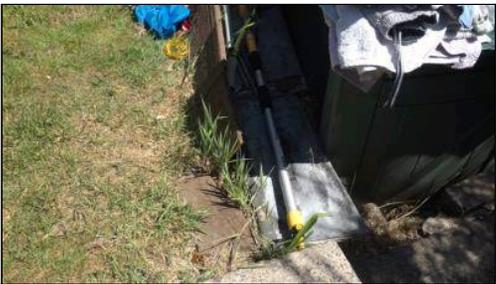
Survey Date:	Lead Surveyor	Survey Type	Floor	Analysis
	3 Jun 2016 to 4 Jun 2016	Sebastian Lawniczak	Management Survey	External	No Asbestos Detected (0)
	Building	Room	Item	Quantity	
	Main House	Throughout E01	Redundant cement panels to front garden floor	3m ²	
	Sample No (S,SP,P,As)	Product Type	Surface Treatment	Condition	Accessibility
	AE001380 (S)	Cement (0)	Surface Sealed (1)	Medium Damage (2)	Easily disturbed (2)

Normal Occupancy	Score	Likelihood of disturbance	Score	Exposure Potential	Score	Maintenance Activity	Score
Main type of activity	N/A	Location	N/A	Number of occupants	N/A	Type of Maintenance	N/A
		Accessibility	N/A	Frequency of use	N/A	Frequency of maintenance	N/A
		Amount	N/A	Average Time	N/A		
Average Score	N/A	Average Score	N/A	Average Score	N/A	Average Score	N/A
Average of Priority	N/A						
Material Assessment Score	N/A						
Recommendation	No further action required						
Surveyor comments	N/A

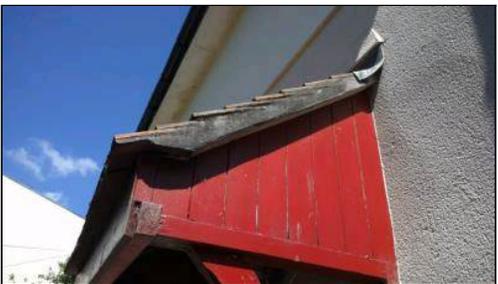
Survey Date:	Lead Surveyor	Survey Type	Floor	Analysis
	3 Jun 2016 to 4 Jun 2016	Sebastian Lawniczak	Management Survey	External	
	Building	Room	Item	Quantity	
	Main House	Throughout E01	Cement undercloaking to front canopy	2lm	
	Sample No (S,SP,P,As)	Product Type	Surface Treatment	Condition	Accessibility
AE001381 (S)	Cement (0)	Surface Sealed (1)	Low Damage (1)	Usually inaccessible or unlikely to be disturbed (0)

Normal Occupancy	Score	Likelihood of disturbance	Score	Exposure Potential	Score	Maintenance Activity	Score
Main type of activity	N/A	Location	N/A	Number of occupants	N/A	Type of Maintenance	N/A
		Accessibility	N/A	Frequency of use	N/A	Frequency of maintenance	N/A
		Amount	N/A	Average Time	N/A		
Average Score	N/A	Average Score	N/A	Average Score	N/A	Average Score	N/A
Average of Priority	N/A						
Material Assessment Score	N/A						
Recommendation	No further action required						
Surveyor comments	N/A
