**WALES & WEST HOUSING  
ASSOCIATION  
3 ALEXANDRA GATE  
FFORDD PENGAM  
TREMORFA  
CARDIFF  
CF24 2UD**

**PROJECT NO: J118795**

**DATE: SEPTEMBER 2013**

**ASBESTOS MANAGEMENT SURVEY  
OF  
14 CYNCOED, YNYSYBWL, PONTYPRIDD, CF37 3PL**

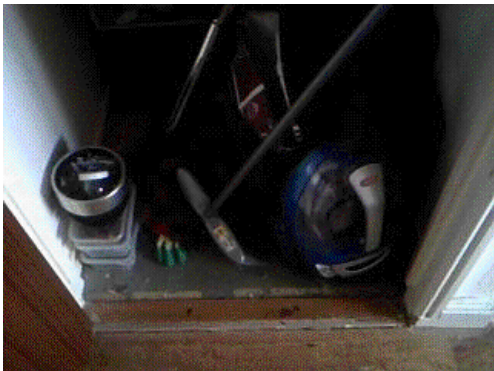
| <b>FLOOR/LOCATION:</b> | 1st Floor Cupboard (103) | |

| SITE ADDRESS: 14 CYNCOED, YNYSYBWL, PONTYPRIDD, CF37 3PL | | | | | | | | DATE: 10/09/2013 | | |
|---|---|---|---|---|---|---|---|---|---|---|
| 1st Floor / Cupboard (103) (1) | 4 - 10 (2) | Grey floor tile (1) | 1m² (1) | Composite Material (0) | Good Condition (0) | Low (1) | EA001462 / Chrysotile (1) | 2 + 5 = 7 | Very Low | Manage, label, monitor and inform maintenance personnel prior to relevant works |

| <b>DESCRIPTION:</b> | Grey floor tile | |
| <b>RESULT:</b> | Chrysotile | |

| <b>RECOMMENDATIONS:</b> | Manage, label, monitor and inform maintenance personnel prior to relevant works | |

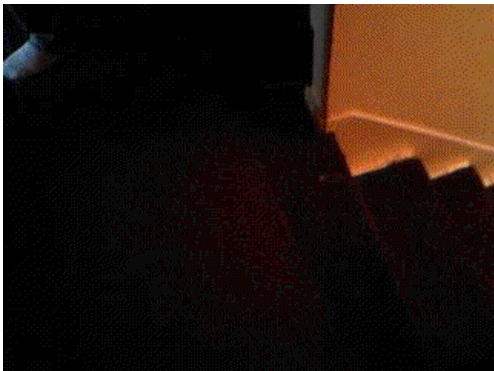
| <b>FLOOR/LOCATION:</b> | 1st Floor Landing (104) | |

| SITE ADDRESS: 14 CYNCOED, YNYSYBWL, PONTYPRIDD, CF37 3PL | | | | | | | | | DATE: 10/09/2013 | |
|---|---|---|---|---|---|---|---|---|---|---|
| 1st Floor /<br>Landing (104) (1) | 4 - 10<br>(2) | Light brown floor tile (1) | 7m <sup>2</sup> (1) | Composite<br>Material (0) | Good<br>Condition (0) | Low (1) | EA001463 /<br>Chrysotile (1) | 2 + 5 = 7 | Very<br>Low | Manage, label, monitor and inform maintenance<br>personnel prior to relevant works |

| <b>DESCRIPTION:</b> | Light brown floor tile | |
| <b>RESULT:</b> | Chrysotile | |

| <b>RECOMMENDATIONS:</b> | Manage, label, monitor and inform maintenance personnel prior to relevant works | |

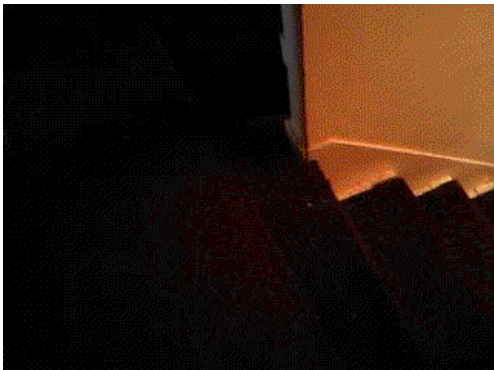
| <b>FLOOR/LOCATION:</b> | 1st Floor Landing (104) | |

| SITE ADDRESS: 14 CYNCOED, YNYSYBWL, PONTYPRIDD, CF37 3PL | | | | | | | | | DATE: 10/09/2013 | |
|---|---|---|---|---|---|---|---|---|---|---|
| 1st Floor /<br>Landing (104) (1) | 4 - 10<br>(2) | Bitumen adhesive to light brown floor tiles (1) | <4m <sup>2</sup><br>(1) | Composite<br>Material (0) | Good<br>Condition (0) | Rare (0) | EA001464 /<br>Chrysotile (1) | 2 + 4 = 6 | Very<br>Low | Manage, label, monitor and inform maintenance<br>personnel prior to relevant works |

| <b>DESCRIPTION:</b> | Bitumen adhesive to light brown floor tiles | |
| <b>RESULT:</b> | Chrysotile | |

| <b>RECOMMENDATIONS:</b> | Manage, label, monitor and inform maintenance personnel prior to relevant works | |

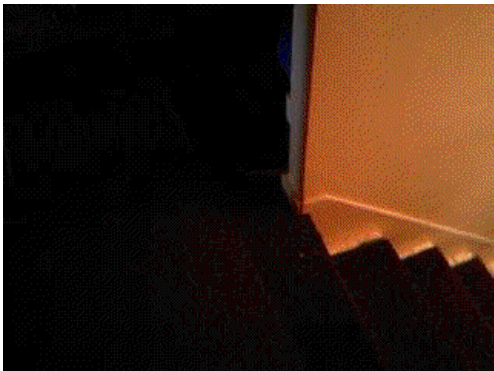
| <b>FLOOR/LOCATION:</b> | 1st Floor Landing (104) | |

| SITE ADDRESS: 14 CYNCOED, YNYSYBWL, PONTYPRIDD, CF37 3PL | | | | | | | | | DATE: 10/09/2013 | |
|---|---|---|---|---|---|---|---|---|---|---|
| 1st Floor /<br>Landing (104) (1) | 4 - 10<br>(2) | Black floor tile (1) | 7m <sup>2</sup> (1) | Composite<br>Material (0) | Good<br>Condition (0) | Low (1) | EA001465 /<br>Chrysotile (1) | 2 + 5 = 7 | Very<br>Low | Manage, label, monitor and inform maintenance<br>personnel prior to relevant works |

| <b>DESCRIPTION:</b> | Black floor tile | |
| <b>RESULT:</b> | Chrysotile | |

| <b>RECOMMENDATIONS:</b> | Manage, label, monitor and inform maintenance personnel prior to relevant works | |

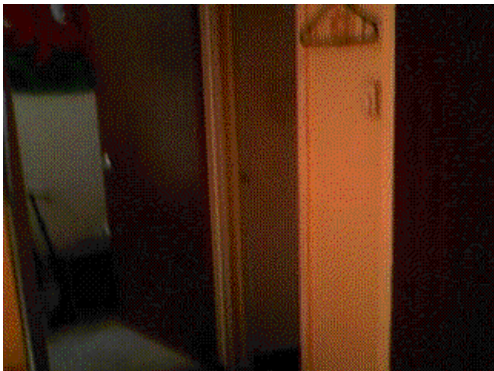
| <b>FLOOR/LOCATION:</b> | 1st Floor Landing (104) | |

| SITE ADDRESS: 14 CYNCOED, YNYSYBWL, PONTYPRIDD, CF37 3PL | | | | | | | | | DATE: 10/09/2013 | |
|---|---|---|---|---|---|---|---|---|---|---|
| 1st Floor /<br>Landing (104) (1) | 4 - 10<br>(2) | Bitumen adhesive to black floor tiles (1) | <4m <sup>2</sup><br>(1) | Composite<br>Material (0) | Good<br>Condition (0) | Rare (0) | BS085367 /<br>Chrysotile (1) | 2 + 4 = 6 | Very<br>Low | Manage, label, monitor and inform maintenance<br>personnel prior to relevant works |

| <b>DESCRIPTION:</b> | Bitumen adhesive to black floor tiles | |
| <b>RESULT:</b> | Chrysotile | |

| <b>RECOMMENDATIONS:</b> | Manage, label, monitor and inform maintenance personnel prior to relevant works | |

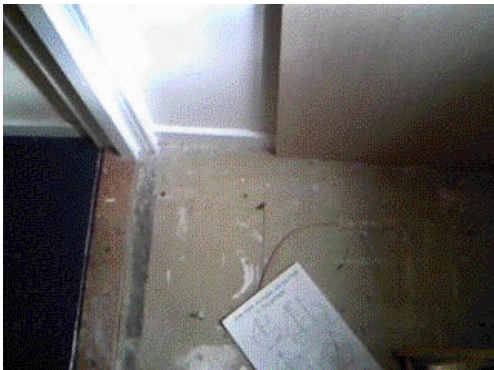
| <b>FLOOR/LOCATION:</b> | 1st Floor Cupboard (105) | |

| SITE ADDRESS: 14 CYNCOED, YNYSYBWL, PONTYPRIDD, CF37 3PL | | | | | | | | DATE: 10/09/2013 | | |
|---|---|---|---|---|---|---|---|---|---|---|
| 1st Floor /<br>Cupboard (105)<br>(1) | 4 - 10<br>(2) | Green floor tile (1) | 1m²<br>(1) | Composite<br>Material (0) | Good<br>Condition (0) | Low (1) | Strongly presumed similar to<br>EA001468 / <b>Chrysotile</b> (1) | 2 + 5 = 7 | Very<br>Low | Manage, label, monitor and inform<br>maintenance personnel prior to<br>relevant works |

| <b>DESCRIPTION:</b> | Green floor tile | |
| <b>RESULT:</b> | Chrysotile | |

| <b>RECOMMENDATIONS:</b> | Manage, label, monitor and inform maintenance personnel prior to relevant works | |

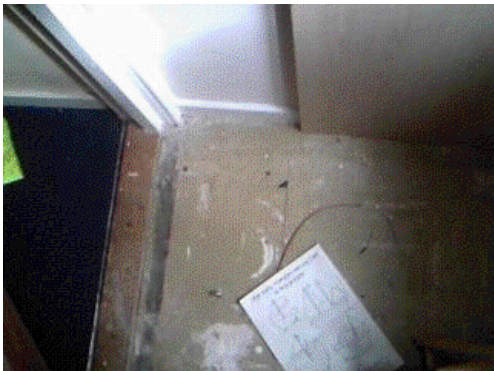
| <b>FLOOR/LOCATION:</b> | 1st Floor Cupboard (105) | |

| SITE ADDRESS: 14 CYNCOED, YNYSYBWL, PONTYPRIDD, CF37 3PL | | | | | | | | DATE: 10/09/2013 | | |
|---|---|---|---|---|---|---|---|---|---|---|
| 1st Floor /<br>Cupboard (105)<br>(1) | 4 - 10<br>(2) | Bitumen adhesive (1) | 1m²<br>(1) | Composite<br>Material (0) | Good<br>Condition (0) | Low (1) | Strongly presumed similar to<br>EA001464 / <b>Chrysotile</b> (1) | 2 + 5 = 7 | Very<br>Low | Manage, label, monitor and inform<br>maintenance personnel prior to<br>relevant works |

| <b>DESCRIPTION:</b> | Bitumen adhesive | |
| <b>RESULT:</b> | Chrysotile | |

| <b>RECOMMENDATIONS:</b> | Manage, label, monitor and inform maintenance personnel prior to relevant works | |

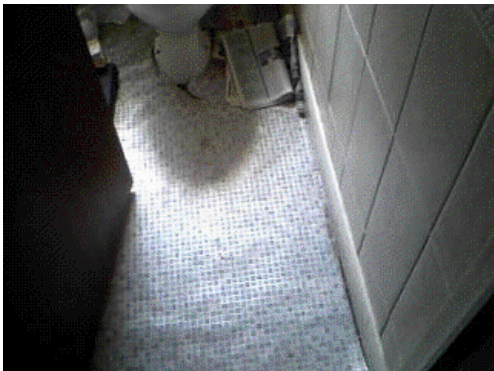
| <b>FLOOR/LOCATION:</b> | 1st Floor Toilet (106) | |

| SITE ADDRESS: 14 CYNCOED, YNYSYBWL, PONTYPRIDD, CF37 3PL | | | | | | | | DATE: 10/09/2013 | | |
|---|---|---|---|---|---|---|---|---|---|---|
| 1st Floor / Toilet (106) (1) | 4 - 10 (2) | Black floor tile (1) | 1m <sup>2</sup> (1) | Composite Material (0) | Good Condition (0) | Low (1) | Strongly presumed similar to EA001465 / <b>Chrysotile (1)</b> | 2 + 5 = 7 | Very Low | Manage, label, monitor and inform maintenance personnel prior to relevant works |

| <b>DESCRIPTION:</b> | Black floor tile | |
| <b>RESULT:</b> | Chrysotile | |

| <b>RECOMMENDATIONS:</b> | Manage, label, monitor and inform maintenance personnel prior to relevant works | |

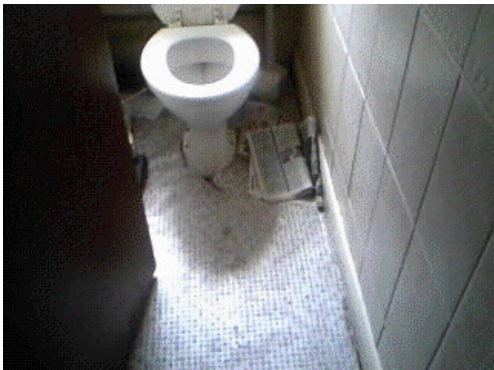
| <b>FLOOR/LOCATION:</b> | 1st Floor Toilet (106) | |

| SITE ADDRESS: 14 CYNCOED, YNYSYBWL, PONTYPRIDD, CF37 3PL | | | | | | | | DATE: 10/09/2013 | | |
|---|---|---|---|---|---|---|---|---|---|---|
| 1st Floor / Toilet (106) (1) | 4 - 10 (2) | Bitumen adhesive (1) | 1m <sup>2</sup> (1) | Composite Material (0) | Good Condition (0) | Low (1) | Strongly presumed similar to EA001464 / <b>Chrysotile (1)</b> | 2 + 5 = 7 | Very Low | Manage, label, monitor and inform maintenance personnel prior to relevant works |

| <b>DESCRIPTION:</b> | Bitumen adhesive | |
| <b>RESULT:</b> | Chrysotile | |

| <b>RECOMMENDATIONS:</b> | Manage, label, monitor and inform maintenance personnel prior to relevant works | |

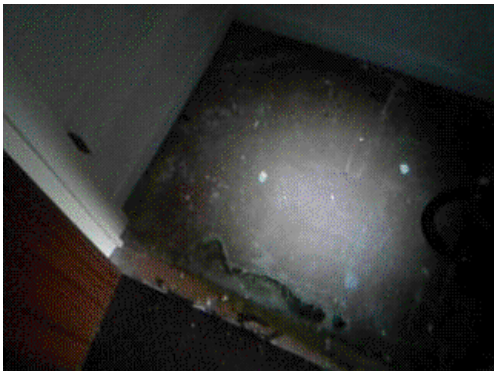
| <b>FLOOR/LOCATION:</b> | 1st Floor Boiler Cupboard (108) | |

| SITE ADDRESS: 14 CYNCOED, YNYSYBWL, PONTYPRIDD, CF37 3PL | | | | | | | | DATE: 10/09/2013 | | |
|---|---|---|---|---|---|---|---|---|---|---|
| 1st Floor / Boiler Cupboard (108) (1) | 4 - 10 (2) | Light brown floor tile (1) | 1m² (1) | Composite Material (0) | Good Condition (0) | Low (1) | Strongly presumed similar to EA001463 / <b>Chrysotile</b> (1) | 2 + 5 = 7 | Very Low | Manage, label, monitor and inform maintenance personnel prior to relevant works |

| <b>DESCRIPTION:</b> | Light brown floor tile | |
| <b>RESULT:</b> | Chrysotile | |

| <b>RECOMMENDATIONS:</b> | Manage, label, monitor and inform maintenance personnel prior to relevant works | |

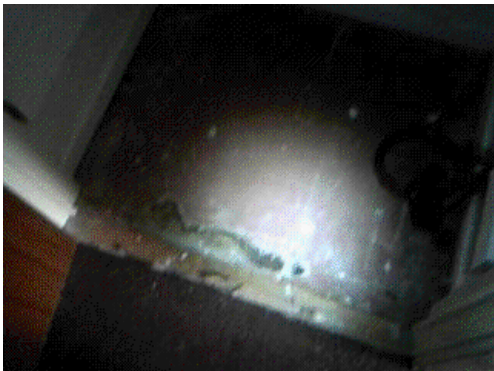
| <b>FLOOR/LOCATION:</b> | 1st Floor Boiler Cupboard (108) | |

| SITE ADDRESS: 14 CYNCOED, YNYSYBWL, PONTYPRIDD, CF37 3PL | | | | | | | | DATE: 10/09/2013 | | |
|---|---|---|---|---|---|---|---|---|---|---|
| 1st Floor / Boiler Cupboard (108) (1) | 4 - 10 (2) | Bitumen adhesive (1) | 1m² (1) | Composite Material (0) | Good Condition (0) | Low (1) | Strongly presumed similar to EA001464 / <b>Chrysotile</b> (1) | 2 + 5 = 7 | Very Low | Manage, label, monitor and inform maintenance personnel prior to relevant works |

| <b>DESCRIPTION:</b> | Bitumen adhesive | |
| <b>RESULT:</b> | Chrysotile | |

| <b>RECOMMENDATIONS:</b> | Manage, label, monitor and inform maintenance personnel prior to relevant works | |

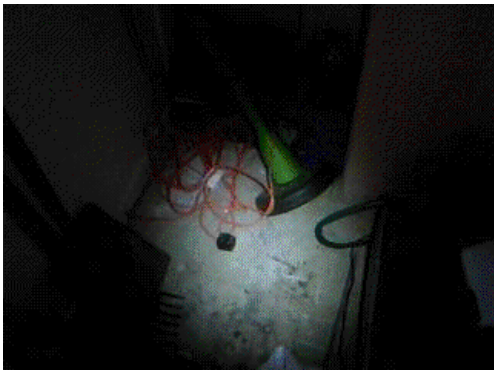
| <b>FLOOR/LOCATION:</b> | 1st Floor Cupboard (109) | |

| SITE ADDRESS: 14 CYNCOED, YNYSYBWL, PONTYPRIDD, CF37 3PL | | | | | | | | DATE: 10/09/2013 | | |
|---|---|---|---|---|---|---|---|---|---|---|
| 1st Floor /<br>Cupboard (109)<br>(1) | 4 - 10<br>(2) | Green floor tile (1) | 1m <sup>2</sup><br>(1) | Composite<br>Material (0) | Good<br>Condition (0) | Low (1) | Strongly presumed similar to<br>EA001468 / <b>Chrysotile</b> (1) | 2 + 5 = 7 | Very<br>Low | Manage, label, monitor and inform<br>maintenance personnel prior to<br>relevant works |

| <b>DESCRIPTION:</b> | Green floor tile | |
| <b>RESULT:</b> | Chrysotile | |

| <b>RECOMMENDATIONS:</b> | Manage, label, monitor and inform maintenance personnel prior to relevant works | |

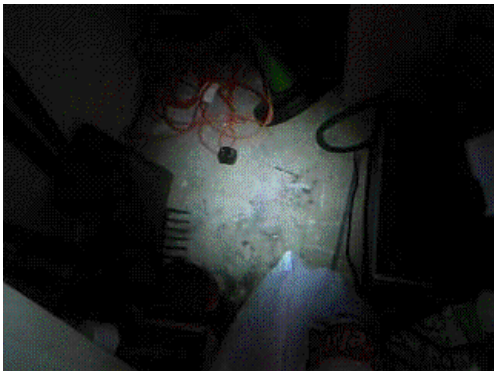
| <b>FLOOR/LOCATION:</b> | 1st Floor Cupboard (109) | |

| SITE ADDRESS: 14 CYNCOED, YNYSYBWL, PONTYPRIDD, CF37 3PL | | | | | | | | DATE: 10/09/2013 | | |
|---|---|---|---|---|---|---|---|---|---|---|
| 1st Floor /<br>Cupboard (109)<br>(1) | 4 - 10<br>(2) | Bitumen adhesive (1) | 1m <sup>2</sup><br>(1) | Composite<br>Material (0) | Good<br>Condition (0) | Low (1) | Strongly presumed similar to<br>EA001464 / <b>Chrysotile</b> (1) | 2 + 5 = 7 | Very<br>Low | Manage, label, monitor and inform<br>maintenance personnel prior to<br>relevant works |

| <b>DESCRIPTION:</b> | Bitumen adhesive | |
| <b>RESULT:</b> | Chrysotile | |

| <b>RECOMMENDATIONS:</b> | Manage, label, monitor and inform maintenance personnel prior to relevant works | |

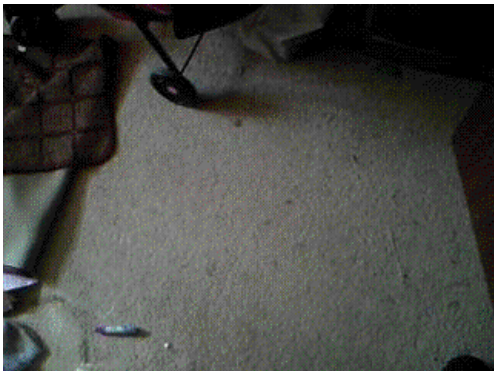
| <b>FLOOR/LOCATION:</b> | 1st Floor Bedroom (110) | |

| SITE ADDRESS: 14 CYNCOED, YNYSYBWL, PONTYPRIDD, CF37 3PL | | | | | | | | DATE: 10/09/2013 | | |
|---|---|---|---|---|---|---|---|---|---|---|
| 1st Floor /<br>Bedroom (110)<br>(1) | 4 - 10<br>(2) | Green floor tile (1) | 8m <sup>2</sup><br>(1) | Composite<br>Material (0) | Good<br>Condition (0) | Low (1) | EA001468 / <b>Chrysotile</b> (1) | 2 + 5 = 7 | Very<br>Low | Manage, label, monitor and inform<br>maintenance personnel prior to<br>relevant works |

| <b>DESCRIPTION:</b> | Green floor tile | |
| <b>RESULT:</b> | Chrysotile | |

| <b>RECOMMENDATIONS:</b> | Manage, label, monitor and inform maintenance personnel prior to relevant works | |

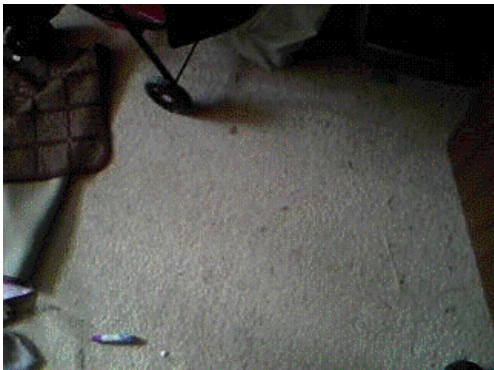
| <b>FLOOR/LOCATION:</b> | 1st Floor Bedroom (110) | |

| <b>DESCRIPTION:</b> | Bitumen adhesive to black floor tiles | |
| <b>RESULT:</b> | Chrysotile | |

| <b>RECOMMENDATIONS:</b> | Manage, label, monitor and inform maintenance personnel prior to relevant works | |

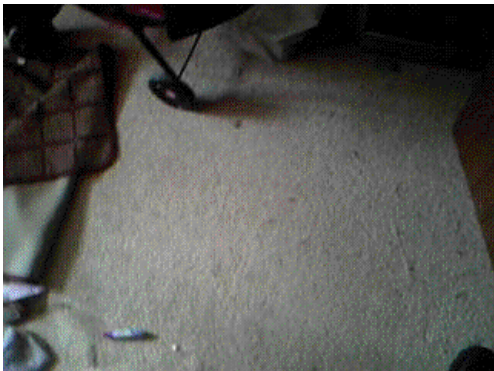
| <b>FLOOR/LOCATION:</b> | 1st Floor Bedroom (110) | |

| <b>DESCRIPTION:</b> | Black floor tile | |
| <b>RESULT:</b> | Chrysotile | |

| <b>RECOMMENDATIONS:</b> | Manage, label, monitor and inform maintenance personnel prior to relevant works | |

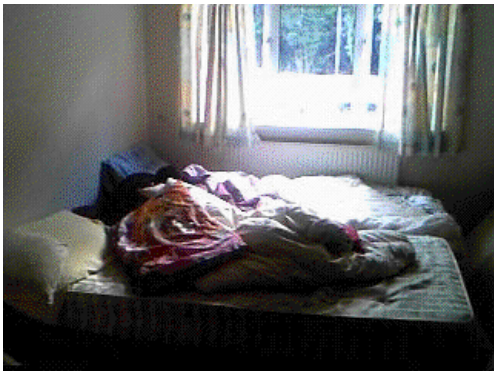
| <b>FLOOR/LOCATION:</b> | 1st Floor Bedroom (110) | |

| <b>DESCRIPTION:</b> | Bitumen adhesive to green floor tiles | |
| <b>RESULT:</b> | Chrysotile | |

| <b>RECOMMENDATIONS:</b> | Manage, label, monitor and inform maintenance personnel prior to relevant works | |

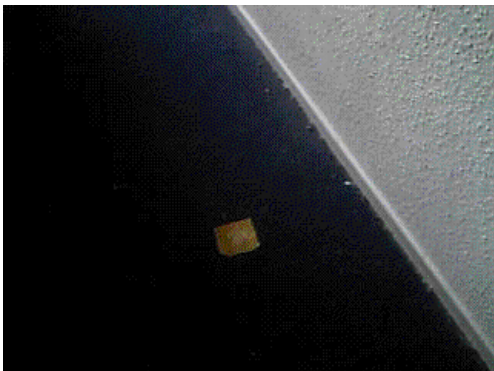
| <b>FLOOR/LOCATION:</b> | 1st Floor Bedroom (111) | |

| <b>DESCRIPTION:</b> | Green floor tile | |
| <b>RESULT:</b> | Chrysotile | |

| <b>RECOMMENDATIONS:</b> | Manage, label, monitor and inform maintenance personnel prior to relevant works | |

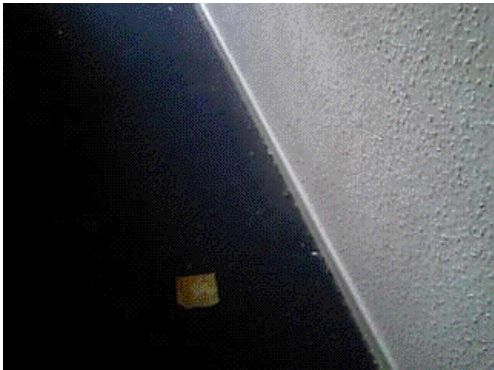
| <b>FLOOR/LOCATION:</b> | 1st Floor Bedroom (111) | |

| <b>DESCRIPTION:</b> | Bitumen adhesive | |
| <b>RESULT:</b> | Chrysotile | |

| <b>RECOMMENDATIONS:</b> | Manage, label, monitor and inform maintenance personnel prior to relevant works | |

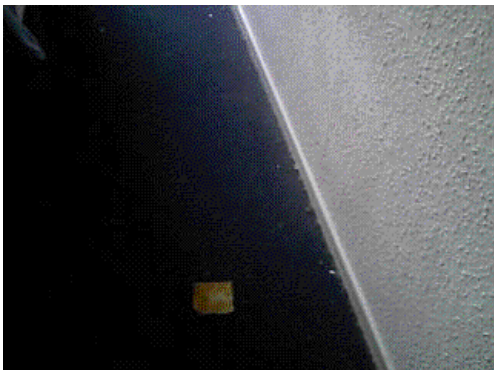
| <b>FLOOR/LOCATION:</b> | 1st Floor Bedroom (111) | |

| <b>DESCRIPTION:</b> | Black floor tile | |

| <b>RECOMMENDATIONS:</b> | Manage, label, monitor and inform maintenance personnel prior to relevant works | |
