Management Survey

17 Cyncoed
Ynysybwll
Pontypridd
CF37 3PL
UPRN: 7922

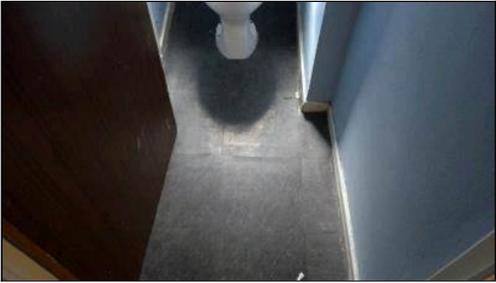
Survey Date:	Lead Surveyor	Survey Type	Floor	Analysis
	14 Jul 2016	Sebastian Lawniczak	Management Survey	Ground	Chrysotile (1)
	Building	Room	Item	Quantity	
	Block 17-20. Flat 17.	WC G02	Strongly presumed vinyl tiles to concrete floor beneath several layers of non-suspect vinyl tile and sheet coverings	<2m ²	
	Sample No (S,SP,P,As)	Product Type	Surface Treatment	Condition	Accessibility
Visual (SP)	Reinforced Composite (1)	Completely Sealed (0)	Good Condition (0)	Usually inaccessible or unlikely to be disturbed (0)

Normal Occupancy	Score	Likelihood of disturbance	Score	Exposure Potential	Score	Maintenance Activity	Score
Main type of activity	1	Location	2	Number of occupants	1	Type of Maintenance	0
		Accessibility	0	Frequency of use	3	Frequency of maintenance	0
		Amount	1	Average Time	0		
Average Score	1	Average Score	1	Average Score	2	Average Score	0
Average of Priority	4						
Material Assessment Score	2						
Recommendation	Inspection required						
Surveyor comments	No access at the time of the survey due to the potential to damage fixtures and fittings.

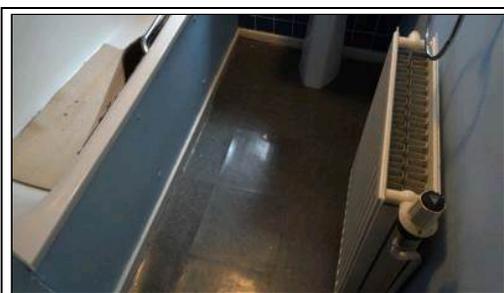
Survey Date:	Lead Surveyor	Survey Type	Floor	Analysis
14 Jul 2016	Sebastian Lawniczak	Management Survey	Ground	Chrysotile (1)
Building	Room	Item	Quantity	
Block 17-20. Flat 17.	Bathroom G03	Strongly presumed vinyl tiles to concrete floor beneath several layers of non-suspect vinyl tile and sheet coverings	3m ²	
Sample No (S,SP,P,As)	Product Type	Surface Treatment	Condition	Accessibility
Visual (SP)	Reinforced Composite (1)	Completely Sealed (0)	Good Condition (0)	Usually inaccessible or unlikely to be disturbed (0)

Normal Occupancy	Score	Likelihood of disturbance	Score	Exposure Potential	Score	Maintenance Activity	Score
Main type of activity	1	Location	2	Number of occupants	1	Type of Maintenance	0
		Accessibility	0	Frequency of use	3	Frequency of maintenance	0
		Amount	1	Average Time	1		
Average Score	1	Average Score	1	Average Score	2	Average Score	0
Average of Priority	4						
Material Assessment Score	2						
Recommendation	Inspection required						
Surveyor comments	No access at the time of the survey due to the potential to damage fixtures and fittings.

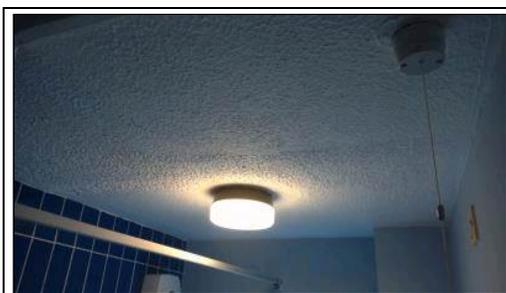
Survey Date:	Lead Surveyor	Survey Type	Floor	Analysis
14 Jul 2016	Sebastian Lawniczak	Management Survey	Ground	Chrysotile (1)
Building	Room	Item	Quantity	
Block 17-20. Flat 17.	Bathroom G03	Textured coating to concrete ceiling	3m ²	
Sample No (S,SP,P,As)	Product Type	Surface Treatment	Condition	Accessibility
AE001565 (S)	Textured Coating (1)	Completely Sealed (0)	Low Damage (1)	Occasionally likely to be disturbed (1)

Normal Occupancy	Score	Likelihood of disturbance	Score	Exposure Potential	Score	Maintenance Activity	Score
Main type of activity	1	Location	2	Number of occupants	1	Type of Maintenance	0
		Accessibility	1	Frequency of use	3	Frequency of maintenance	0
		Amount	1	Average Time	1		
Average Score	1	Average Score	2	Average Score	2	Average Score	0
Average of Priority	5						
Material Assessment Score	3						
Recommendation	Manage and re-inspect						
Surveyor comments	N/A

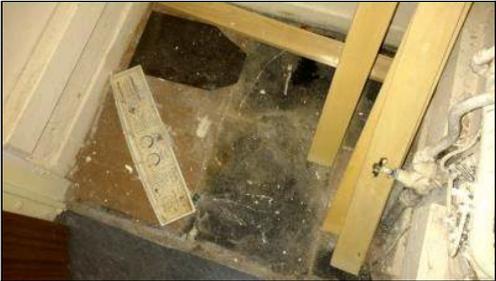
Survey Date:	Lead Surveyor	Survey Type	Floor	Analysis
	14 Jul 2016	Sebastian Lawniczak	Management Survey	Ground	Chrysotile (1)
	Building	Room	Item	Quantity	
	Block 17-20. Flat 17.	Bathroom Cupboard G04	Brown thermoplastic tiles and bitumen adhesive below to concrete floor	1m ²	
	Sample No (S,SP,P,As)	Product Type	Surface Treatment	Condition	Accessibility
	As AE001564 (SP)	Vinyl floor tiles (1)	Completely Sealed (0)	Low Damage (1)	Routinely disturbed (3)

Normal Occupancy	Score	Likelihood of disturbance	Score	Exposure Potential	Score	Maintenance Activity	Score
Main type of activity	0	Location	2	Number of occupants	1	Type of Maintenance	0
		Accessibility	3	Frequency of use	2	Frequency of maintenance	0
		Amount	1	Average Time	0		
Average Score	0	Average Score	2	Average Score	1	Average Score	0
Average of Priority	3						
Material Assessment Score	3						
Recommendation	Manage and re-inspect						
Surveyor comments	N/A

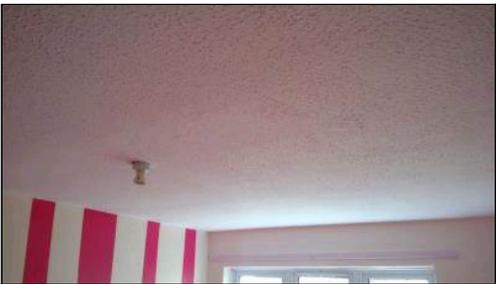
Survey Date:	Lead Surveyor	Survey Type	Floor	Analysis
	14 Jul 2016	Sebastian Lawniczak	Management Survey	Ground	Chrysotile (1)
	Building	Room	Item	Quantity	
	Block 17-20. Flat 17.	Bedroom 1 G05	Textured coating to concrete ceiling	8m ²	
	Sample No (S,SP,P,As)	Product Type	Surface Treatment	Condition	Accessibility
As AE001563 (SP)	Textured Coating (1)	Completely Sealed (0)	Good Condition (0)	Occasionally likely to be disturbed (1)

Normal Occupancy	Score	Likelihood of disturbance	Score	Exposure Potential	Score	Maintenance Activity	Score
Main type of activity	1	Location	2	Number of occupants	1	Type of Maintenance	0
		Accessibility	1	Frequency of use	3	Frequency of maintenance	0
		Amount	1	Average Time	3		
Average Score	1	Average Score	2	Average Score	3	Average Score	0
Average of Priority	6						
Material Assessment Score	2						
Recommendation	Manage and re-inspect						
Surveyor comments	N/A

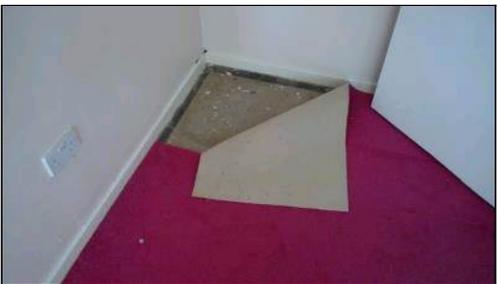
Survey Date:	Lead Surveyor	Survey Type	Floor	Analysis
	14 Jul 2016	Sebastian Lawniczak	Management Survey	Ground	Chrysotile (1)
	Building	Room	Item	Quantity	
	Block 17-20. Flat 17.	Bedroom 1 G05	Beige thermoplastic tiles and bitumen adhesive below to concrete floor	8m ²	
	Sample No (S,SP,P,As)	Product Type	Surface Treatment	Condition	Accessibility
AE001566 (S)	Well Bound Material (1)	Completely Sealed (0)	Low Damage (1)	Usually inaccessible or unlikely to be disturbed (0)

Normal Occupancy	Score	Likelihood of disturbance	Score	Exposure Potential	Score	Maintenance Activity	Score
Main type of activity	1	Location	2	Number of occupants	1	Type of Maintenance	0
		Accessibility	0	Frequency of use	3	Frequency of maintenance	0
		Amount	1	Average Time	3		
Average Score	1	Average Score	1	Average Score	3	Average Score	0
Average of Priority	5						
Material Assessment Score	3						
Recommendation	Manage and re-inspect						
Surveyor comments	Beneath carpet covering.

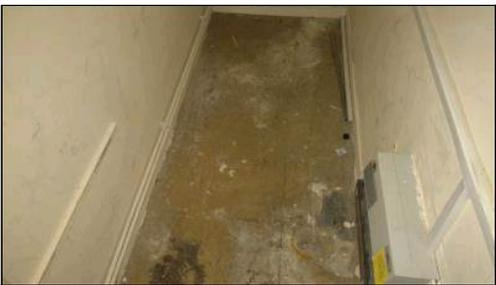
Survey Date:	Lead Surveyor	Survey Type	Floor	Analysis
	14 Jul 2016	Sebastian Lawniczak	Management Survey	Ground	Chrysotile (1)
	Building	Room	Item	Quantity	
	Block 17-20. Flat 17.	Store Cupboard 1 G06	Beige thermoplastic tiles and bitumen adhesive below to concrete floor	2m ²	
	Sample No (S,SP,P,As)	Product Type	Surface Treatment	Condition	Accessibility
As AE001566 (SP)	Well Bound Material (1)	Completely Sealed (0)	Good Condition (0)	Routinely disturbed (3)

Normal Occupancy	Score	Likelihood of disturbance	Score	Exposure Potential	Score	Maintenance Activity	Score
Main type of activity	0	Location	2	Number of occupants	1	Type of Maintenance	0
		Accessibility	3	Frequency of use	2	Frequency of maintenance	0
		Amount	1	Average Time	0		
Average Score	0	Average Score	2	Average Score	1	Average Score	0
Average of Priority	3						
Material Assessment Score	2						
Recommendation	Manage and re-inspect						
Surveyor comments	N/A

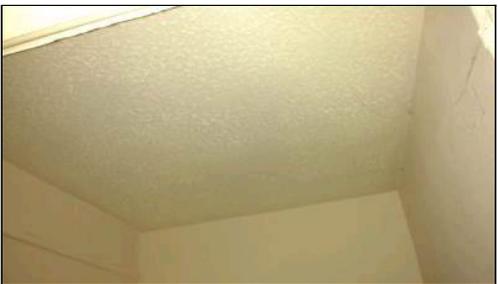
Survey Date:	Lead Surveyor	Survey Type	Floor	Analysis
	14 Jul 2016	Sebastian Lawniczak	Management Survey	Ground	Chrysotile (1)
	Building	Room	Item	Quantity	
	Block 17-20. Flat 17.	Store Cupboard 2 G07	Textured coating to concrete ceiling	1m ²	
	Sample No (S,SP,P,As)	Product Type	Surface Treatment	Condition	Accessibility
As AE001563 (SP)	Textured Coating (1)	Completely Sealed (0)	Good Condition (0)	Occasionally likely to be disturbed (1)

Normal Occupancy	Score	Likelihood of disturbance	Score	Exposure Potential	Score	Maintenance Activity	Score
Main type of activity	0	Location	2	Number of occupants	1	Type of Maintenance	0
		Accessibility	1	Frequency of use	2	Frequency of maintenance	0
		Amount	1	Average Time	0		
Average Score	0	Average Score	2	Average Score	1	Average Score	0
Average of Priority	3						
Material Assessment Score	2						
Recommendation	Manage and re-inspect						
Surveyor comments	N/A

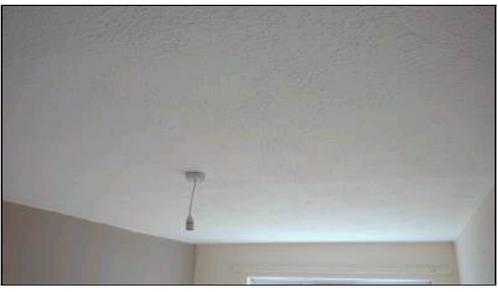
Survey Date:	Lead Surveyor	Survey Type	Floor	Analysis
	14 Jul 2016	Sebastian Lawniczak	Management Survey	Ground	Chrysotile (1)
	Building	Room	Item	Quantity	
	Block 17-20. Flat 17.	Bedroom 2 G08	Textured coating to concrete ceiling	10m ²	
	Sample No (S,SP,P,As)	Product Type	Surface Treatment	Condition	Accessibility
As AE001565 (SP)	Textured Coating (1)	Completely Sealed (0)	Good Condition (0)	Occasionally likely to be disturbed (1)

Normal Occupancy	Score	Likelihood of disturbance	Score	Exposure Potential	Score	Maintenance Activity	Score
Main type of activity	1	Location	2	Number of occupants	1	Type of Maintenance	0
		Accessibility	1	Frequency of use	3	Frequency of maintenance	0
		Amount	2	Average Time	3		
Average Score	1	Average Score	2	Average Score	3	Average Score	0
Average of Priority	6						
Material Assessment Score	2						
Recommendation	Manage and re-inspect						
Surveyor comments	N/A

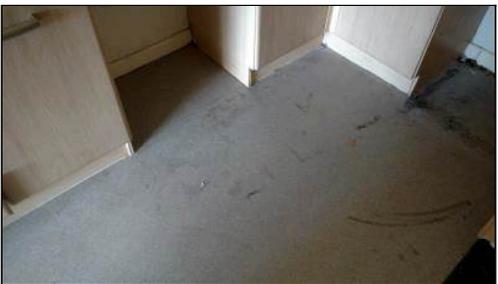
Survey Date:	Lead Surveyor	Survey Type	Floor	Analysis
	14 Jul 2016	Sebastian Lawniczak	Management Survey	Ground	Chrysotile (1)
	Building	Room	Item	Quantity	
	Block 17-20. Flat 17.	Kitchen G09	Strongly presumed vinyl tiles to concrete floor beneath fixed non-suspect beige vinyl sheet covering	8m ²	
	Sample No (S,SP,P,As)	Product Type	Surface Treatment	Condition	Accessibility
Visual (SP)	Reinforced Composite (1)	Completely Sealed (0)	Good Condition (0)	Usually inaccessible or unlikely to be disturbed (0)

Normal Occupancy	Score	Likelihood of disturbance	Score	Exposure Potential	Score	Maintenance Activity	Score
Main type of activity	1	Location	2	Number of occupants	1	Type of Maintenance	0
		Accessibility	0	Frequency of use	3	Frequency of maintenance	0
		Amount	1	Average Time	1		
Average Score	1	Average Score	1	Average Score	2	Average Score	0
Average of Priority	4						
Material Assessment Score	2						
Recommendation	Inspection required						
Surveyor comments	No access at the time of the survey due to the potential to damage fixtures and fittings.

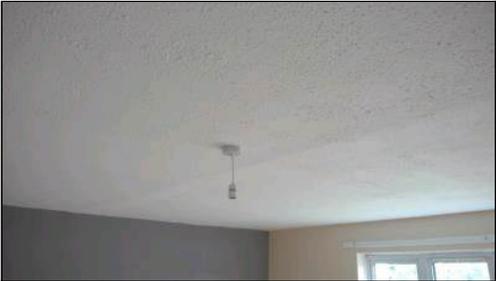
Survey Date:	Lead Surveyor	Survey Type	Floor	Analysis
	14 Jul 2016	Sebastian Lawniczak	Management Survey	Ground	No Asbestos Detected (0)
	Building	Room	Item	Quantity	
	Block 17-20. Flat 17.	Living Room G10	Textured coating to concrete ceiling	18m ²	
	Sample No (S,SP,P,As)	Product Type	Surface Treatment	Condition	Accessibility
As AE001567 (SP)	Textured Coating (1)	Completely Sealed (0)	Low Damage (1)	Occasionally likely to be disturbed (1)

Normal Occupancy	Score	Likelihood of disturbance	Score	Exposure Potential	Score	Maintenance Activity	Score
Main type of activity	N/A	Location	N/A	Number of occupants	N/A	Type of Maintenance	N/A
		Accessibility	N/A	Frequency of use	N/A	Frequency of maintenance	N/A
		Amount	N/A	Average Time	N/A		
Average Score	N/A	Average Score	N/A	Average Score	N/A	Average Score	N/A
Average of Priority	N/A						
Material Assessment Score	N/A						
Recommendation	No further action required						
Surveyor comments	N/A

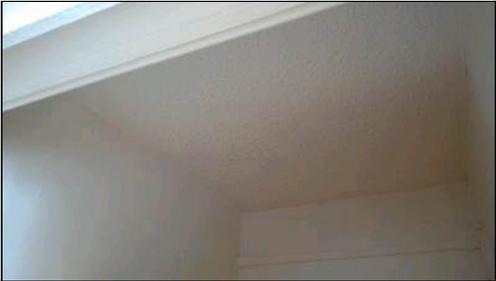
Survey Date:	Lead Surveyor	Survey Type	Floor	Analysis
	14 Jul 2016	Sebastian Lawniczak	Management Survey	Ground	No Asbestos Detected (0)
	Building	Room	Item	Quantity	
	Block 17-20. Flat 17.	Store Cupboard 3 G11	Textured coating to concrete ceiling	1m ²	
	Sample No (S,SP,P,As)	Product Type	Surface Treatment	Condition	Accessibility
As AE001567 (SP)	Textured Coating (1)	Completely Sealed (0)	Good Condition (0)	Occasionally likely to be disturbed (1)

Normal Occupancy	Score	Likelihood of disturbance	Score	Exposure Potential	Score	Maintenance Activity	Score
Main type of activity	N/A	Location	N/A	Number of occupants	N/A	Type of Maintenance	N/A
		Accessibility	N/A	Frequency of use	N/A	Frequency of maintenance	N/A
		Amount	N/A	Average Time	N/A		
Average Score	N/A	Average Score	N/A	Average Score	N/A	Average Score	N/A
Average of Priority	N/A						
Material Assessment Score	N/A						
Recommendation	No further action required						
Surveyor comments	N/A

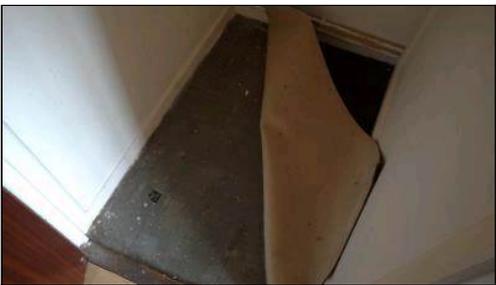
Survey Date:	Lead Surveyor	Survey Type	Floor	Analysis
	14 Jul 2016	Sebastian Lawniczak	Management Survey	Ground	Chrysotile (1)
	Building	Room	Item	Quantity	
	Block 17-20. Flat 17.	Store Cupboard 3 G11	Grey thermoplastic tiles and bitumen adhesive below to concrete floor	1m ²	
	Sample No (S,SP,P,As)	Product Type	Surface Treatment	Condition	Accessibility
AE001568 (S)	Well Bound Material (1)	Completely Sealed (0)	Low Damage (1)	Usually inaccessible or unlikely to be disturbed (0)

Normal Occupancy	Score	Likelihood of disturbance	Score	Exposure Potential	Score	Maintenance Activity	Score
Main type of activity	0	Location	2	Number of occupants	1	Type of Maintenance	0
		Accessibility	0	Frequency of use	2	Frequency of maintenance	0
		Amount	1	Average Time	0		
Average Score	0	Average Score	1	Average Score	1	Average Score	0
Average of Priority	2						
Material Assessment Score	3						
Recommendation	Manage and re-inspect						
Surveyor comments	Beneath carpet covering.
