## Asbestos Refurbishment Survey

18 Cyncoed  
Ynysybwl  
Pontypridd  
Mid Glamorgan  
CF37 3PL  
UPRN: 007923

**Scope of Works:** The 'Asbestos Refurbishment Survey' was carried out to the external porch canopy and immediate surrounding areas.

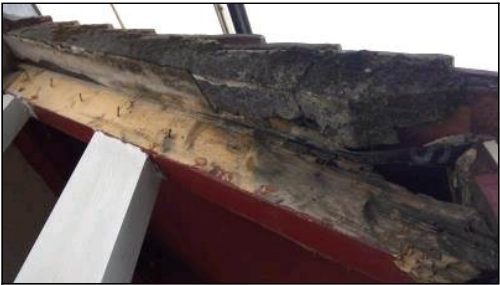
| | 9 Dec 2019 | Dave Milton | Refurbishment Survey | External | No Asbestos Detected (0) |
| | AI008243 (S) | Cement (0) | Surface Sealed (1) | Medium Damage (2) | Usually inaccessible or unlikely to be disturbed (0) |

| Recommendation | No further action required | | | | | | |
