**WALES & WEST HOUSING
ASSOCIATION
3 ALEXANDRA GATE
FFORDD PENGAM
TREMORFA
CARDIFF
CF24 2UD**

PROJECT NO: J118792

DATE: SEPTEMBER 2013

**ASBESTOS MANAGEMENT SURVEY
OF
30 CYNCOED, YNYSYBWL, PONTYPRIDD, CF37 3PL**

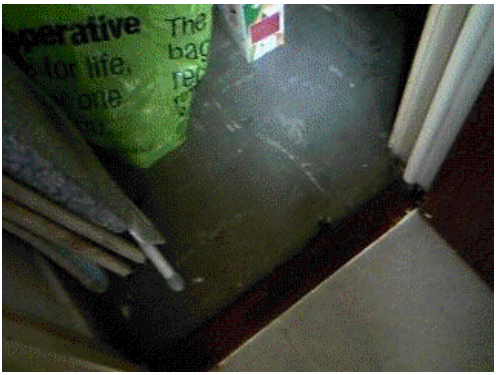
FLOOR/LOCATION:	Ground Floor Cupboard (002)

DESCRIPTION:	Green floor tile.	
RECOMMENDATIONS:	Manage, label, monitor and inform maintenance personnel prior to relevant works	
EXTENT:	<10m² or <10m pipe run	
SAMPLE REF:	EA001444	
RESULT:	Chrysotile

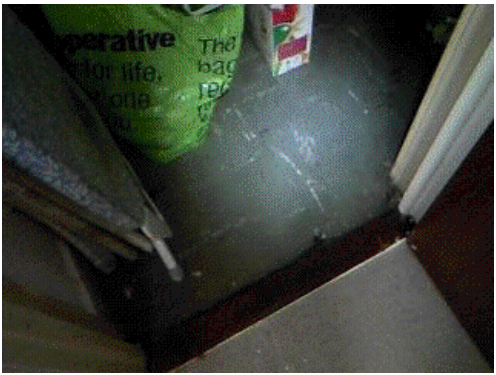
FLOOR/LOCATION:	Ground Floor Cupboard (002)

Ground Floor / Cupboard (002) (1)	4 - 10 (2)	Bitumen adhesive (1)	2m ² (1)	Composite Material (0)	Good Condition (0)	Low (1)	EA001445 / Chrysotile (1)	2 + 5 = 7	Very Low	Manage, label, monitor and inform maintenance personnel prior to relevant works
Ground Floor / Cupboard (002)	-	Accessed - no suspect materials visually identified	-	-	-	-		-	-	No further action required
Ground Floor / Cupboard (002)		Plasterboard ceiling, solid plastered walls, solid concrete floor, timber door and frame.								
Ground Floor / Lounge(003) (1)	4 - 10 (2)	Brown floor tile. (1)	15m ² (2)	Composite Material (0)	Good Condition (0)	Low (1)	EA001446 / Chrysotile (1)	2 + 6 = 8	Very Low	Manage, label, monitor and inform maintenance personnel prior to relevant works
Indicates parameter for Material Assessment algorithm(MA)			Product type *C Surface Treatment *E Extent of damage *F Asbestos Type *H					Priority Rating: Very low <9 Low 10-12 Medium 13-15 High ≥16

DESCRIPTION:	Bitumen adhesive	
RECOMMENDATIONS:	Manage, label, monitor and inform maintenance personnel prior to relevant works	
EXTENT:	<10m² or <10m pipe run	
SAMPLE REF:	EA001445	
RESULT:	Chrysotile

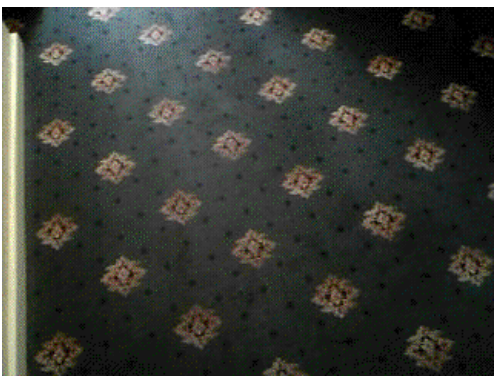
FLOOR/LOCATION:	Ground Floor Lounge(003)

DESCRIPTION:	Brown floor tile.	
RECOMMENDATIONS:	Manage, label, monitor and inform maintenance personnel prior to relevant works	
EXTENT:	10 - 50 m² or 10 - 50m pipe run	
SAMPLE REF:	EA001446	
RESULT:	Chrysotile

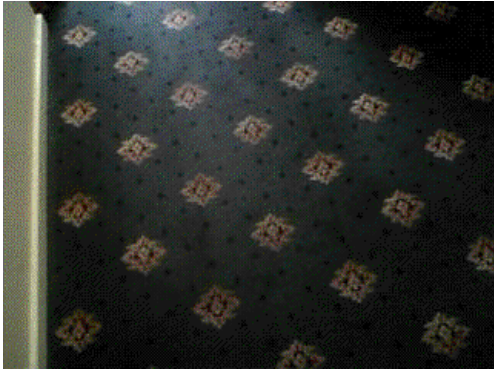
FLOOR/LOCATION:	Ground Floor Lounge(003)

Lounge (003) / Ground Floor	Bitumen adhesive	Very Low	Manage, label, monitor and inform maintenance personnel prior to relevant works

DESCRIPTION:	Bitumen adhesive	
RECOMMENDATIONS:	Manage, label, monitor and inform maintenance personnel prior to relevant works	
EXTENT:	10 - 50 m² or 10 - 50m pipe run	
SAMPLE REF:	EA001447	
RESULT:	Chrysotile

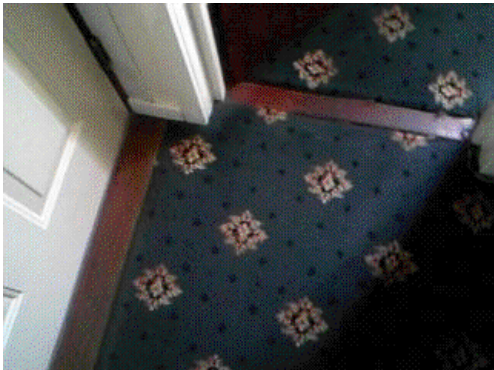
FLOOR/LOCATION:	Ground Floor Hallway (004)

Ground Floor / Hallway (004) (1)	4 - 10 (2)	Brown floor tile. (1)	3m ² (1)	Composite Material (0)	Good Condition (0)	Low (1)	Strongly presumed similar to EA001446 / Chrysotile (1)	2 + 5 = 7	Very Low	Manage, label, monitor and inform maintenance personnel prior to relevant works
Ground Floor / Hallway (004) (1)	4 - 10 (2)	Bitumen adhesive (1)	3m ² (1)	Composite Material (0)	Good Condition (0)	Low (1)	Strongly presumed similar to EA001447 / Chrysotile (1)	2 + 5 = 7	Very Low	Manage, label, monitor and inform maintenance personnel prior to relevant works
Ground Floor / Hallway (004)	-	Accessed - no suspect materials visually identified	-	-	-	-		-	-	No further action required
Ground Floor / Hallway (004)		Plasterboard ceiling, solid plastered walls, solid concrete floor with carpet, timber stairs with carpet, timber doors and frames, UPVC door and frames.								
Indicates parameter for Material Assessment algorithm(MA)			Product type *C Surface Treatment *E Extent of damage *F Asbestos Type *H					Priority Rating: Very low <9 Low 10-12 Medium 13-15 High ≥16

DESCRIPTION:	Brown floor tile.	
RECOMMENDATIONS:	Manage, label, monitor and inform maintenance personnel prior to relevant works	
EXTENT:	<10m² or <10m pipe run	
SAMPLE REF:	SPST EA001446	
RESULT:	Chrysotile

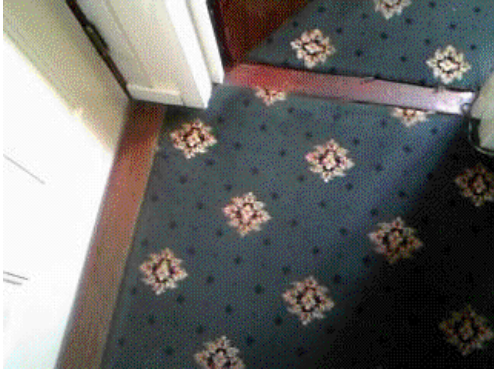
FLOOR/LOCATION:	Ground Floor Hallway (004)

DESCRIPTION:	Bitumen adhesive	
RECOMMENDATIONS:	Manage, label, monitor and inform maintenance personnel prior to relevant works	
EXTENT:	<10m² or <10m pipe run	
SAMPLE REF:	SPST EA001447	
RESULT:	Chrysotile

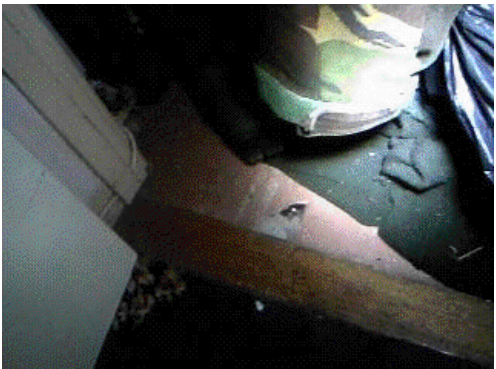
FLOOR/LOCATION:	Ground Floor Cupboard (006)

DESCRIPTION:	Light brown floor tile.	
RECOMMENDATIONS:	Manage, label, monitor and inform maintenance personnel prior to relevant works	
EXTENT:	<10m² or <10m pipe run	
SAMPLE REF:	EA001448	
RESULT:	Chrysotile

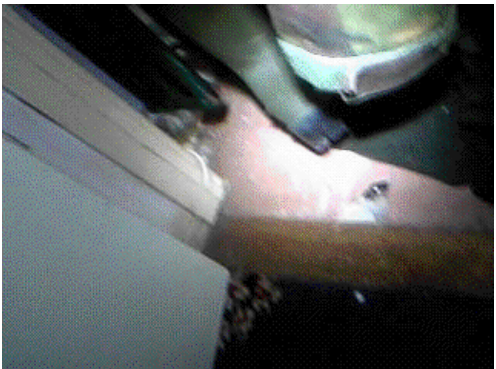
FLOOR/LOCATION:	Ground Floor Cupboard (006)

Ground Floor / Cupboard (006) (1)	4 - 10 (2)	Bitumen adhesive (1)	1m ² (1)	Composite Material (0)	Good Condition (0)	Rare (0)	BS085361 / Chrysotile (1)	2 + 4 = 6	Very Low	Manage, label, monitor and inform maintenance personnel prior to relevant works
Ground Floor / Cupboard (006)	-	Accessed - no suspect materials visually identified	-	-	-	-		-	-	No further action required
Ground Floor / Cupboard (006)		Plasterboard ceiling, solid plastered walls, solid concrete floor, timber door and frame, non suspect electrical box.								
1st Floor / Landing (101)	4 - 10	Textured coating to ceiling	3m ²	Sealed	Good Condition	Low	EA001449 / No Asbestos Detected	-	-	No further action required
Indicates parameter for Material Assessment algorithm(MA)			Product type *C Surface Treatment *E Extent of damage *F Asbestos Type *H					Priority Rating: Very low <9 Low 10-12 Medium 13-15 High ≥16		
Indicates parameter for Priority Assessment algorithm(PA)			Location ✓ A No.of Occupants ✓ B Vulnerability to damage ✓ G Extent of materials ✓ D

DESCRIPTION:	Bitumen adhesive	
RECOMMENDATIONS:	Manage, label, monitor and inform maintenance personnel prior to relevant works	
EXTENT:	<10m² or <10m pipe run	
SAMPLE REF:	BS085361	
RESULT:	Chrysotile
