**ASBESTOS MANAGEMENT SURVEY  
OF  
9 CYNCOED, YNYSYBWL, PONTYPRIDD, CF37 3PL**

**CLIENT: WALES & WEST HOUSING ASSOCIATION  
3 ALEXANDRA GATE, FFORDD PENGAM, TREMORFA, CARDIFF, CF24 2UD**

**UPRN NO: 7914  
PROJECT NO: J248452  
DATE: MAY 2015**

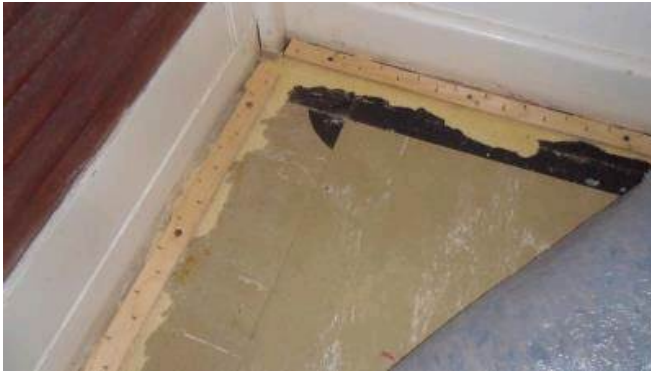
<b>FLOOR/LOCATION:</b>	Ground Floor Bedroom 2. (002)	
<b>DESCRIPTION:</b>	Beige floor tile covering.	
<b>RECOMMENDATIONS:</b>	Manage, monitor and inform maintenance personnel prior to relevant works	
<b>EXTENT:</b>	10 - 50 m <sup>2</sup> or 10 - 50m pipe run	
<b>SAMPLE REF:</b>	DK006098	
<b>RESULT:</b>	Chrysotile

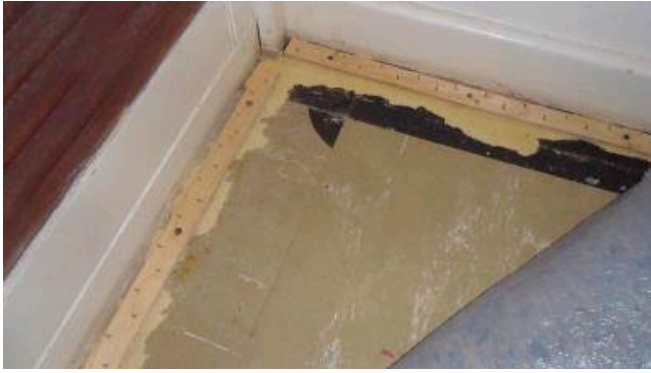
<b>FLOOR/LOCATION:</b>	Ground Floor Bedroom 2. (002)	
<b>DESCRIPTION:</b>	Black floor tile covering.	
<b>RECOMMENDATIONS:</b>	Manage, monitor and inform maintenance personnel prior to relevant works	
<b>EXTENT:</b>	<10m <sup>2</sup> or <10m pipe run	
<b>SAMPLE REF:</b>	DK006099	
<b>RESULT:</b>	Chrysotile

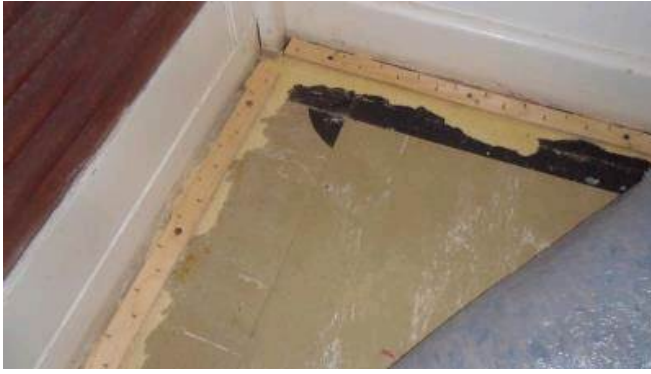
<b>FLOOR/LOCATION:</b>	Ground Floor Bedroom 2. (002)	
<b>DESCRIPTION:</b>	Adhesive to beige and black floor tile covering.	
<b>RECOMMENDATIONS:</b>	Manage, monitor and inform maintenance personnel prior to relevant works	
<b>EXTENT:</b>	10 - 50 m <sup>2</sup> or 10 - 50m pipe run	
<b>SAMPLE REF:</b>	DK006100	
<b>RESULT:</b>	Chrysotile

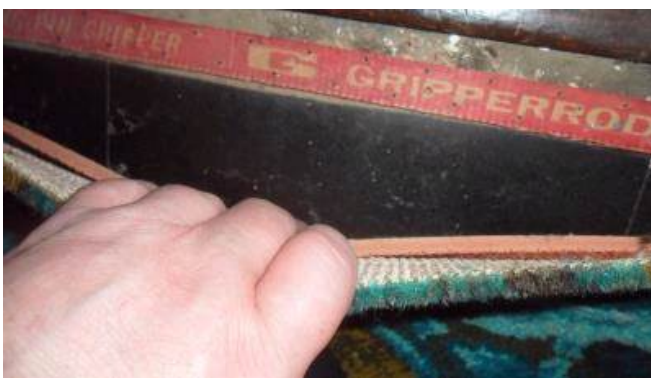
<b>FLOOR/LOCATION:</b>	Ground Floor Lounge. (003)	
<b>DESCRIPTION:</b>	Black floor tile covering.	
<b>RECOMMENDATIONS:</b>	Manage, monitor and inform maintenance personnel prior to relevant works	
<b>EXTENT:</b>	10 - 50 m <sup>2</sup> or 10 - 50m pipe run	
<b>SAMPLE REF:</b>	SPST DK006099	
<b>RESULT:</b>	Chrysotile

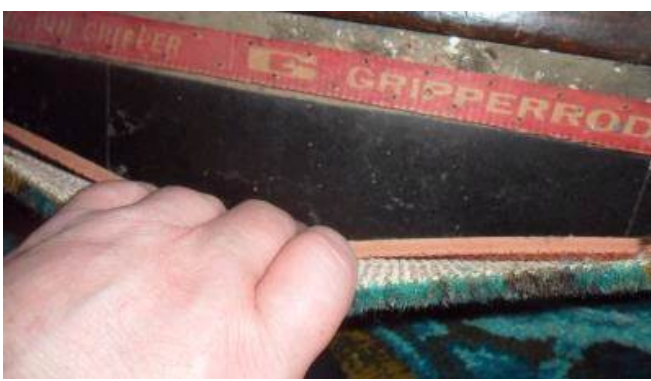
<b>FLOOR/LOCATION:</b>	Ground Floor Lounge. (003)	
<b>DESCRIPTION:</b>	Adhesive to black floor tile covering.	
<b>RECOMMENDATIONS:</b>	Manage, monitor and inform maintenance personnel prior to relevant works	
<b>EXTENT:</b>	10 - 50 m <sup>2</sup> or 10 - 50m pipe run	
<b>SAMPLE REF:</b>	SPST DK006100	
<b>RESULT:</b>	Chrysotile

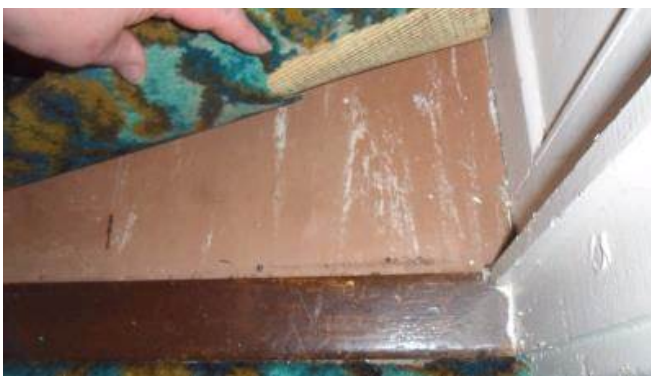
<b>FLOOR/LOCATION:</b>	Ground Floor Lounge cupboard. (007)	
<b>DESCRIPTION:</b>	Peach floor tile covering.	
<b>RECOMMENDATIONS:</b>	Manage, monitor and inform maintenance personnel prior to relevant works	
<b>EXTENT:</b>	<10m <sup>2</sup> or <10m pipe run	
<b>SAMPLE REF:</b>	DK006103	
<b>RESULT:</b>	Chrysotile

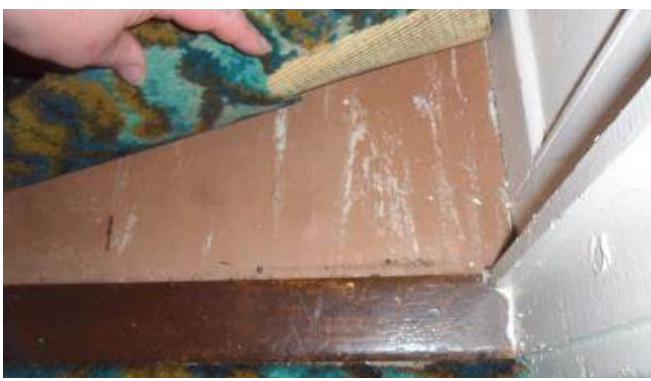
<b>FLOOR/LOCATION:</b>	Ground Floor Lounge cupboard. (007)	
<b>DESCRIPTION:</b>	Adhesive to peach floor tile covering.	
<b>RECOMMENDATIONS:</b>	Manage, monitor and inform maintenance personnel prior to relevant works	
<b>EXTENT:</b>	<10m² or <10m pipe run	
<b>SAMPLE REF:</b>	DK006104	
<b>RESULT:</b>	Chrysotile

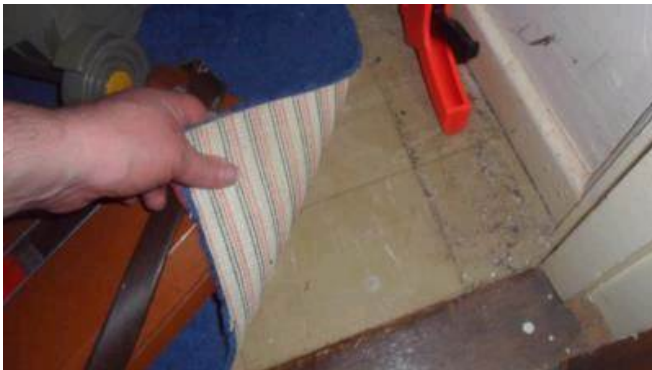
<b>FLOOR/LOCATION:</b>	Ground Floor Understairs Cupboard. (009)	
<b>DESCRIPTION:</b>	Beige floor tile covering.	
<b>RECOMMENDATIONS:</b>	Manage, monitor and inform maintenance personnel prior to relevant works	
<b>EXTENT:</b>	<10m² or <10m pipe run	
<b>SAMPLE REF:</b>	SPST DK006098	
<b>RESULT:</b>	Chrysotile

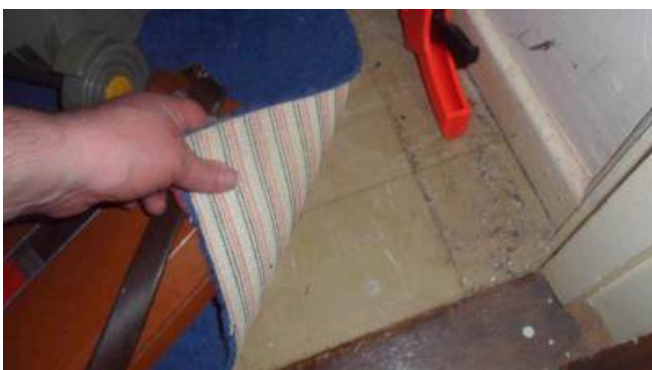
Ground Floor / Understairs Cupboard. (009) (1)	1 - 3 (1)	Adhesive to beige floor tile covering. (1)	1m <sup>2</sup> (1)	Sealed (0)	Good Condition (0)	Low (1)	Strongly presumed similar to DK006100 / <b>Chrysotile</b> (1)	2 + 4 = 6	Very Low	Manage, monitor and inform maintenance personnel prior to relevant works
Ground Floor / Understairs Cupboard. (009)	-	All other areas visually no asbestos identified.	-	-	-	-		-	-	No further action required
Ground Floor / Understairs Cupboard. (009)		Block walls, timber skirting, concrete floor beneath tiles and carpet, timber door and frame.								
Ground Floor / Hall Cupboard. (010)	1 - 3	Textured coating to concrete ceiling.	2m <sup>2</sup>	Sealed	Low Damage	Low	Strongly presumed similar to DK006101 / No Asbestos Detected	-	-	No further action required
Indicates parameter for Material Assessment algorithm(MA)			Product type *C Surface Treatment *E Extent of damage *F Asbestos Type *H				Priority Rating: Very low <9 Low 10-12 Medium 13-15 High ≥16

<b>FLOOR/LOCATION:</b>	Ground Floor Understairs Cupboard. (009)	
<b>DESCRIPTION:</b>	Adhesive to beige floor tile covering.	
<b>RECOMMENDATIONS:</b>	Manage, monitor and inform maintenance personnel prior to relevant works	
<b>EXTENT:</b>	<10m² or <10m pipe run	
<b>SAMPLE REF:</b>	SPST DK006100	
<b>RESULT:</b>	Chrysotile

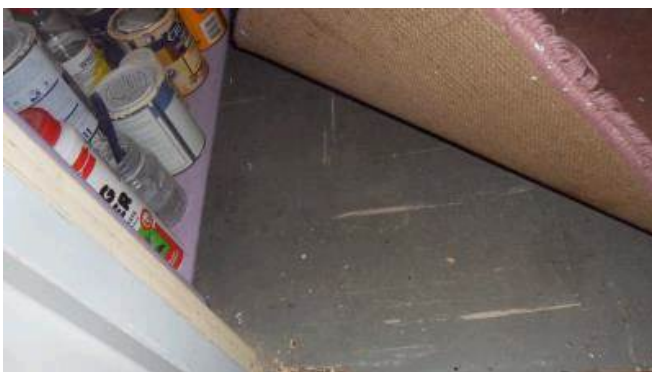
<b>FLOOR/LOCATION:</b>	Ground Floor Hall Cupboard. (010)	
<b>DESCRIPTION:</b>	Grey floor tile covering.	
<b>RECOMMENDATIONS:</b>	Manage, monitor and inform maintenance personnel prior to relevant works	
<b>EXTENT:</b>	<10m² or <10m pipe run	
<b>SAMPLE REF:</b>	DK006105	
<b>RESULT:</b>	Chrysotile

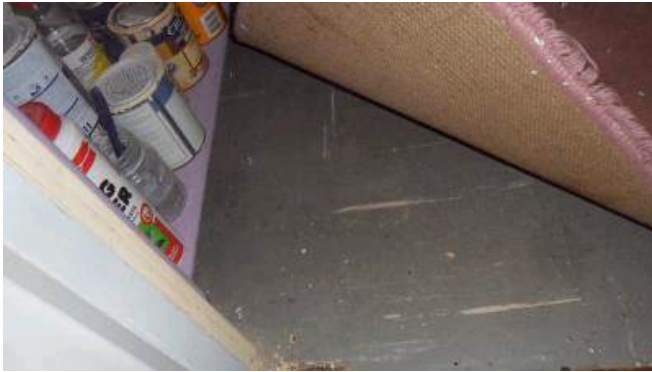
<b>FLOOR/LOCATION:</b>	Ground Floor Hall Cupboard. (010)	
<b>DESCRIPTION:</b>	Adhesive to grey floor tile covering.	
<b>RECOMMENDATIONS:</b>	Manage, monitor and inform maintenance personnel prior to relevant works	
<b>EXTENT:</b>	<10m² or <10m pipe run	
<b>SAMPLE REF:</b>	DK006106	
<b>RESULT:</b>	Chrysotile
