Asbestos Management Survey with Targeted Refurbishment Survey

Flat 42
Ty Ddewi
Ton Pentre
Pentre
Mid Glamorgan
CF417BG
UPRN: N/A

Report issue date:	12 Oct 2021

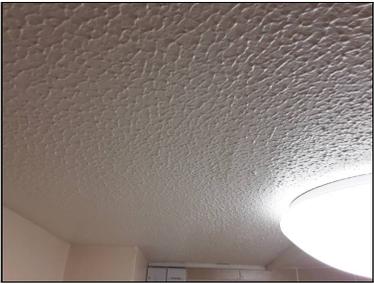
Survey Date:	Lead Surveyor	Survey Type	Floor	Analysis
	5 Oct 2021	Dave Milton	Refurbishment and Demolition Survey	Ground	
	Building	Room	Item	Quantity	
	Flat 42, Block 42-45	Bathroom G01	Textured coating to plasterboard ceiling	4m ²	
Sample No (S,SP,P,As)	Product Type	Surface Treatment	Condition	Accessibility	
BF000963 (S)	Textured Coating (1)	Completely Sealed (0)	Good Condition (0)	Occasionally likely to be disturbed (1)

Normal Occupancy	Score	Likelihood of disturbance	Score	Exposure Potential	Score	Maintenance Activity	Score
Main type of activity	N/A	Location	N/A	Number of occupants	N/A	Type of Maintenance	N/A
		Accessibility	N/A	Frequency of use	N/A	Frequency of maintenance	N/A
		Amount	N/A	Average Time	N/A		
Average Score	N/A	Average Score	N/A	Average Score	N/A	Average Score	N/A
Average of Priority	N/A						
Material Assessment Score	N/A						
Recommendation	No further action required						
Surveyor comments	Please refer to Section 6.2 of this report and project desktop study (additional inspection required if going beyond suspect material). Â

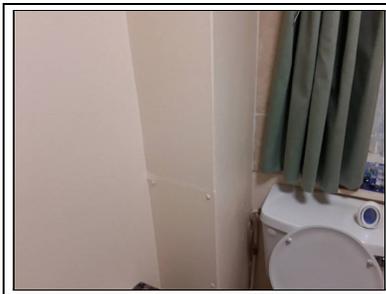
Survey Date:	Lead Surveyor	Survey Type	Floor	Analysis
5 Oct 2021	Dave Milton	Refurbishment and Demolition Survey	Ground	No Asbestos Detected (0)
Building	Room	Item	Quantity	
Flat 42, Block 42-45	Bathroom G01	Insulating board boxing	2m ²	
Sample No (S,SP,P,As)	Product Type	Surface Treatment	Condition	Accessibility
BF000964 (S)	Insulating Board (0)	Surface Sealed (1)	Good Condition (0)	Easily disturbed (2)

Normal Occupancy	Score	Likelihood of disturbance	Score	Exposure Potential	Score	Maintenance Activity	Score
Main type of activity	N/A	Location	N/A	Number of occupants	N/A	Type of Maintenance	N/A
		Accessibility	N/A	Frequency of use	N/A	Frequency of maintenance	N/A
		Amount	N/A	Average Time	N/A		
Average Score	N/A	Average Score	N/A	Average Score	N/A	Average Score	N/A
Average of Priority	N/A						
Material Assessment Score	N/A						
Recommendation	No further action required						
Surveyor comments	Please refer to Section 6.2 of this report and project desktop study (additional inspection required if going beyond suspect material). Â

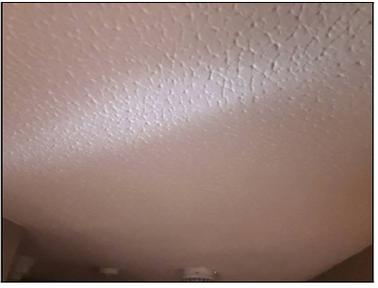
Survey Date:	Lead Surveyor	Survey Type	Floor	Analysis	
	5 Oct 2021	Dave Milton	Management Survey	Ground		No Asbestos Detected (0)
	Building	Room	Item	Quantity		
	Flat 42, Block 42-45	Hall G02	Textured coating to plasterboard ceiling	3m ²		
	Sample No (S,SP,P,As)	Product Type	Surface Treatment	Condition	Accessibility	
As BF000963 (SP)	Textured Coating (1)	Completely Sealed (0)	Good Condition (0)	Occasionally likely to be disturbed (1)

Normal Occupancy	Score	Likelihood of disturbance	Score	Exposure Potential	Score	Maintenance Activity	Score
Main type of activity	N/A	Location	N/A	Number of occupants	N/A	Type of Maintenance	N/A
		Accessibility	N/A	Frequency of use	N/A	Frequency of maintenance	N/A
		Amount	N/A	Average Time	N/A		
Average Score	N/A	Average Score	N/A	Average Score	N/A	Average Score	N/A
Average of Priority	N/A						
Material Assessment Score	N/A						
Recommendation	No further action required						
Surveyor comments	N/A

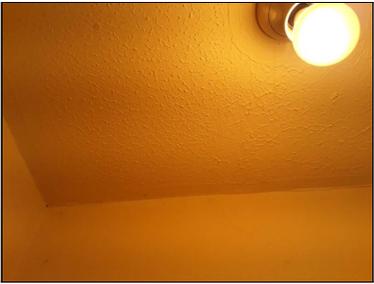
Survey Date:	Lead Surveyor	Survey Type	Floor	Analysis
	5 Oct 2021	Dave Milton	Management Survey	Ground	No Asbestos Detected (0)
	Building	Room	Item	Quantity	
	Flat 42, Block 42-45	Electric Cupboard G03	Textured coating to plasterboard ceiling	0.5m ²	
	Sample No (S,SP,P,As)	Product Type	Surface Treatment	Condition	Accessibility
As BF000963 (SP)	Textured Coating (1)	Completely Sealed (0)	Good Condition (0)	Occasionally likely to be disturbed (1)

Normal Occupancy	Score	Likelihood of disturbance	Score	Exposure Potential	Score	Maintenance Activity	Score
Main type of activity	N/A	Location	N/A	Number of occupants	N/A	Type of Maintenance	N/A
		Accessibility	N/A	Frequency of use	N/A	Frequency of maintenance	N/A
		Amount	N/A	Average Time	N/A		
Average Score	N/A	Average Score	N/A	Average Score	N/A	Average Score	N/A
Average of Priority	N/A						
Material Assessment Score	N/A						
Recommendation	No further action required						
Surveyor comments	N/A

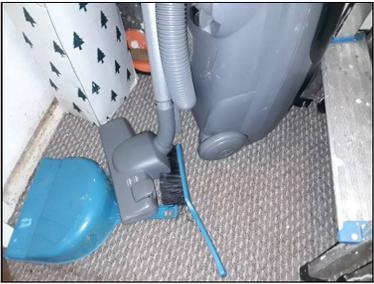
Survey Date:	Lead Surveyor	Survey Type	Floor	Analysis
	5 Oct 2021	Dave Milton	Management Survey	Ground	Chrysotile (1)
	Building	Room	Item	Quantity	
	Flat 42, Block 42-45	Electric Cupboard G03	Presumed vinyl tiles to chipboard floor beneath fitted beige carpet	0.5m ²	
	Sample No (S,SP,P,As)	Product Type	Surface Treatment	Condition	Accessibility
Visual (P)	Reinforced Composite (1)	Completely Sealed (0)	Good Condition (0)	Occasionally likely to be disturbed (1)

Normal Occupancy	Score	Likelihood of disturbance	Score	Exposure Potential	Score	Maintenance Activity	Score
Main type of activity	0	Location	2	Number of occupants	1	Type of Maintenance	0
		Accessibility	1	Frequency of use	3	Frequency of maintenance	0
		Amount	1	Average Time	0		
Average Score	0	Average Score	2	Average Score	2	Average Score	0
Average of Priority	4						
Material Assessment Score	2						
Recommendation	Inspection required						
Surveyor comments	No access due to the potential to cause significant damage to fixtures and fittings.

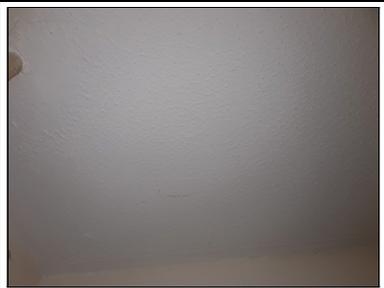
Survey Date:	Lead Surveyor	Survey Type	Floor	Analysis
	5 Oct 2021	Dave Milton	Management Survey	Ground	No Asbestos Detected (0)
	Building	Room	Item	Quantity	
	Flat 42, Block 42-45	Airing Cupboard G04	Textured coating to plasterboard ceiling	1m ²	
	Sample No (S,SP,P,As)	Product Type	Surface Treatment	Condition	Accessibility
As BF000963 (SP)	Textured Coating (1)	Completely Sealed (0)	Good Condition (0)	Occasionally likely to be disturbed (1)

Normal Occupancy	Score	Likelihood of disturbance	Score	Exposure Potential	Score	Maintenance Activity	Score
Main type of activity	N/A	Location	N/A	Number of occupants	N/A	Type of Maintenance	N/A
		Accessibility	N/A	Frequency of use	N/A	Frequency of maintenance	N/A
		Amount	N/A	Average Time	N/A		
Average Score	N/A	Average Score	N/A	Average Score	N/A	Average Score	N/A
Average of Priority	N/A						
Material Assessment Score	N/A						
Recommendation	No further action required						
Surveyor comments	N/A

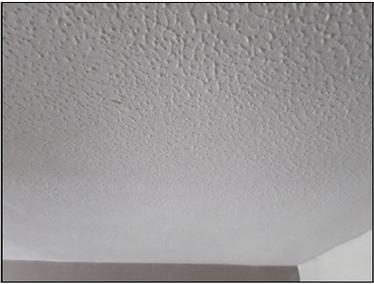
Survey Date:	Lead Surveyor	Survey Type	Floor	Analysis
	5 Oct 2021	Dave Milton	Management Survey	Ground	No Asbestos Detected (0)
	Building	Room	Item	Quantity	
	Flat 42, Block 42-45	Lounge G05	Textured coating to plasterboard ceiling	9m ²	
	Sample No (S,SP,P,As)	Product Type	Surface Treatment	Condition	Accessibility
As BF000963 (SP)	Textured Coating (1)	Completely Sealed (0)	Good Condition (0)	Occasionally likely to be disturbed (1)

Normal Occupancy	Score	Likelihood of disturbance	Score	Exposure Potential	Score	Maintenance Activity	Score
Main type of activity	N/A	Location	N/A	Number of occupants	N/A	Type of Maintenance	N/A
		Accessibility	N/A	Frequency of use	N/A	Frequency of maintenance	N/A
		Amount	N/A	Average Time	N/A		
Average Score	N/A	Average Score	N/A	Average Score	N/A	Average Score	N/A
Average of Priority	N/A						
Material Assessment Score	N/A						
Recommendation	No further action required						
Surveyor comments	N/A

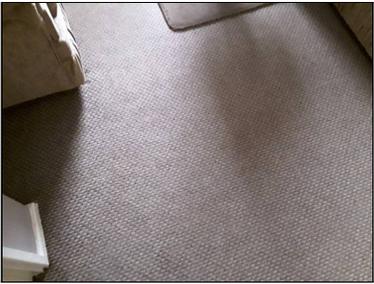
Survey Date:	Lead Surveyor	Survey Type	Floor	Analysis
	5 Oct 2021	Dave Milton	Management Survey	Ground	Chrysotile (1)
	Building	Room	Item	Quantity	
	Flat 42, Block 42-45	Lounge G05	Presumed vinyl tiles to chipboard floor beneath fitted beige carpet	9m ²	
	Sample No (S,SP,P,As)	Product Type	Surface Treatment	Condition	Accessibility
Visual (P)	Reinforced Composite (1)	Completely Sealed (0)	Good Condition (0)	Occasionally likely to be disturbed (1)

Normal Occupancy	Score	Likelihood of disturbance	Score	Exposure Potential	Score	Maintenance Activity	Score
Main type of activity	1	Location	2	Number of occupants	1	Type of Maintenance	0
		Accessibility	1	Frequency of use	3	Frequency of maintenance	0
		Amount	1	Average Time	3		
Average Score	1	Average Score	2	Average Score	3	Average Score	0
Average of Priority	6						
Material Assessment Score	2						
Recommendation	Inspection required						
Surveyor comments	No access due to the potential to cause significant damage to fixtures and fittings.

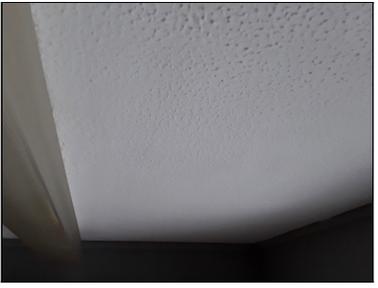
Survey Date:	Lead Surveyor	Survey Type	Floor	Analysis
	5 Oct 2021	Dave Milton	Management Survey	Ground	No Asbestos Detected (0)
	Building	Room	Item	Quantity	
	Flat 42, Block 42-45	Kitchen G06	Textured coating to plasterboard ceiling	4m ²	
	Sample No (S,SP,P,As)	Product Type	Surface Treatment	Condition	Accessibility
As BF000963 (SP)	Textured Coating (1)	Completely Sealed (0)	Good Condition (0)	Occasionally likely to be disturbed (1)

Normal Occupancy	Score	Likelihood of disturbance	Score	Exposure Potential	Score	Maintenance Activity	Score
Main type of activity	N/A	Location	N/A	Number of occupants	N/A	Type of Maintenance	N/A
		Accessibility	N/A	Frequency of use	N/A	Frequency of maintenance	N/A
		Amount	N/A	Average Time	N/A		
Average Score	N/A	Average Score	N/A	Average Score	N/A	Average Score	N/A
Average of Priority	N/A						
Material Assessment Score	N/A						
Recommendation	No further action required						
Surveyor comments	N/A

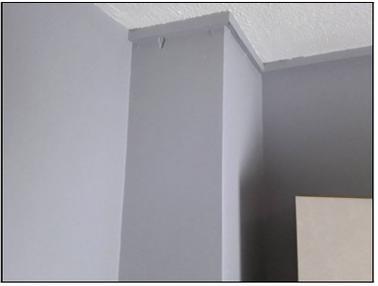
Survey Date:	Lead Surveyor	Survey Type	Floor	Analysis
	5 Oct 2021	Dave Milton	Management Survey	Ground	No Asbestos Detected (0)
	Building	Room	Item	Quantity	
	Flat 42, Block 42-45	Kitchen G06	Insulating board boxing	2m ²	
	Sample No (S,SP,P,As)	Product Type	Surface Treatment	Condition	Accessibility
	As BF000964 (SP)	Insulating Board (0)	Surface Sealed (1)	Good Condition (0)	Occasionally likely to be disturbed (1)

Normal Occupancy	Score	Likelihood of disturbance	Score	Exposure Potential	Score	Maintenance Activity	Score
Main type of activity	N/A	Location	N/A	Number of occupants	N/A	Type of Maintenance	N/A
		Accessibility	N/A	Frequency of use	N/A	Frequency of maintenance	N/A
		Amount	N/A	Average Time	N/A		
Average Score	N/A	Average Score	N/A	Average Score	N/A	Average Score	N/A
Average of Priority	N/A						
Material Assessment Score	N/A						
Recommendation	No further action required						
Surveyor comments	N/A

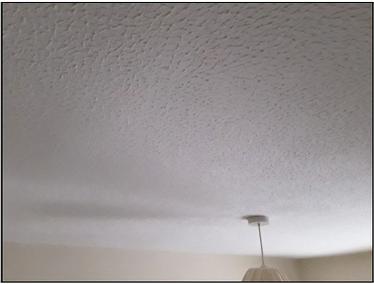
Survey Date:	Lead Surveyor	Survey Type	Floor	Analysis
	5 Oct 2021	Dave Milton	Management Survey	Ground	No Asbestos Detected (0)
	Building	Room	Item	Quantity	
	Flat 42, Block 42-45	Bedroom G07	Textured coating to plasterboard ceiling	6m ²	
	Sample No (S,SP,P,As)	Product Type	Surface Treatment	Condition	Accessibility
	As BF000963 (SP)	Textured Coating (1)	Completely Sealed (0)	Good Condition (0)	Occasionally likely to be disturbed (1)

Normal Occupancy	Score	Likelihood of disturbance	Score	Exposure Potential	Score	Maintenance Activity	Score
Main type of activity	N/A	Location	N/A	Number of occupants	N/A	Type of Maintenance	N/A
		Accessibility	N/A	Frequency of use	N/A	Frequency of maintenance	N/A
		Amount	N/A	Average Time	N/A		
Average Score	N/A	Average Score	N/A	Average Score	N/A	Average Score	N/A
Average of Priority	N/A						
Material Assessment Score	N/A						
Recommendation	No further action required						
Surveyor comments	N/A
