## Asbestos Refurbishment Survey

Flat 7  
Ty Ddewi  
Ton Pentre  
Pentre  
Mid Glamorgan  
CF41 7BG  
UPRN: 006483

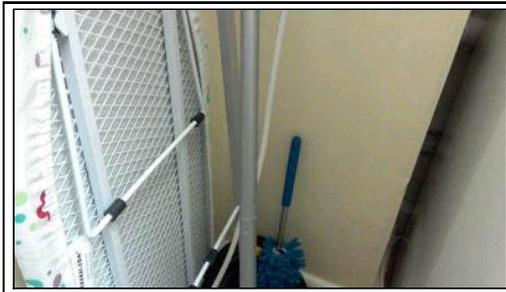
<b>Survey Date:</b>	<b>Lead Surveyor</b>	<b>Survey Type</b>	<b>Floor</b>	<b>Analysis</b>
23 Jan 2020	Dave Milton	Refurbishment Survey	Ground	No Asbestos Detected (0)
<b>Building</b>	<b>Room</b>	<b>Item</b>	<b>Quantity</b>	
Flat 7, Block 1-35	Kitchen G01	Insulating board boxing	2m <sup>2</sup>	
<b>Sample No (S,SP,P,As)</b>	<b>Product Type</b>	<b>Surface Treatment</b>	<b>Condition</b>	<b>Accessibility</b>
AI008514 (S)	Insulating Board (0)	Surface Sealed (1)	Good Condition (0)	Easily disturbed (2)

Normal Occupancy	Score	Likelihood of disturbance	Score	Exposure Potential	Score	Maintenance Activity	Score
Main type of activity	N/A	Location	N/A	Number of occupants	N/A	Type of Maintenance	N/A
		Accessibility	N/A	Frequency of use	N/A	Frequency of maintenance	N/A
		Amount	N/A	Average Time	N/A		
Average Score	N/A	Average Score	N/A	Average Score	N/A	Average Score	N/A
Average of Priority	N/A						
Material Assessment Score	N/A						
Recommendation	No further action required						
Surveyor comments	N/A
