**WALES & WEST HOUSING  
ASSOCIATION  
3 ALEXANDRA GATE  
FFORDD PENGAM  
TREMORFA  
CARDIFF  
CF24 2UD**

**PROJECT NO:** J024782

**DATE:** AUGUST 2012

**ASBESTOS MANAGEMENT SURVEY  
OF  
LLYS BEN BOWEN THOMAS, GELLIGALED STREET, YSTRAD, CF41 7SB**

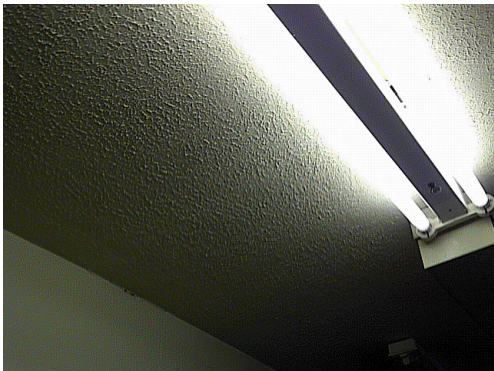
<b>FLOOR/LOCATION:</b>	2nd Floor Motor room (201)

<b>DESCRIPTION:</b>	Textured coating to plasterboard ceiling.	
<b>RECOMMENDATIONS:</b>	Manage, monitor and inform maintenance personnel prior to relevant works	
<b>EXTENT:</b>	<10m <sup>2</sup> or <10m pipe run	
<b>SAMPLE REF:</b>	CW000525	
<b>RESULT:</b>	Chrysotile

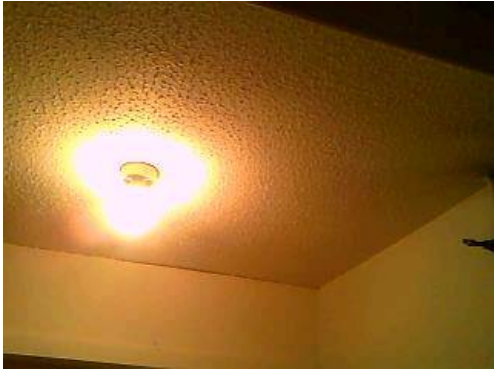
<b>FLOOR/LOCATION:</b>	Ground Floor Store adjacent flat 12. (001)

<b>DESCRIPTION:</b>	Textured coating to plasterboard ceiling.	
<b>RECOMMENDATIONS:</b>	Manage, label, monitor and inform maintenance personnel prior to relevant works	
<b>EXTENT:</b>	<10m² or <10m pipe run	
<b>SAMPLE REF:</b>	DK003333	
<b>RESULT:</b>	Chrysotile

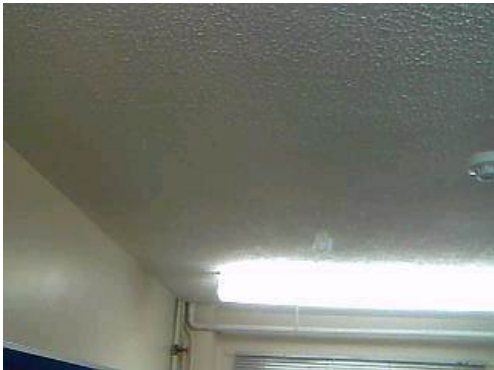
<b>FLOOR/LOCATION:</b>	Ground Floor Hobbies room. (003)

<b>DESCRIPTION:</b>	Textured coating to plasterboard ceiling.	
<b>RECOMMENDATIONS:</b>	Manage, label, monitor and inform maintenance personnel prior to relevant works	
<b>EXTENT:</b>	10 - 50 m² or 10 - 50m pipe run	
<b>SAMPLE REF:</b>	DK003336	
<b>RESULT:</b>	Chrysotile

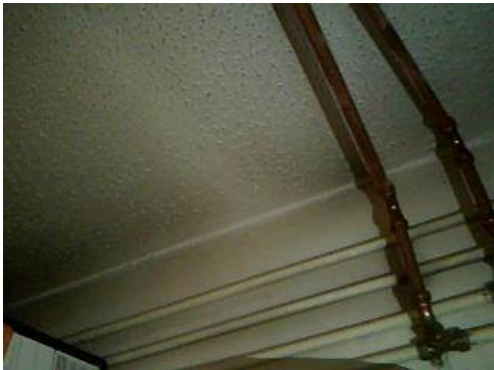
<b>FLOOR/LOCATION:</b>	1st Floor Store Adjacent to Guest Room. (102)

<b>DESCRIPTION:</b>	Textured coating to plasterboard ceiling.	
<b>RECOMMENDATIONS:</b>	Manage, label, monitor and inform maintenance personnel prior to relevant works	
<b>EXTENT:</b>	<10m² or <10m pipe run	
<b>SAMPLE REF:</b>	DK003326	
<b>RESULT:</b>	Chrysotile

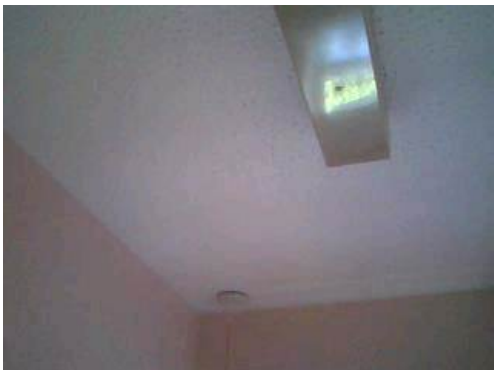
<b>FLOOR/LOCATION:</b>	1st Floor W.C. (103)

<b>DESCRIPTION:</b>	Textured coating to plasterboard ceiling.	
<b>RECOMMENDATIONS:</b>	Manage, label, monitor and inform maintenance personnel prior to relevant works	
<b>EXTENT:</b>	<10m² or <10m pipe run	
<b>SAMPLE REF:</b>	DK003328	
<b>RESULT:</b>	Chrysotile

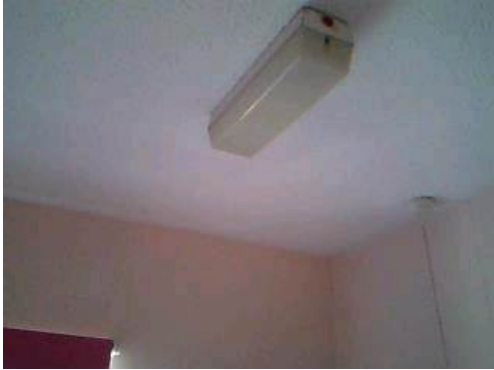
<b>FLOOR/LOCATION:</b>	1st Floor W.C. (104)

<b>DESCRIPTION:</b>	Textured coating to plasterboard ceiling.	
<b>RECOMMENDATIONS:</b>	Manage, label, monitor and inform maintenance personnel prior to relevant works	
<b>EXTENT:</b>	<10m² or <10m pipe run	
<b>SAMPLE REF:</b>	DK003329	
<b>RESULT:</b>	Chrysotile

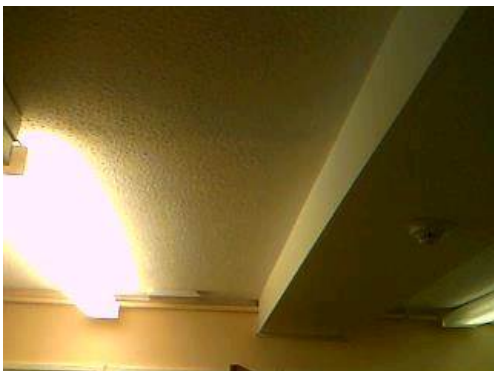
<b>FLOOR/LOCATION:</b>	1st Floor Communal Kitchen. (106)

<b>DESCRIPTION:</b>	Textured coating to plasterboard ceiling.	
<b>RECOMMENDATIONS:</b>	Manage, label, monitor and inform maintenance personnel prior to relevant works	
<b>EXTENT:</b>	10 - 50 m² or 10 - 50m pipe run	
<b>SAMPLE REF:</b>	DK003331	
<b>RESULT:</b>	Chrysotile

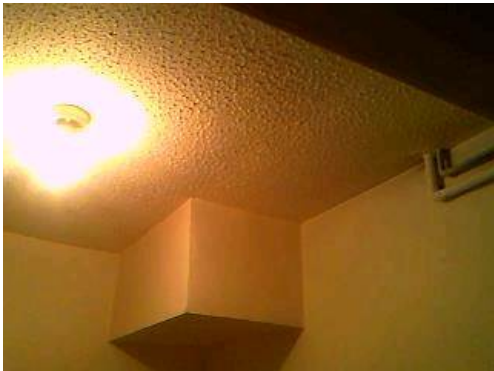
<b>FLOOR/LOCATION:</b>	1st Floor Store Adjacent Flat 26. (107)

<b>DESCRIPTION:</b>	Textured coating to plasterboard ceiling.	
<b>RECOMMENDATIONS:</b>	Manage, label, monitor and inform maintenance personnel prior to relevant works	
<b>EXTENT:</b>	<10m² or <10m pipe run	
<b>SAMPLE REF:</b>	DK003332	
<b>RESULT:</b>	Chrysotile

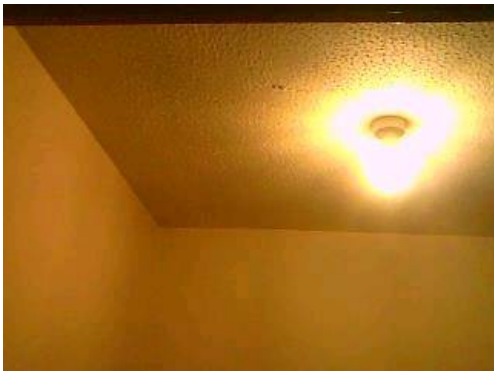
<b>FLOOR/LOCATION:</b>	2nd Floor Store adjacent flat 39. (201)

<b>DESCRIPTION:</b>	Textured coating to plasterboard ceiling.	
<b>RECOMMENDATIONS:</b>	Manage, label, monitor and inform maintenance personnel prior to relevant works	
<b>EXTENT:</b>	<10m <sup>2</sup> or <10m pipe run	
<b>SAMPLE REF:</b>	DK003324	
<b>RESULT:</b>	Chrysotile

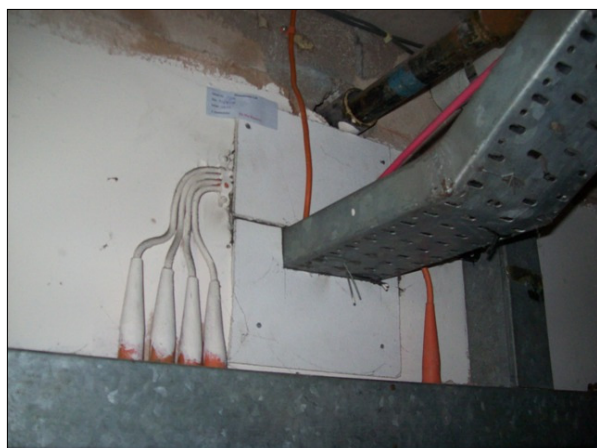
<b>Condition:</b>	Fair	<b>Accessibility:</b>	Medium
<b>Friability:</b>	Medium	<b>Exposure:</b>	Staff & maintenance
<b>Surface:</b>	None	<b>Amount:</b>	1 m <sup>2</sup>
<b>Position:</b>	Internal	<b>RISK:</b>	<b>NONE</b>

N.A.D.I.S insulating board to wall.

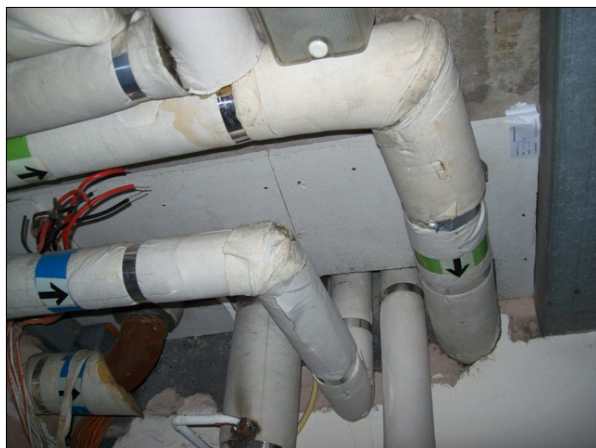
<b>Condition:</b>	Fair	<b>Accessibility:</b>	Medium
<b>Friability:</b>	Medium	<b>Exposure:</b>	Public
<b>Surface:</b>	None	<b>Amount:</b>	1 m <sup>2</sup>
<b>Position:</b>	Internal	<b>RISK:</b>	<b>NONE</b>

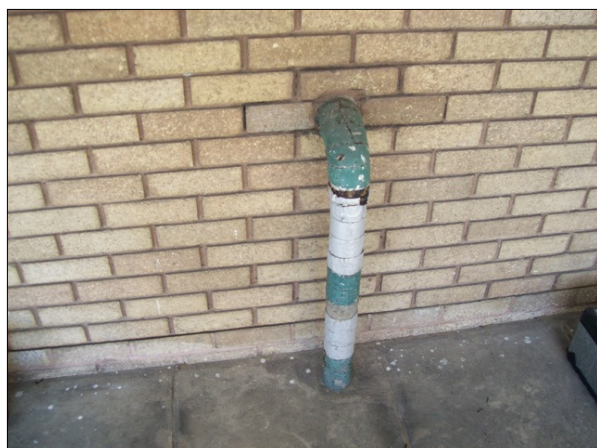
<b>Condition:</b>	Fair	<b>Accessibility:</b>	High
<b>Friability:</b>	Low	<b>Exposure:</b>	Public
<b>Surface:</b>	Partial seal	<b>Amount:</b>	2 Lm
<b>Position:</b>	External	<b>RISK:</b>	<b>NONE</b>

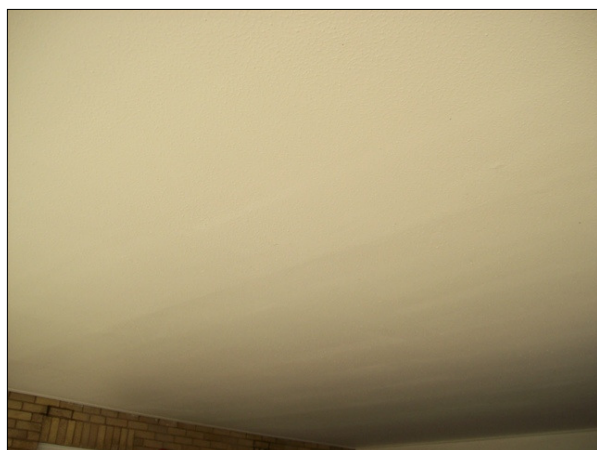
<b>Condition:</b>	Good	<b>Accessibility:</b>	Low
<b>Friability:</b>	Low	<b>Exposure:</b>	Public
<b>Surface:</b>	Fully sealed	<b>Amount:</b>	12 m <sup>2</sup>
<b>Position:</b>	External	<b>RISK:</b>	<b>NONE</b>

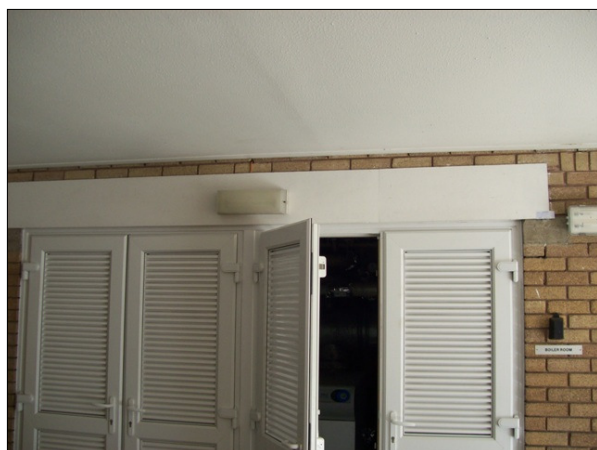
<b>Condition:</b>	Good	<b>Accessibility:</b>	Medium
<b>Friability:</b>	Medium	<b>Exposure:</b>	Public
<b>Surface:</b>	Fully sealed	<b>Amount:</b>	10 Lm
<b>Position:</b>	External	<b>RISK:</b>	<b>NONE</b>

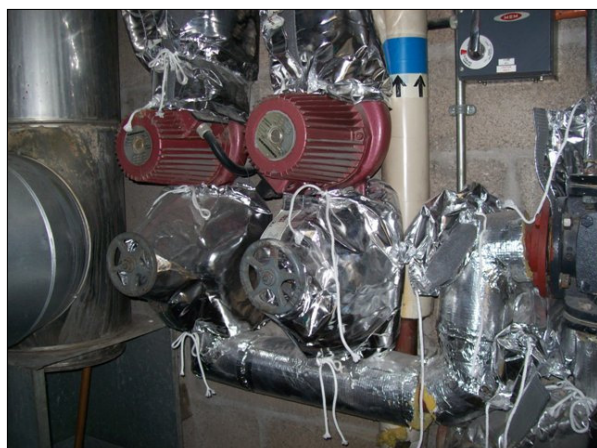
<b>Condition:</b>	Fair	<b>Accessibility:</b>	Low
<b>Friability:</b>	Medium	<b>Exposure:</b>	Staff & maintenance
<b>Surface:</b>	None	<b>Amount:</b>	Small Amounts No units
<b>Position:</b>	Internal	<b>RISK:</b>	<b>LOW (11)</b>

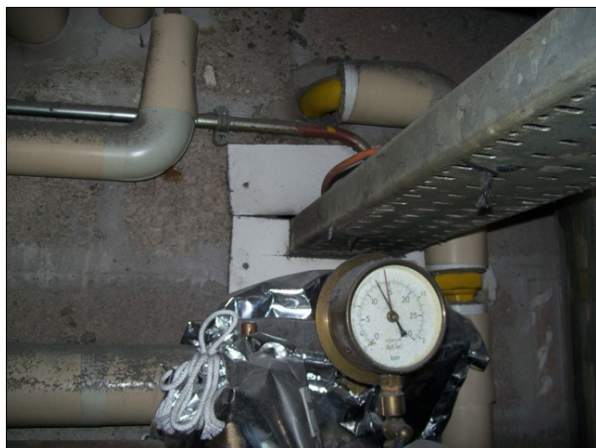
<b>Condition:</b>	Good	<b>Accessibility:</b>	Low
<b>Friability:</b>	Medium	<b>Exposure:</b>	Staff & maintenance
<b>Surface:</b>	None	<b>Amount:</b>	1 m <sup>2</sup>
<b>Position:</b>	Internal	<b>RISK:</b>	<b>NONE</b>

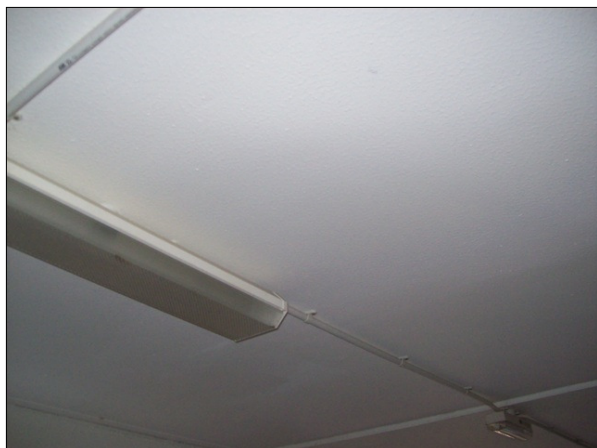
<b>Condition:</b>	Good	<b>Accessibility:</b>	Medium
<b>Friability:</b>	Low	<b>Exposure:</b>	Public
<b>Surface:</b>	Fully sealed	<b>Amount:</b>	8 m <sup>2</sup>
<b>Position:</b>	Internal	<b>RISK:</b>	<b>NONE</b>

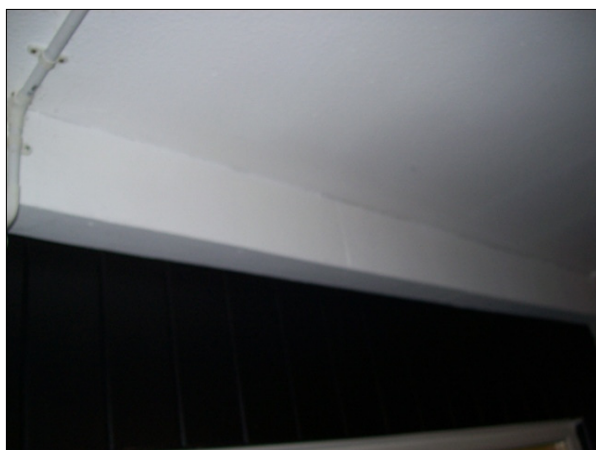
<b>Condition:</b>	Good	<b>Accessibility:</b>	Medium
<b>Friability:</b>	Medium	<b>Exposure:</b>	Public
<b>Surface:</b>	Fully sealed	<b>Amount:</b>	6 Lm
<b>Position:</b>	Internal	<b>RISK:</b>	<b>NONE</b>
