# **Asbestos Survey Report**

**Project Ref. No: M10538**

**12 Llys Ben Bowen Thomas**

**Full type 2 survey**

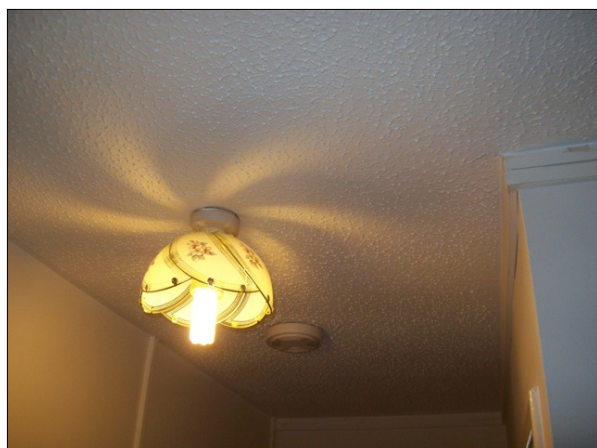
| Condition: | Good | Accessibility: | Low |
| Surface: | Fully sealed | Amount: | 4 m <sup>2</sup> |
| Position: | Internal | RISK: | <b>MINOR (3)</b> |

Asbestos textured coating to plasterboard ceiling.

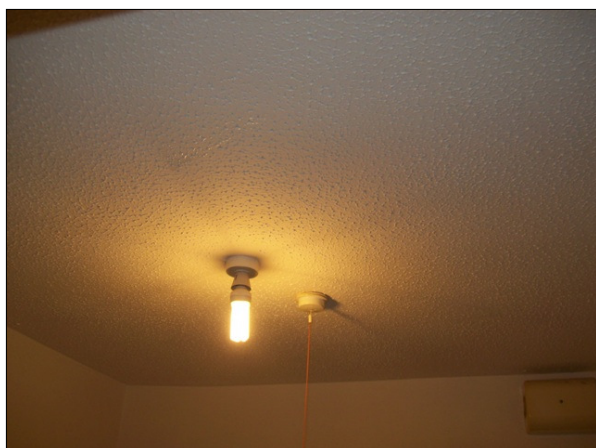
| Condition: | Good | Accessibility: | Medium |
| Surface: | Fully sealed | Amount: | 4 m <sup>2</sup> |
| Position: | Internal | RISK: | <b>MINOR (4)</b> |

Presumed asbestos textured coating to plasterboard ceiling.

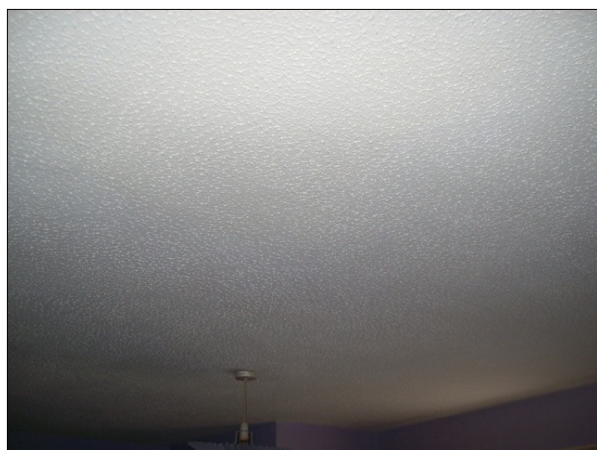
| <b>Condition:</b> | Good | <b>Accessibility:</b> | Medium |
| <b>Surface:</b> | Fully sealed | <b>Amount:</b> | 8 m <sup>2</sup> |
| <b>Position:</b> | Internal | <b>RISK:</b> | <b>MINOR (4)</b> |

Presumed asbestos textured coating to plasterboard ceiling.

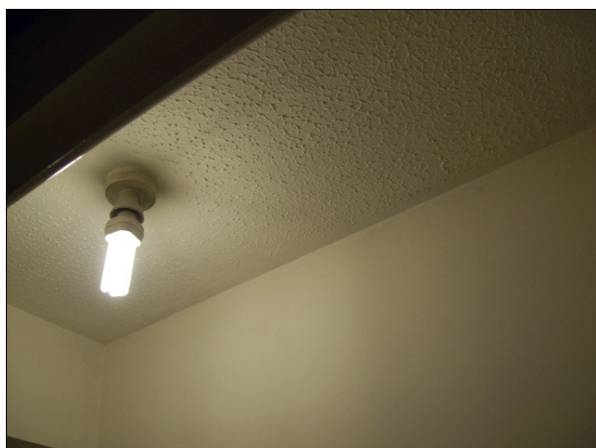
| <b>Condition:</b> | Good | <b>Accessibility:</b> | Medium |
| <b>Surface:</b> | Fully sealed | <b>Amount:</b> | 1 m <sup>2</sup> |
| <b>Position:</b> | Internal | <b>RISK:</b> | <b>MINOR (4)</b> |

Presumed asbestos textured coating to plasterboard ceiling.

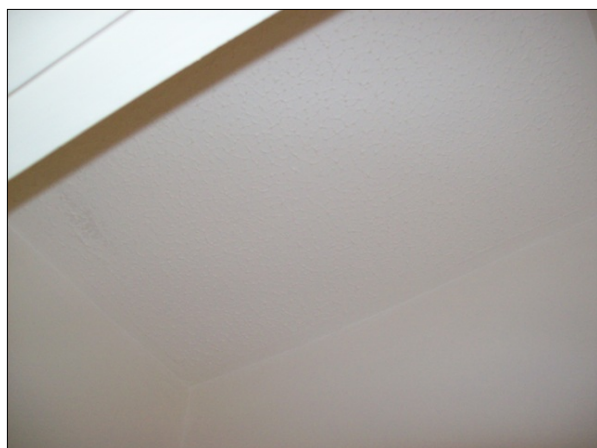
| Condition: | Good | Accessibility: | Medium |
| Surface: | Fully sealed | Amount: | 1 m <sup>2</sup> |
| Position: | Internal | RISK: | <b>MINOR (4)</b> |

Asbestos textured coating to plasterboard ceiling.

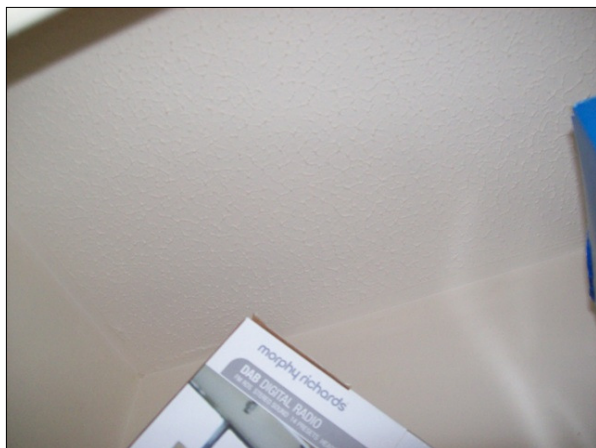
| <b>Condition:</b> | Good | <b>Accessibility:</b> | Medium |
| <b>Surface:</b> | Fully sealed | <b>Amount:</b> | 1 m <sup>2</sup> |
| <b>Position:</b> | Internal | <b>RISK:</b> | <b>MINOR (4)</b> |

Presumed asbestos textured coating to plasterboard ceiling.

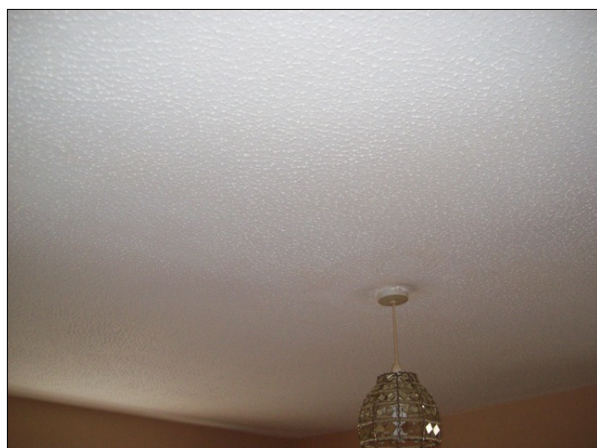
| Condition: | Good | Accessibility: | Medium |
| Surface: | Fully sealed | Amount: | 1 m <sup>2</sup> |
| Position: | Internal | RISK: | <b>MINOR (4)</b> |

Presumed asbestos textured coating to plasterboard ceiling.

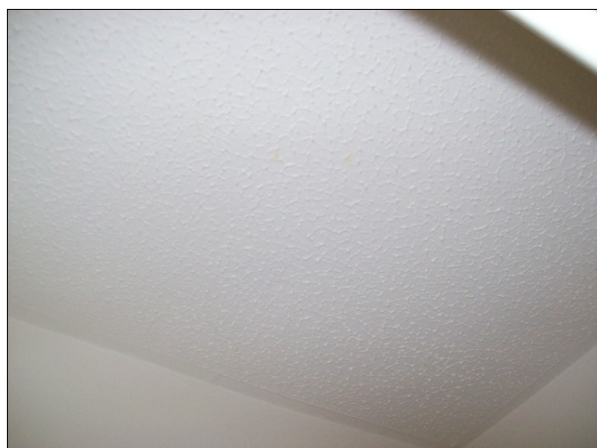
| <b>Condition:</b> | Good | <b>Accessibility:</b> | Medium |
| <b>Surface:</b> | Fully sealed | <b>Amount:</b> | 6 m <sup>2</sup> |
| <b>Position:</b> | Internal | <b>RISK:</b> | <b>MINOR (4)</b> |

Presumed asbestos textured coating to plasterboard ceiling.

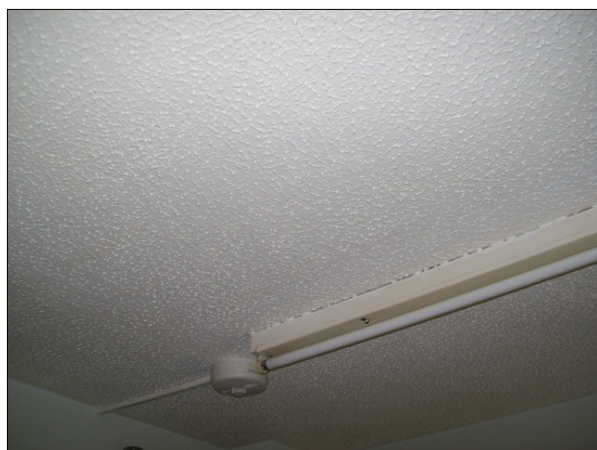
| <b>Condition:</b> | Good | <b>Accessibility:</b> | Medium |
| <b>Surface:</b> | Fully sealed | <b>Amount:</b> | 4 m <sup>2</sup> |
| <b>Position:</b> | Internal | <b>RISK:</b> | <b>MINOR (4)</b> |

Presumed asbestos textured coating to plasterboard ceiling.
