# **Asbestos Survey Report**

**Project Ref. No: M10538**

**15 Llys Ben Bowen Thomas**

**Full type 2 survey**

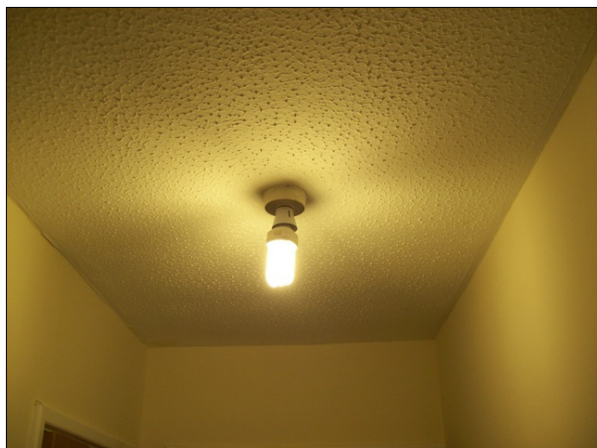
| Condition: | Good | Accessibility: | Medium |
| Surface: | Fully sealed | Amount: | 2 m <sup>2</sup> |
| Position: | Internal | RISK: | <b>MINOR (4)</b> |

Asbestos textured coating to plasterboard ceiling.

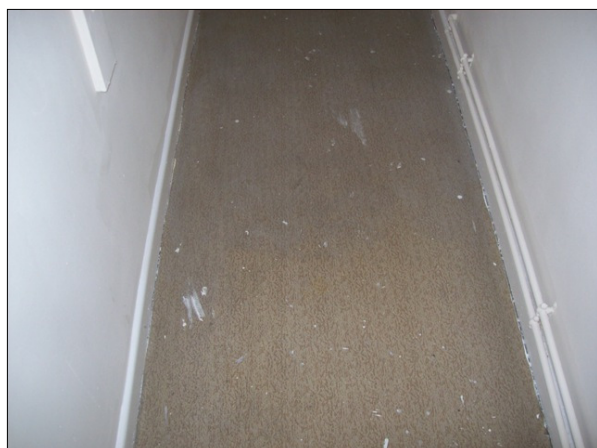
N.A.D.I.S. vinyl floor tiles (beige) to concrete floor.

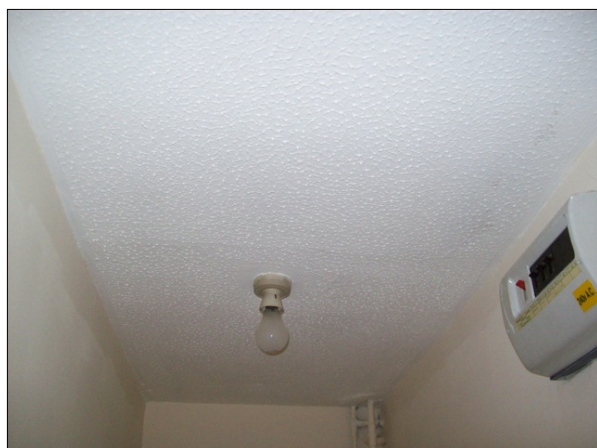
| <b>Condition:</b> | Good | <b>Accessibility:</b> | Medium |
| <b>Surface:</b> | Fully sealed | <b>Amount:</b> | 2 m <sup>2</sup> |
| <b>Position:</b> | Internal | <b>RISK:</b> | <b>MINOR (4)</b> |

Strongly presumed asbestos textured coating to plasterboard ceiling.

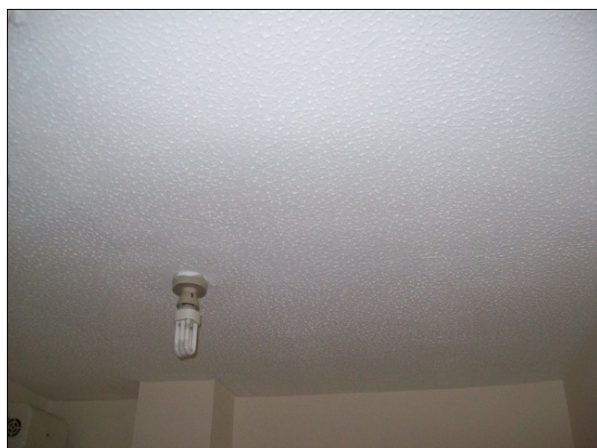
| Condition: | Good | Accessibility: | Medium |
| Surface: | Fully sealed | Amount: | 4 m <sup>2</sup> |
| Position: | Internal | RISK: | <b>MINOR (4)</b> |

Strongly presumed asbestos textured coating to plasterboard ceiling.

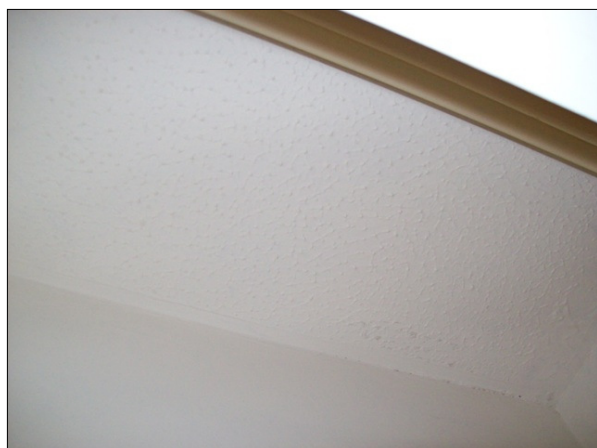
| <b>Condition:</b> | Good | <b>Accessibility:</b> | Medium |
| <b>Surface:</b> | Fully sealed | <b>Amount:</b> | 1 m <sup>2</sup> |
| <b>Position:</b> | Internal | <b>RISK:</b> | <b>MINOR (4)</b> |

Strongly presumed asbestos textured coating to plasterboard ceiling.

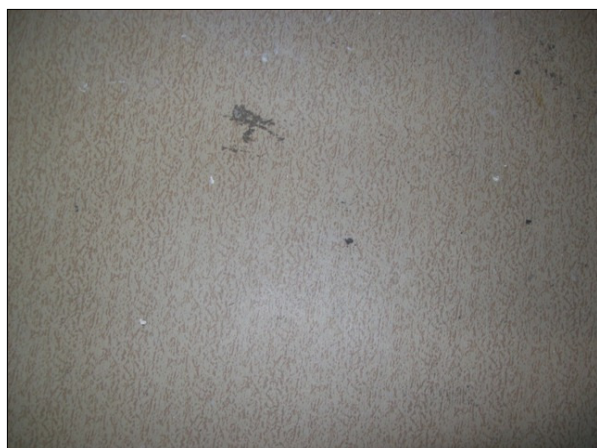
N.A.D.I.S. vinyl floor tiles (beige) to concrete floor.

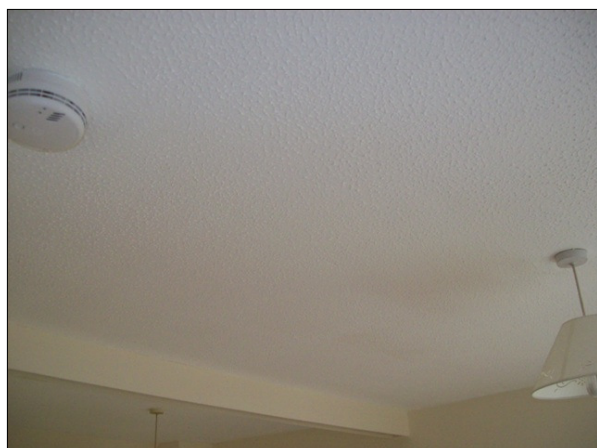
| Condition: | Good | Accessibility: | Medium |
| Surface: | Fully sealed | Amount: | 10 m <sup>2</sup> |
| Position: | Internal | RISK: | <b>MINOR (4)</b> |

Asbestos textured coating to plasterboard ceiling.

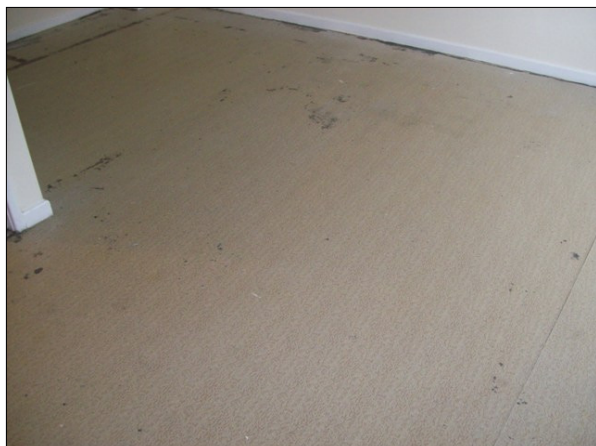
N.A.D.I.S. vinyl floor tiles (beige) to concrete floor.

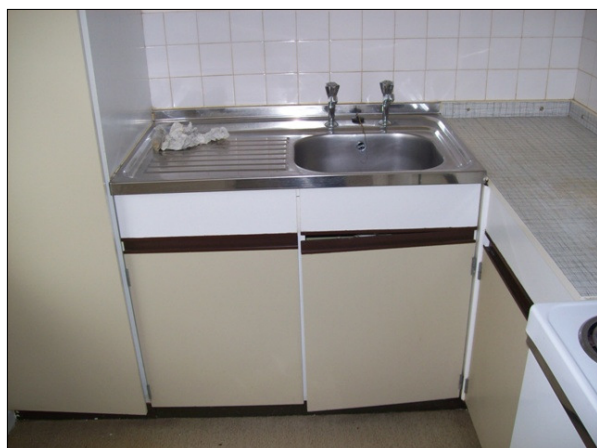
N.A.D.I.S. bitumastic sink pad beneath sink unit (x 2)

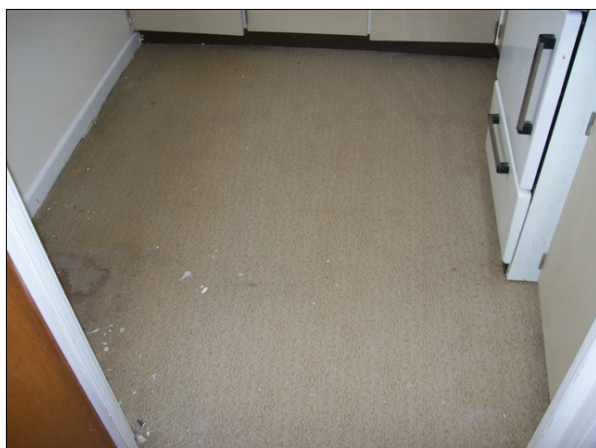
N.A.D.I.S. vinyl floor tiles (beige) to concrete floor.

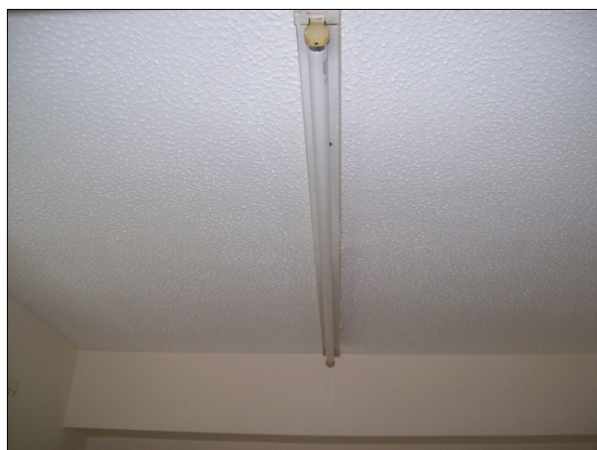
| Condition: | Good | Accessibility: | Medium |
| Surface: | Fully sealed | Amount: | 4 m <sup>2</sup> |
| Position: | Internal | RISK: | <b>MINOR (4)</b> |

Strongly presumed asbestos textured coating to plasterboard ceiling.
