Asbestos Survey Report

Project Ref. No: M10538

7 Llys Ben Bowen Thomas

Full type 2 survey

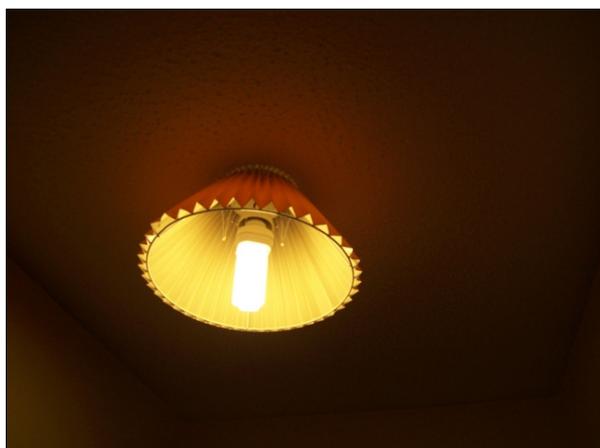
Asbestos Sample Record - 01a

Condition:	Good	Accessibility:	Medium
Friability:	Low	Exposure:	Public
Surface:	Fully sealed	Amount:	2 m ²
Position:	Internal	RISK:	MINOR (4)

Asbestos textured coating to plasterboard ceiling.

Action required:	Inspect		
Next action due date:	31/03/2009	Approximate cost:

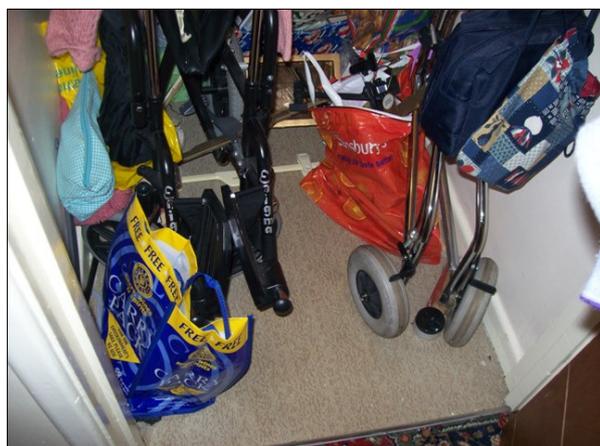
Asbestos Sample Record - 02a

Condition:	Good	Accessibility:	High	
Friability:	Low	Exposure:	Public	
Surface:	None	Amount:	2 m ²	
Position:	Internal	RISK:	NONE

N.A.D.I.S. vinyl floor tiles (beige).

Action required:	None		
Next action due date:	N/A	Approximate cost:

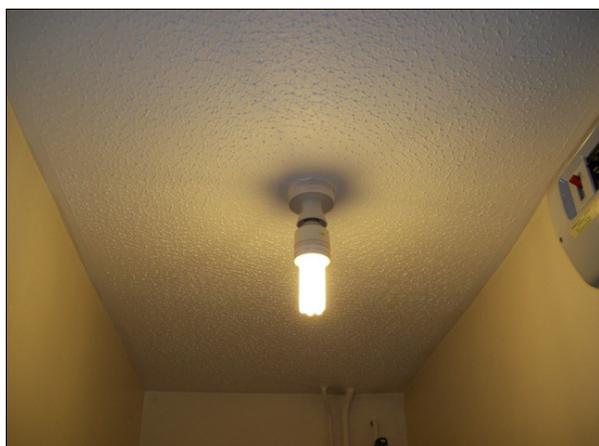
Asbestos Sample Record - 01m01

Condition:	Good	Accessibility:	Low
Friability:	Low	Exposure:	Staff & maintenance
Surface:	Fully sealed	Amount:	2 m ²
Position:	Internal	RISK:	MINOR (3)

Strongly presumed asbestos textured coating to plasterboard ceiling.

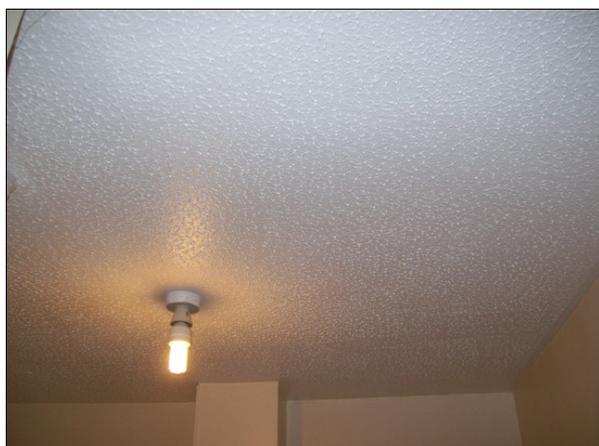
Condition:	Good	Accessibility:	Medium
Friability:	Low	Exposure:	Public
Surface:	Fully sealed	Amount:	3 m ²
Position:	Internal	RISK:	MINOR (4)

Strongly presumed asbestos textured coating to plasterboard ceiling.

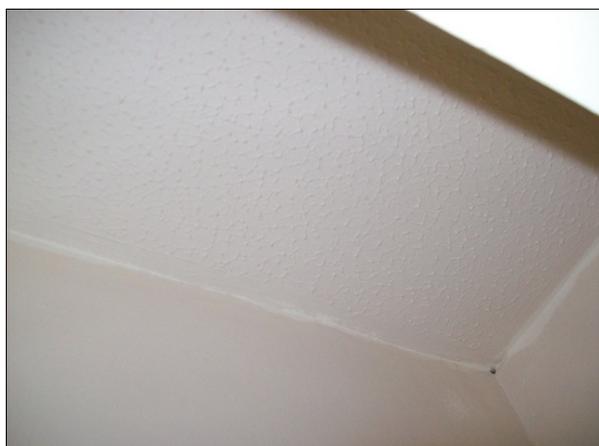
Condition:	Good	Accessibility:	Low	
Friability:	Low	Exposure:	Public	
Surface:	Fully sealed	Amount:	1 m ²	
Position:	Internal	RISK:	MINOR (3)

Strongly presumed asbestos textured coating to plasterboard ceiling.

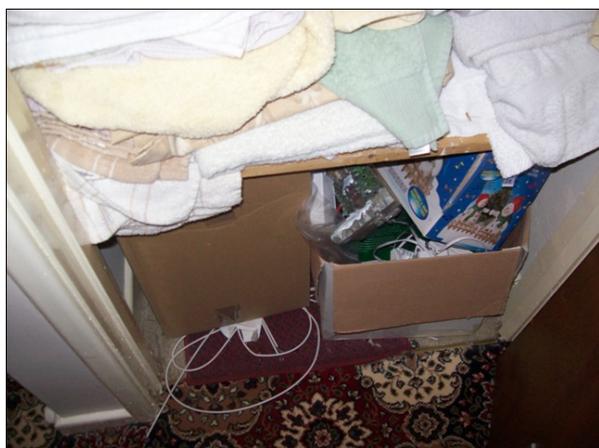
Condition:	Good	Accessibility:	High	
Friability:	Low	Exposure:	Public	
Surface:	None	Amount:	1 m ²	
Position:	Internal	RISK:	NONE

N.A.D.I.S. vinyl floor tiles (beige).

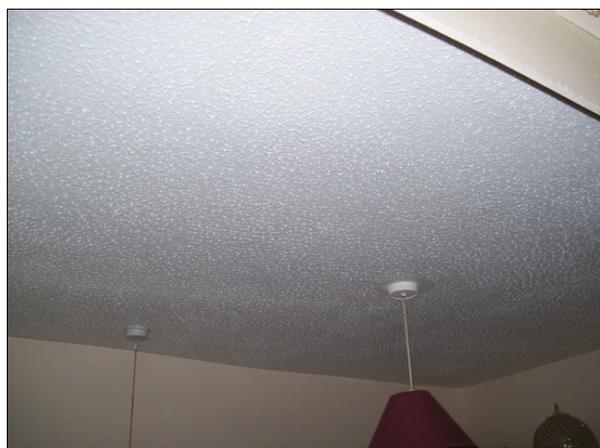
Condition:	Good	Accessibility:	Low	
Friability:	Low	Exposure:	Public	
Surface:	Fully sealed	Amount:	3 m ²	
Position:	Internal	RISK:	MINOR (3)

Asbestos textured coating to plasterboard ceiling.

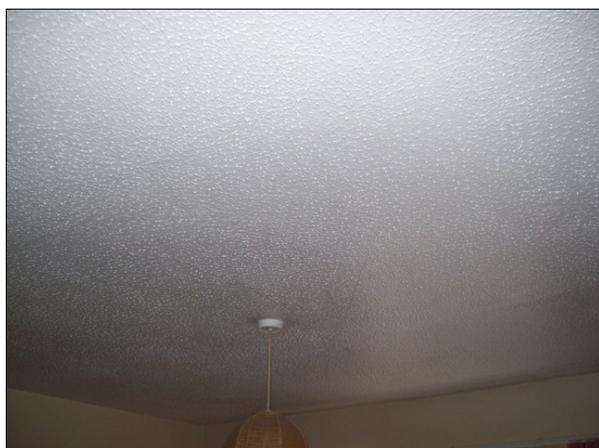
Condition:	Good	Accessibility:	Low
Friability:	Low	Exposure:	Public
Surface:	Fully sealed	Amount:	4 m ²
Position:	Internal	RISK:	MINOR (3)

Strongly presumed asbestos textured coating to plasterboard ceiling.

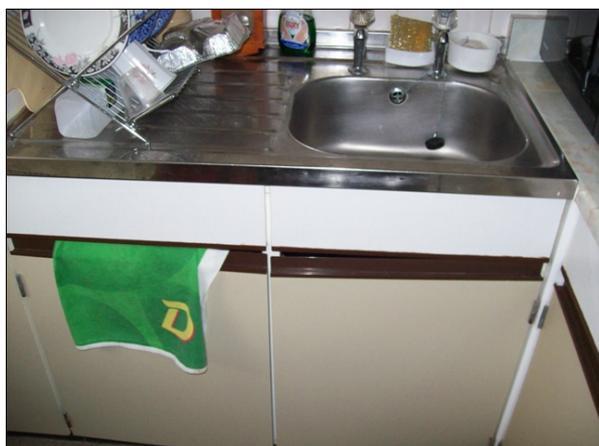
Condition:	Good	Accessibility:	Low
Friability:	Low	Exposure:	Public
Surface:	None	Amount:	<1 m ²
Position:	Internal	RISK:	NONE

N.A.D.I.S. bitumastic sink pad (x 2)

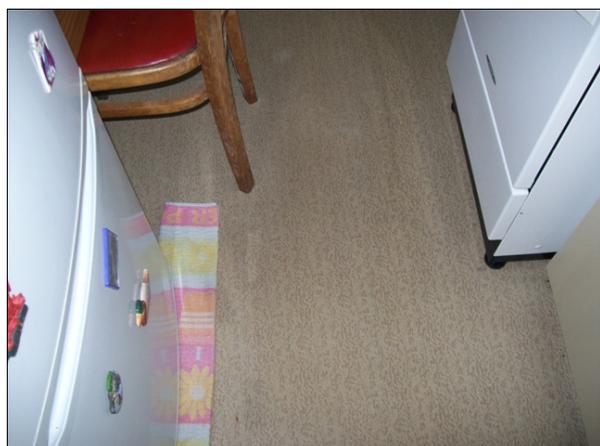
Condition:	Good	Accessibility:	High	
Friability:	Low	Exposure:	Public	
Surface:	None	Amount:	4 m ²	
Position:	Internal	RISK:	NONE

N.A.D.I.S. vinyl floor tiles (beige).

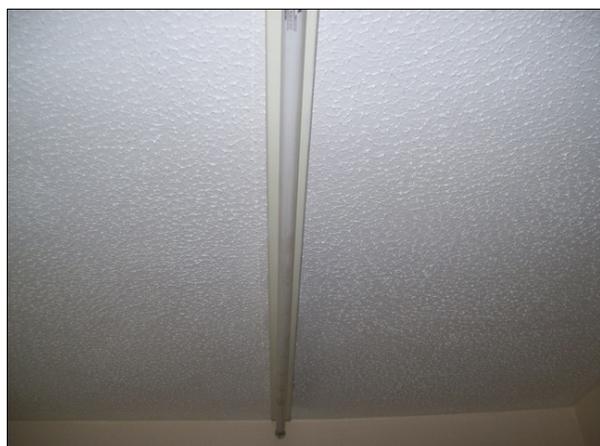
Condition:	Good	Accessibility:	Low
Friability:	Low	Exposure:	Public
Surface:	Fully sealed	Amount:	4 m ²
Position:	Internal	RISK:	MINOR (3)

Strongly presumed asbestos textured coating to plasterboard ceiling.
