**PROJECT NO: J132640**

**DATE: NOVEMBER 2013**

**ASBESTOS MANAGEMENT SURVEY  
OF**

**1 LLYS BEN BOWEN THOMAS, GELLIGALED ROAD, YSTRAD, RHONDDA, CF417SB**

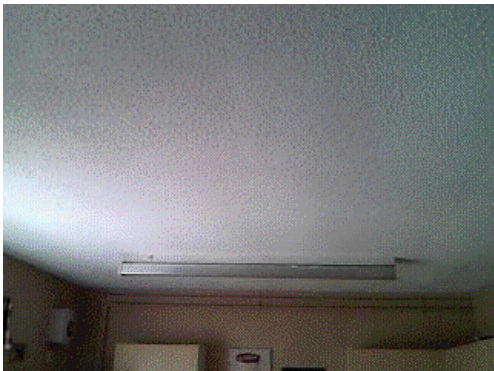
| <b>FLOOR/LOCATION:</b> | Ground Floor Kitchen (001) | |

| SITE ADDRESS: 1 LLYS BEN BOWEN THOMAS, GELLIGALED ROAD, YSTRAD, RHONDDA, CF417SB | | | | | | | | | DATE: 07/11/2013 | |
|---|---|---|---|---|---|---|---|---|---|---|
| Ground Floor /<br>Kitchen (001)<br>(1) | 1 - 3<br>(1) | Textured coating to ceiling (1) | 10m²<br>(1) | Sealed<br>(0) | Good<br>Condition (0) | Low (1) | CZ002170 / <b>Chrysotile</b> (1) | 2 + 4 = 6 | Very<br>Low | Manage, label, monitor and inform<br>maintenance personnel prior to<br>relevant works |

| <b>DESCRIPTION:</b> | Textured coating to ceiling | |
| <b>SAMPLE REF:</b> | CZ002170 | |
| <b>RESULT:</b> | Chrysotile | |

| <b>RECOMMENDATIONS:</b> | Manage, label, monitor and inform maintenance personnel prior to relevant works | |

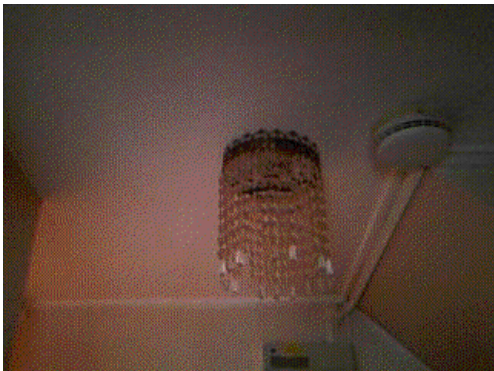
| <b>FLOOR/LOCATION:</b> | Ground Floor Hall (002) | |

| SITE ADDRESS: 1 LLYS BEN BOWEN THOMAS, GELLIGALED ROAD, YSTRAD, RHONDDA, CF417SB | | | | | | | | | DATE: 07/11/2013 | |
|---|---|---|---|---|---|---|---|---|---|---|
| Ground Floor /<br>Hall (002) (1) | 1 - 3<br>(1) | Textured coating to ceiling (1) | 5m²<br>(1) | Sealed<br>(0) | Good<br>Condition (0) | Low (1) | CZ002171 / <b>Chrysotile</b> (1) | 2 + 4 = 6 | Very<br>Low | Manage, label, monitor and inform<br>maintenance personnel prior to<br>relevant works |

| <b>DESCRIPTION:</b> | Textured coating to ceiling | |
| <b>SAMPLE REF:</b> | CZ002171 | |
| <b>RESULT:</b> | Chrysotile | |

| <b>RECOMMENDATIONS:</b> | Manage, label, monitor and inform maintenance personnel prior to relevant works | |

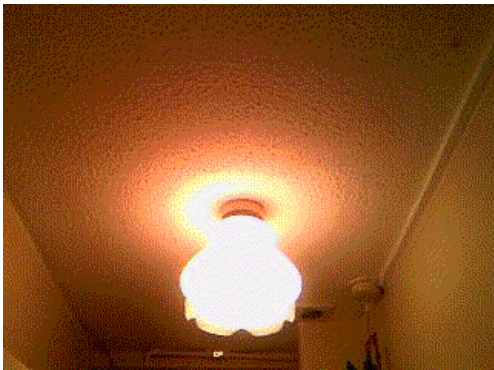
| <b>FLOOR/LOCATION:</b> | Ground Floor Toilet (003) | |

| SITE ADDRESS: 1 LLYS BEN BOWEN THOMAS, GELLIGALED ROAD, YSTRAD, RHONDDA, CF417SB | | | | | | | | | DATE: 07/11/2013 | |
|---|---|---|---|---|---|---|---|---|---|---|
| Ground Floor /<br>Toilet (003) (1) | 1 - 3<br>(1) | Textured coating to ceiling (1) | <2m²<br>(1) | Sealed<br>(0) | Good<br>Condition (0) | Low (1) | Strongly presumed similar<br>to CZ002171 /<br><b>Chrysotile</b> (1) | 2 + 4 = 6 | Very<br>Low | Manage, label, monitor and inform<br>maintenance personnel prior to<br>relevant works |

| <b>DESCRIPTION:</b> | Textured coating to ceiling | |
| <b>RESULT:</b> | Chrysotile | |

| <b>RECOMMENDATIONS:</b> | Manage, label, monitor and inform maintenance personnel prior to relevant works | |

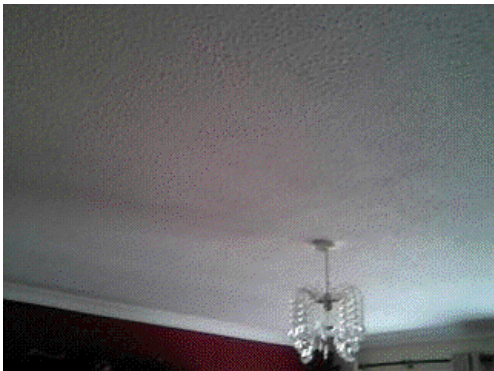
| <b>FLOOR/LOCATION:</b> | Ground Floor Lounge (004) | |

| SITE ADDRESS: 1 LLYS BEN BOWEN THOMAS, GELLIGALED ROAD, YSTRAD, RHONDDA, CF417SB | | | | | | | | | DATE: 07/11/2013 | |
|---|---|---|---|---|---|---|---|---|---|---|
| Ground Floor / Lounge (004) (1) | 1 - 3 (1) | Textured coating to ceiling (1) | 10m <sup>2</sup> (1) | Sealed (0) | Good Condition (0) | Low (1) | Strongly presumed similar to CZ002171 / <b>Chrysotile (1)</b> | 2 + 4 = 6 | Very Low | Manage, label, monitor and inform maintenance personnel prior to relevant works |

| <b>DESCRIPTION:</b> | Textured coating to ceiling | |
| <b>SAMPLE REF:</b> | SPST CZ002171 | |
| <b>RESULT:</b> | Chrysotile | |

| <b>RECOMMENDATIONS:</b> | Manage, label, monitor and inform maintenance personnel prior to relevant works | |

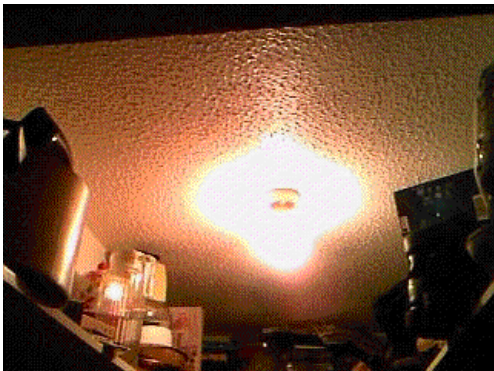
| <b>FLOOR/LOCATION:</b> | Ground Floor Cupboard (005) | |

| SITE ADDRESS: 1 LLYS BEN BOWEN THOMAS, GELLIGALED ROAD, YSTRAD, RHONDDA, CF417SB | | | | | | | | | DATE: 07/11/2013 | |
|---|---|---|---|---|---|---|---|---|---|---|
| Ground Floor / Cupboard (005) (1) | 1 - 3 (1) | Textured coating to ceiling (1) | 2m <sup>2</sup> (1) | Sealed (0) | Good Condition (0) | Low (1) | Strongly presumed similar to CZ002170 / <b>Chrysotile (1)</b> | 2 + 4 = 6 | Very Low | Manage, label, monitor and inform maintenance personnel prior to relevant works |

| <b>DESCRIPTION:</b> | Textured coating to ceiling | |
| <b>SAMPLE REF:</b> | SPST CZ002170 | |
| <b>RESULT:</b> | Chrysotile | |

| <b>RECOMMENDATIONS:</b> | Manage, label, monitor and inform maintenance personnel prior to relevant works | |

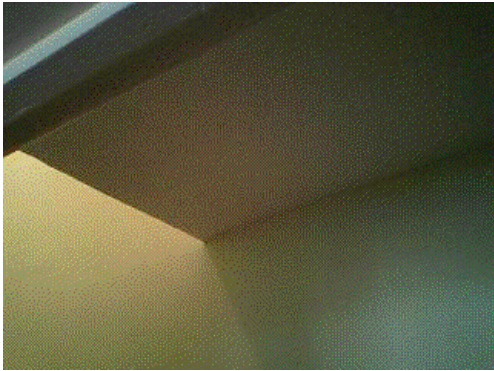
| <b>FLOOR/LOCATION:</b> | Ground Floor Stairs (006) | |

| <b>DESCRIPTION:</b> | Textured coating to ceiling | |
| <b>RESULT:</b> | Chrysotile | |

| <b>RECOMMENDATIONS:</b> | Manage, label, monitor and inform maintenance personnel prior to relevant works | |

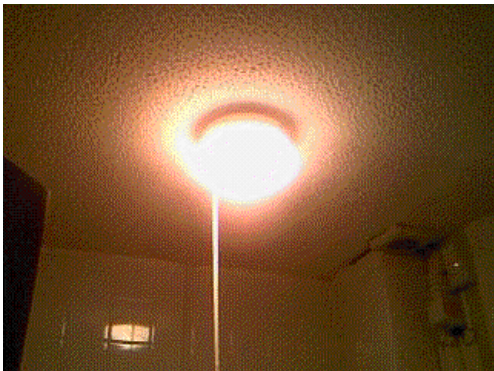
| <b>FLOOR/LOCATION:</b> | 1st Floor Bathroom (101) | |

| <b>DESCRIPTION:</b> | Textured coating to ceiling | |
| <b>SAMPLE REF:</b> | CZ002173 | |
| <b>RESULT:</b> | Chrysotile | |

| <b>RECOMMENDATIONS:</b> | Manage, label, monitor and inform maintenance personnel prior to relevant works | |

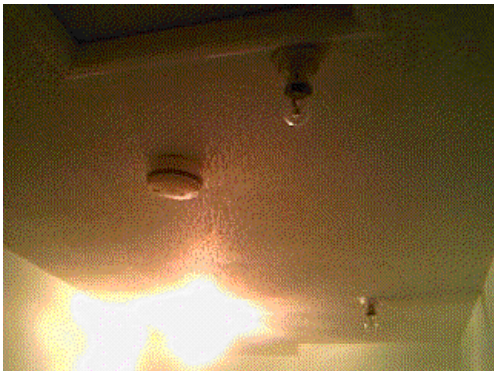
| <b>FLOOR/LOCATION:</b> | 1st Floor Landing (102) | |

| SITE ADDRESS: 1 LLYS BEN BOWEN THOMAS, GELLIGALED ROAD, YSTRAD, RHONDDA, CF417SB | | | | | | | | | DATE: 07/11/2013 | |
|---|---|---|---|---|---|---|---|---|---|---|
| 1st Floor /<br>Landing (102) (1) | 1 - 3<br>(1) | Textured coating to ceiling (1) | 8m <sup>2</sup><br>(1) | Sealed<br>(0) | Good<br>Condition (0) | Low (1) | CZ002174 / <b>Chrysotile</b> (1) | 2 + 4 = 6 | Very<br>Low | Manage, label, monitor and inform<br>maintenance personnel prior to relevant<br>works |

| <b>DESCRIPTION:</b> | Textured coating to ceiling | |
| <b>SAMPLE REF:</b> | CZ002174 | |
| <b>RESULT:</b> | Chrysotile | |

| <b>RECOMMENDATIONS:</b> | Manage, label, monitor and inform maintenance personnel prior to relevant works | |

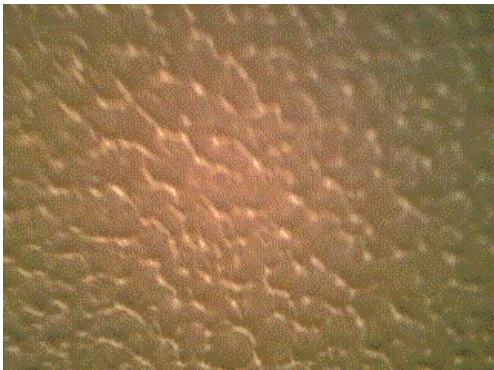
| <b>FLOOR/LOCATION:</b> | 1st Floor Cupboard (103) | |

| SITE ADDRESS: 1 LLYS BEN BOWEN THOMAS, GELLIGALED ROAD, YSTRAD, RHONDDA, CF417SB | | | | | | | | | DATE: 07/11/2013 | |
|---|---|---|---|---|---|---|---|---|---|---|
| 1st Floor /<br>Cupboard (103)<br>(1) | 1 - 3<br>(1) | Textured coating to ceiling (1) | 1m <sup>2</sup><br>(1) | Sealed<br>(0) | Good<br>Condition (0) | Low (1) | Strongly presumed similar to<br>CZ002174 / <b>Chrysotile</b> (1) | 2 + 4 = 6 | Very<br>Low | Manage, label, monitor and inform<br>maintenance personnel prior to relevant<br>works |

| <b>DESCRIPTION:</b> | Textured coating to ceiling | |
| <b>RESULT:</b> | Chrysotile | |

| <b>RECOMMENDATIONS:</b> | Manage, label, monitor and inform maintenance personnel prior to relevant works | |

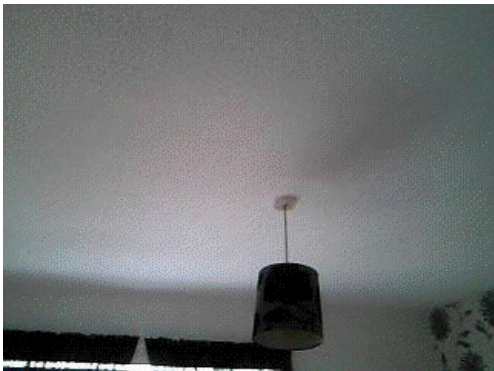
| <b>FLOOR/LOCATION:</b> | 1st Floor Bedroom (104) | |

| SITE ADDRESS: 1 LLYS BEN BOWEN THOMAS, GELLIGALED ROAD, YSTRAD, RHONDDA, CF417SB | | | | | | | | | DATE: 07/11/2013 | |
|---|---|---|---|---|---|---|---|---|---|---|
| 1st Floor /<br>Bedroom (104)<br>(1) | 1 - 3<br>(1) | Textured coating to ceiling (1) | 8m <sup>2</sup><br>(1) | Sealed<br>(0) | Good<br>Condition (0) | Low (1) | Strongly presumed similar to<br>CZ002173 / <b>Chrysotile</b> (1) | 2 + 4 = 6 | Very<br>Low | Manage, label, monitor and inform<br>maintenance personnel prior to relevant<br>works |

| <b>DESCRIPTION:</b> | Textured coating to ceiling | |
| <b>SAMPLE REF:</b> | SPST CZ002173 | |
| <b>RESULT:</b> | Chrysotile | |

| <b>RECOMMENDATIONS:</b> | Manage, label, monitor and inform maintenance personnel prior to relevant works | |

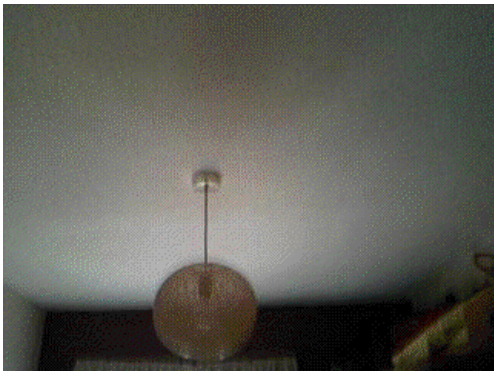
| <b>FLOOR/LOCATION:</b> | 1st Floor Bedroom (105) | |

| SITE ADDRESS: 1 LLYS BEN BOWEN THOMAS, GELLIGALED ROAD, YSTRAD, RHONDDA, CF417SB | | | | | | | | | DATE: 07/11/2013 | |
|---|---|---|---|---|---|---|---|---|---|---|
| 1st Floor /<br>Bedroom (105)<br>(1) | 1 - 3<br>(1) | Textured coating to ceiling (1) | 6m²<br>(1) | Sealed<br>(0) | Good<br>Condition (0) | Low (1) | Strongly presumed similar to<br>CZ002173 / Chrysotile (1) | 2 + 4 = 6 | Very<br>Low | Manage, label, monitor and inform<br>maintenance personnel prior to relevant<br>works |

| <b>DESCRIPTION:</b> | Textured coating to ceiling | |
| <b>SAMPLE REF:</b> | SPST CZ002173 | |
| <b>RESULT:</b> | Chrysotile | |

| <b>RECOMMENDATIONS:</b> | Manage, label, monitor and inform maintenance personnel prior to relevant works | |

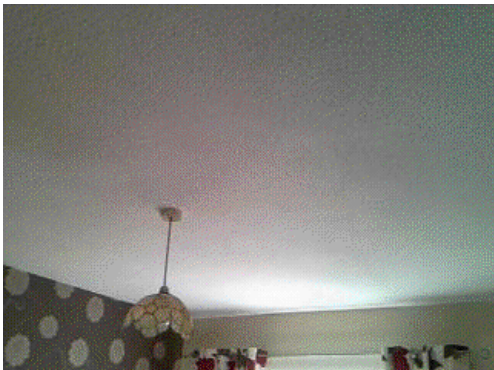
| <b>FLOOR/LOCATION:</b> | 1st Floor Bedroom (106) | |

| SITE ADDRESS: 1 LLYS BEN BOWEN THOMAS, GELLIGALED ROAD, YSTRAD, RHONDDA, CF417SB | | | | | | | | | DATE: 07/11/2013 | |
|---|---|---|---|---|---|---|---|---|---|---|
| 1st Floor /<br>Bedroom (106)<br>(1) | 1 - 3<br>(1) | Textured coating to ceiling (1) | 8m²<br>(1) | Sealed<br>(0) | Good<br>Condition (0) | Low (1) | Strongly presumed similar to<br>CZ002174 / Chrysotile (1) | 2 + 4 = 6 | Very<br>Low | Manage, label, monitor and inform<br>maintenance personnel prior to relevant<br>works |

| <b>DESCRIPTION:</b> | Textured coating to ceiling | |
| <b>RESULT:</b> | Chrysotile | |

| <b>RECOMMENDATIONS:</b> | Manage, label, monitor and inform maintenance personnel prior to relevant works | |

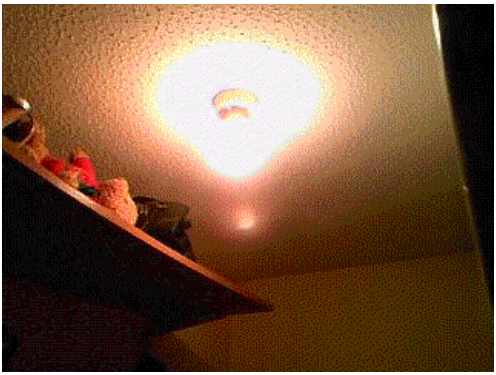
| <b>FLOOR/LOCATION:</b> | 1st Floor Cupboard (107) | |

| <b>DESCRIPTION:</b> | Textured coating to ceiling | |

| <b>RECOMMENDATIONS:</b> | Manage, label, monitor and inform maintenance personnel prior to relevant works | |
