**WALES & WEST HOUSING  
ASSOCIATION  
3 ALEXANDRA GATE  
FFORDD PENGAM  
TREMORFA  
CARDIFF  
CF24 2UD**

**PROJECT NO: J118861**

**DATE: SEPTEMBER 2013**

**ASBESTOS MANAGEMENT SURVEY  
OF  
2 LLYS BEN BOWEN THOMAS, GELLIGALED ROAD, YSTRAD, RHONDDA, CF41 7SB**

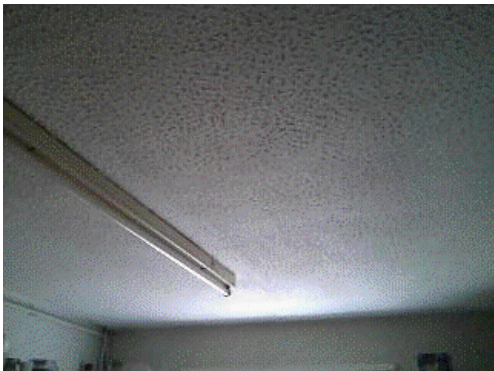
| <b>FLOOR/LOCATION:</b> | Ground Floor Kitchen (001) | |

| SITE ADDRESS: 2 LLYS BEN BOWEN THOMAS, GELLIGALED ROAD, YSTRAD, RHONDDA, CF41 7SB | | | | | | | | | DATE: 10/09/2013 | |
|---|---|---|---|---|---|---|---|---|---|---|
| Ground Floor /<br>Kitchen (001)<br>(1) | 1 - 3<br>(1) | Textured coating to ceiling (1) | 5m²<br>(1) | Sealed<br>(0) | Good<br>Condition (0) | Low (1) | CZ001590 / <b>Chrysotile</b> (1) | 2 + 4 = 6 | Very<br>Low | Manage, label, monitor and inform<br>maintenance personnel prior to<br>relevant works |

| <b>DESCRIPTION:</b> | Textured coating to ceiling | |
| <b>SAMPLE REF:</b> | CZ001590 | |
| <b>RESULT:</b> | Chrysotile | |

| <b>RECOMMENDATIONS:</b> | Manage, label, monitor and inform maintenance personnel prior to relevant works | |

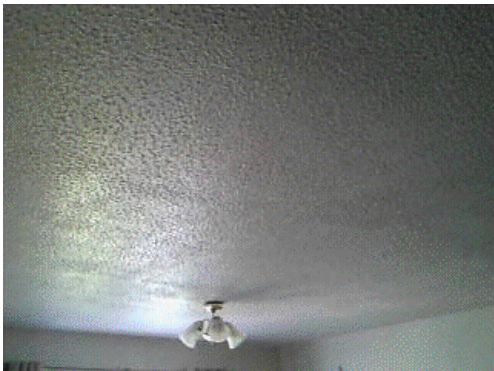
| <b>FLOOR/LOCATION:</b> | Ground Floor Lounge (002) | |

| SITE ADDRESS: 2 LLYS BEN BOWEN THOMAS, GELLIGALED ROAD, YSTRAD, RHONDDA, CF41 7SB | | | | | | | | | DATE: 10/09/2013 | |
|---|---|---|---|---|---|---|---|---|---|---|
| Ground Floor /<br>Lounge (002) (1) | 1 - 3<br>(1) | Textured coating to ceiling (1) | 10m²<br>(1) | Sealed<br>(0) | Good<br>Condition (0) | Low (1) | Strongly presumed similar to<br>CZ001590 / <b>Chrysotile</b> (1) | 2 + 4 = 6 | Very<br>Low | Manage, label, monitor and inform<br>maintenance personnel prior to<br>relevant works |

| <b>DESCRIPTION:</b> | Textured coating to ceiling | |
| <b>SAMPLE REF:</b> | SPST CZ001590 | |
| <b>RESULT:</b> | Chrysotile | |

| <b>RECOMMENDATIONS:</b> | Manage, label, monitor and inform maintenance personnel prior to relevant works | |

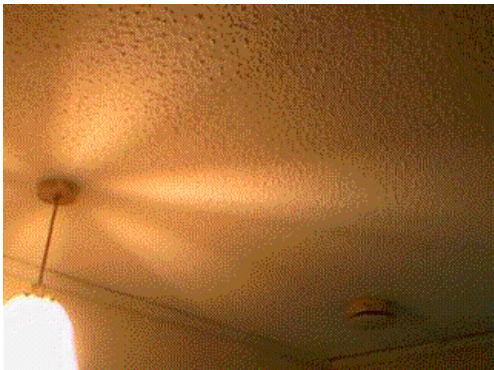
| <b>FLOOR/LOCATION:</b> | Ground Floor Lobby (003) | |

| SITE ADDRESS: 2 LLYS BEN BOWEN THOMAS, GELLIGALED ROAD, YSTRAD, RHONDDA, CF41 7SB | | | | | | | | | DATE: 10/09/2013 | |
|---|---|---|---|---|---|---|---|---|---|---|
| Ground Floor / Lobby (003) (1) | 1 - 3 (1) | Textured coating to ceiling (1) | 4m <sup>2</sup> (1) | Sealed (0) | Good Condition (0) | Low (1) | Strongly presumed similar to CZ001590 / Chrysotile (1) | 2 + 4 = 6 | Very Low | Manage, label, monitor and inform maintenance personnel prior to relevant works |

| <b>DESCRIPTION:</b> | Textured coating to ceiling | |
| <b>RESULT:</b> | Chrysotile | |

| <b>RECOMMENDATIONS:</b> | Manage, label, monitor and inform maintenance personnel prior to relevant works | |

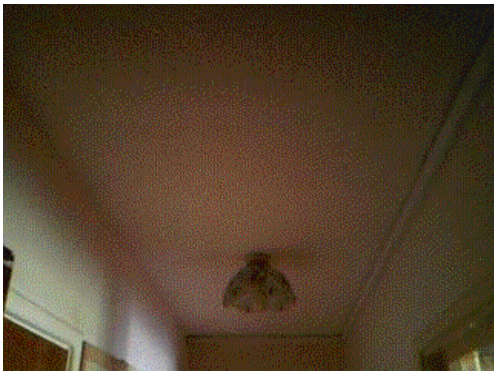
| <b>FLOOR/LOCATION:</b> | Ground Floor Hall (004) | |

| SITE ADDRESS: 2 LLYS BEN BOWEN THOMAS, GELLIGALED ROAD, YSTRAD, RHONDDA, CF41 7SB | | | | | | | | | DATE: 10/09/2013 | |
|---|---|---|---|---|---|---|---|---|---|---|
| Ground Floor / Hall (004) (1) | 1 - 3 (1) | Textured coating to ceiling (1) | 3m <sup>2</sup> (1) | Sealed (0) | Good Condition (0) | Low (1) | Strongly presumed similar to CZ001590 / Chrysotile (1) | 2 + 4 = 6 | Very Low | Manage, label, monitor and inform maintenance personnel prior to relevant works |

| <b>DESCRIPTION:</b> | Textured coating to ceiling | |
| <b>SAMPLE REF:</b> | SPST CZ001590 | |
| <b>RESULT:</b> | Chrysotile | |

| <b>RECOMMENDATIONS:</b> | Manage, label, monitor and inform maintenance personnel prior to relevant works | |

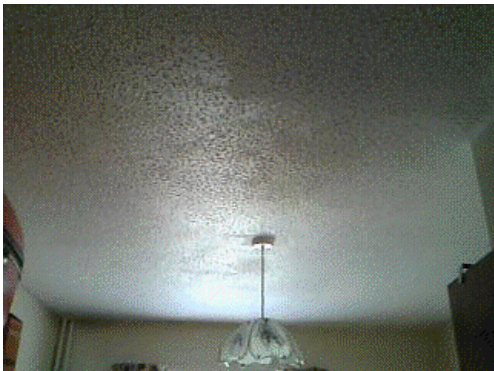
| <b>FLOOR/LOCATION:</b> | Ground Floor Bedroom (005) | |

| SITE ADDRESS: 2 LLYS BEN BOWEN THOMAS, GELLIGALED ROAD, YSTRAD, RHONDDA, CF41 7SB | | | | | | | | | DATE: 10/09/2013 | |
|---|---|---|---|---|---|---|---|---|---|---|
| Ground Floor / Bedroom (005) (1) | 1 - 3 (1) | Textured coating to ceiling (1) | 5m <sup>2</sup> (1) | Sealed (0) | Good Condition (0) | Low (1) | CZ001592 / Chrysotile (1) | 2 + 4 = 6 | Very Low | Manage, label, monitor and inform maintenance personnel prior to relevant works |

| <b>DESCRIPTION:</b> | Textured coating to ceiling | |
| <b>SAMPLE REF:</b> | CZ001592 | |
| <b>RESULT:</b> | Chrysotile | |

| <b>RECOMMENDATIONS:</b> | Manage, label, monitor and inform maintenance personnel prior to relevant works | |

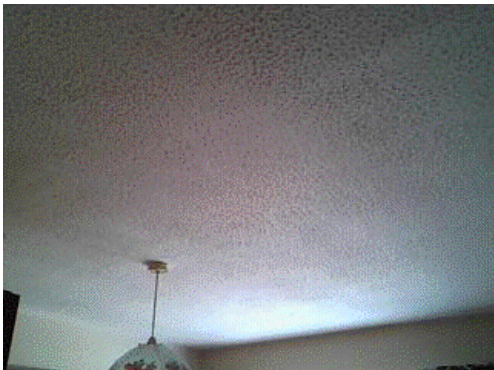
| <b>FLOOR/LOCATION:</b> | Ground Floor Bedroom (006) | |

| SITE ADDRESS: 2 LLYS BEN BOWEN THOMAS, GELLIGALED ROAD, YSTRAD, RHONDDA, CF41 7SB | | | | | | | | | DATE: 10/09/2013 | | |
|---|---|---|---|---|---|---|---|---|---|---|--|
| Ground Floor /<br>Bedroom (006)<br>(1) | 1 - 3<br>(1) | Textured coating to ceiling (1) | 9m <sup>2</sup><br>(1) | Sealed<br>(0) | Good<br>Condition<br>(0) | Low (1) | | 2 + 4 = 6 | Very<br>Low | Manage, label, monitor and inform<br>maintenance personnel prior to<br>relevant works | |

| <b>DESCRIPTION:</b> | Textured coating to ceiling | |
| <b>RESULT:</b> | Chrysotile | |

| <b>RECOMMENDATIONS:</b> | Manage, label, monitor and inform maintenance personnel prior to relevant works | |

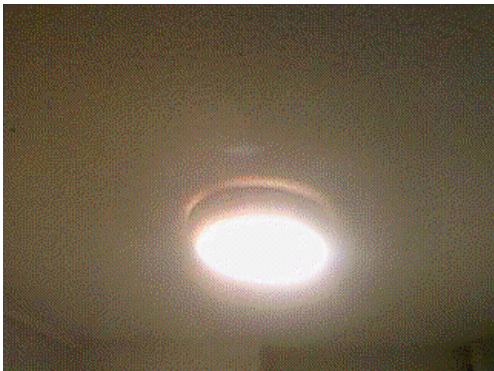
| <b>FLOOR/LOCATION:</b> | Ground Floor Bathroom (007) | |

| SITE ADDRESS: 2 LLYS BEN BOWEN THOMAS, GELLIGALED ROAD, YSTRAD, RHONDDA, CF41 7SB | | | | | | | | | DATE: 10/09/2013 | | |
|---|---|---|---|---|---|---|---|---|---|---|--|
| Ground Floor /<br>Bathroom (007)<br>(1) | 1 - 3<br>(1) | Textured coating to ceiling (1) | 5m <sup>2</sup><br>(1) | Sealed<br>(0) | Good<br>Condition<br>(0) | Low (1) | | 2 + 4 = 6 | Very<br>Low | Manage, label, monitor and inform<br>maintenance personnel prior to<br>relevant works | |

| <b>DESCRIPTION:</b> | Textured coating to ceiling | |
| <b>SAMPLE REF:</b> | CZ001593 | |
| <b>RESULT:</b> | Chrysotile | |

| <b>RECOMMENDATIONS:</b> | Manage, label, monitor and inform maintenance personnel prior to relevant works | |

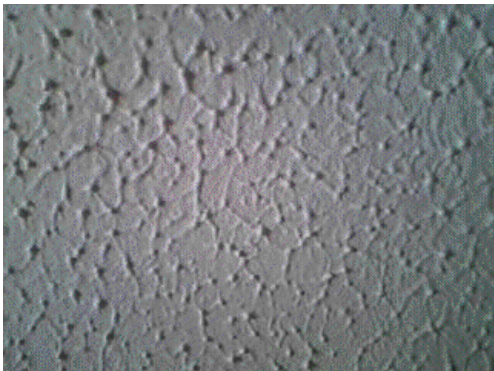
| <b>FLOOR/LOCATION:</b> | Ground Floor Cupboard (008) | |

| SITE ADDRESS: 2 LLYS BEN BOWEN THOMAS, GELLIGALED ROAD, YSTRAD, RHONDDA, CF41 7SB | | | | | | | | | DATE: 10/09/2013 | |
|---|---|---|---|---|---|---|---|---|---|---|
| Ground Floor /<br>Cupboard (008) (1) | 1 - 3<br>(1) | Textured coating to ceiling (1) | <2m²<br>(1) | Sealed<br>(0) | Good<br>Condition (0) | Low (1) | Strongly presumed similar to<br>CZ001590 / <b>Chrysotile</b> (1) | 2 + 4 = 6 | Very<br>Low | Manage, label, monitor and inform<br>maintenance personnel prior to relevant<br>works |

| <b>DESCRIPTION:</b> | Textured coating to ceiling | |
| <b>SAMPLE REF:</b> | SPST CZ001590 | |
| <b>RESULT:</b> | Chrysotile | |

| <b>RECOMMENDATIONS:</b> | Manage, label, monitor and inform maintenance personnel prior to relevant works | |

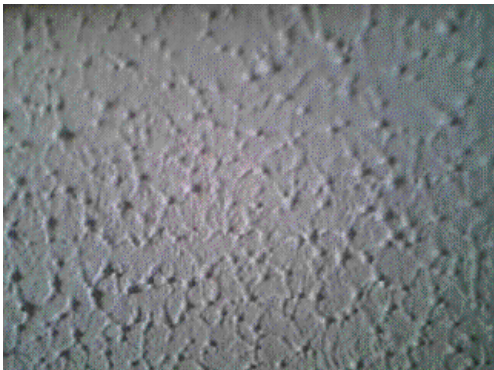
| <b>FLOOR/LOCATION:</b> | Ground Floor Cupboard (009) | |

| SITE ADDRESS: 2 LLYS BEN BOWEN THOMAS, GELLIGALED ROAD, YSTRAD, RHONDDA, CF41 7SB | | | | | | | | | DATE: 10/09/2013 | |
|---|---|---|---|---|---|---|---|---|---|---|
| Ground Floor /<br>Cupboard (009) (1) | 1 - 3<br>(1) | Textured coating to ceiling (1) | >2m²<br>(1) | Sealed<br>(0) | Good<br>Condition (0) | Low (1) | Strongly presumed similar to<br>CZ001590 / <b>Chrysotile</b> (1) | 2 + 4 = 6 | Very<br>Low | Manage, label, monitor and inform<br>maintenance personnel prior to relevant<br>works |

| <b>DESCRIPTION:</b> | Textured coating to ceiling | |
| <b>RESULT:</b> | Chrysotile | |

| <b>RECOMMENDATIONS:</b> | Manage, label, monitor and inform maintenance personnel prior to relevant works | |

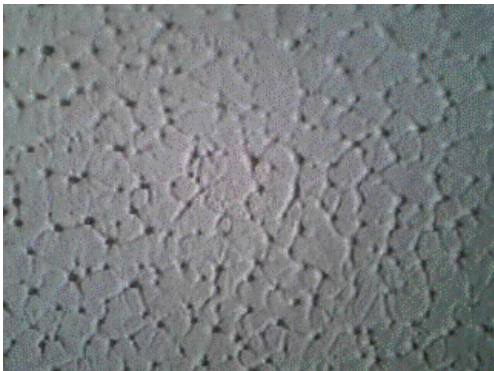
| <b>FLOOR/LOCATION:</b> | Ground Floor Cupboard (010) | |

| SITE ADDRESS: 2 LLYS BEN BOWEN THOMAS, GELLIGALED ROAD, YSTRAD, RHONDDA, CF41 7SB | | | | | | | | | DATE: 10/09/2013 | |
|---|---|---|---|---|---|---|---|---|---|---|
| Ground Floor /<br>Cupboard (010) (1) | 1 - 3<br>(1) | Textured coating to ceiling (1) | 1m²<br>(1) | Sealed<br>(0) | Good<br>Condition (0) | Low (1) | Strongly presumed similar to<br>CZ001592 / <b>Chrysotile</b> (1) | 2 + 4 = 6 | Very<br>Low | Manage, label, monitor and inform<br>maintenance personnel prior to relevant<br>works |

| <b>DESCRIPTION:</b> | Textured coating to ceiling | |
| <b>SAMPLE REF:</b> | SPST CZ001592 | |
| <b>RESULT:</b> | Chrysotile | |

| <b>RECOMMENDATIONS:</b> | Manage, label, monitor and inform maintenance personnel prior to relevant works | |

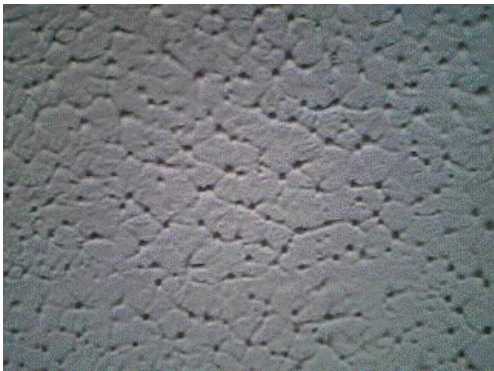
| <b>FLOOR/LOCATION:</b> | Ground Floor Cupboard (011) | |

| SITE ADDRESS: 2 LLYS BEN BOWEN THOMAS, GELLIGALED ROAD, YSTRAD, RHONDDA, CF41 7SB | | | | | | | | | DATE: 10/09/2013 | | |
|---|---|---|---|---|---|---|---|---|---|---|--|
| <b>Ground Floor /<br/>Cupboard (011) (1)</b> | <b>1 - 3<br/>(1)</b> | <b>Textured coating to ceiling (1)</b> | <b>1m²<br/>(1)</b> | <b>Sealed<br/>(0)</b> | <b>Good<br/>Condition (0)</b> | <b>Low (1)</b> | | <b>2 + 4 = 6</b> | <b>Very<br/>Low</b> | <b>Manage, label, monitor and inform<br/>maintenance personnel prior to relevant<br/>works</b> | |

| <b>DESCRIPTION:</b> | Textured coating to ceiling | |

| <b>RECOMMENDATIONS:</b> | Manage, label, monitor and inform maintenance personnel prior to relevant works | |
