**UPRN NO: 6458**

**PROJECT NO: J157311**

**DATE: FEBRUARY 2014 Rev. 1**

**REPLACEMENT REPORT FOR ASBESTOS MANAGEMENT SURVEY WITH  
REFURBISHMENT SURVEY TO THE BATHROOM OF  
22 LLYS BEN BOWEN THOMAS, GELLIGALED STREET, YSTRAD, CF41 7SB**

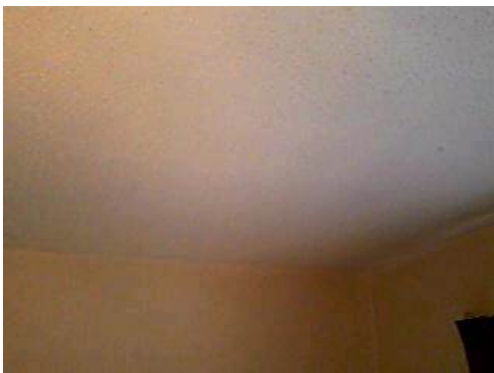
| <b>FLOOR/LOCATION:</b> | 1st Floor Lounge/Bedroom (104) | |

| SITE ADDRESS: 22 LLYS BEN BOWEN THOMAS, GELLIGALED STREET, YSTRAD, CF41 7SB | | | | | | | | | DATE: 20/02/2014 | |
|---|---|---|---|---|---|---|---|---|---|---|
| 1st Floor / Lounge/Bedroom (104) (1) | 1 - 3 (1) | Textured coating to ceiling (1) | 18m² (2) | Sealed (0) | Good Condition (0) | Medium (2) | CX004105 / Chrysotile (1) | 2 + 6 = 8 | Very Low | Manage, label, monitor and inform maintenance personnel prior to relevant works |

| <b>DESCRIPTION:</b> | Textured coating to ceiling | |
| <b>RESULT:</b> | Chrysotile | |

| <b>RECOMMENDATIONS:</b> | Manage, label, monitor and inform maintenance personnel prior to relevant works | |

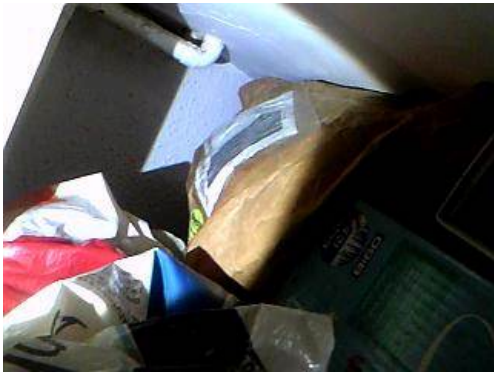
| <b>FLOOR/LOCATION:</b> | 1st Floor Cupboard (105) | |

| SITE ADDRESS: 22 LLYS BEN BOWEN THOMAS, GELLIGALED STREET, YSTRAD, CF41 7SB | | | | | | | | | DATE: 20/02/2014 | |
|---|---|---|---|---|---|---|---|---|---|---|
| 1st Floor / Cupboard<br>(105) (1) | 1 - 3<br>(1) | Textured coating to ceiling (1) | 1m <sup>2</sup><br>(1) | Sealed<br>(0) | Good<br>Condition (0) | Medium<br>(2) | Strongly presumed similar to<br>CX004105 / Chrysotile (1) | 2 + 5 = 7 | Very<br>Low | Manage, label, monitor and inform<br>maintenance personnel prior to<br>relevant works |

| <b>DESCRIPTION:</b> | Textured coating to ceiling | |
| <b>RESULT:</b> | Chrysotile | |

| <b>RECOMMENDATIONS:</b> | Manage, label, monitor and inform maintenance personnel prior to relevant works | |

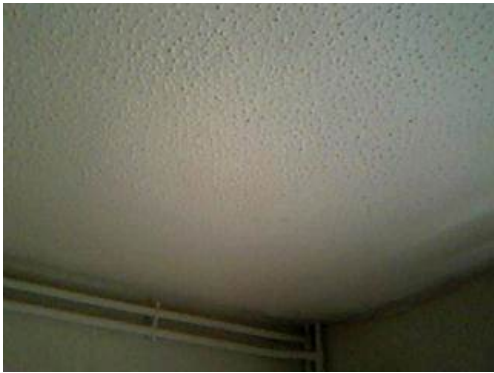
| <b>FLOOR/LOCATION:</b> | 1st Floor Kitchen (106) | |

| SITE ADDRESS: 22 LLYS BEN BOWEN THOMAS, GELLIGALED STREET, YSTRAD, CF41 7SB | | | | | | | | | DATE: 20/02/2014 | |
|---|---|---|---|---|---|---|---|---|---|---|
| 1st Floor / Kitchen<br>(106) (1) | 1 - 3<br>(1) | Textured coating to ceiling (1) | 4m <sup>2</sup><br>(1) | Sealed<br>(0) | Good<br>Condition (0) | Medium<br>(2) | Strongly presumed similar to<br>CX004105 / Chrysotile (1) | 2 + 5 = 7 | Very<br>Low | Manage, label, monitor and inform<br>maintenance personnel prior to<br>relevant works |

| <b>DESCRIPTION:</b> | Textured coating to ceiling | |

| <b>RECOMMENDATIONS:</b> | Manage, label, monitor and inform maintenance personnel prior to relevant works | |
