Asbestos Survey Report
Project Ref. No: M10538
Common Areas Llys Bryn Felin
Full type 2 survey

Common Areas Llys Bryn Felin

Survey Date: 10/04/2008 to 10/04/2008
Surveyor: C Tolley & M Walters
Report Print Date: 15/05/2008
Report Authorised By: Arif Palejwala - Project Manager

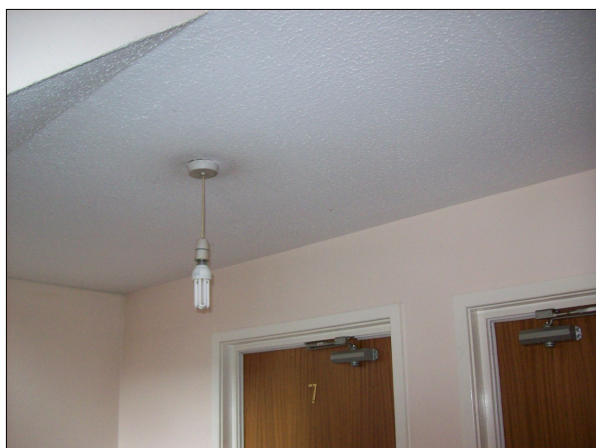
Asbestos Sample Record - 01a

Flats 7 - 10, Ground floor, Lobby & Stairwell

Inspection Dates:	10/04/2008 to 10/04/2008	Reference No.:	01a
Surveyor:	CT&MW	Survey/Inspection:	Survey
Component:	Textured coatings and plaster		
Asbestos?:	No		
Asbestos type(s):	N/A

Condition:	Good	Accessibility:	Low
Friability:	Low	Exposure:	Public
Surface:	Fully sealed	Amount:	10 m ²
Position:	Internal	RISK:	NONE

N.A.D.I.S textured coating to plasterboard ceiling.

Action required:	None		
Next action due date:	N/A	Approximate cost:

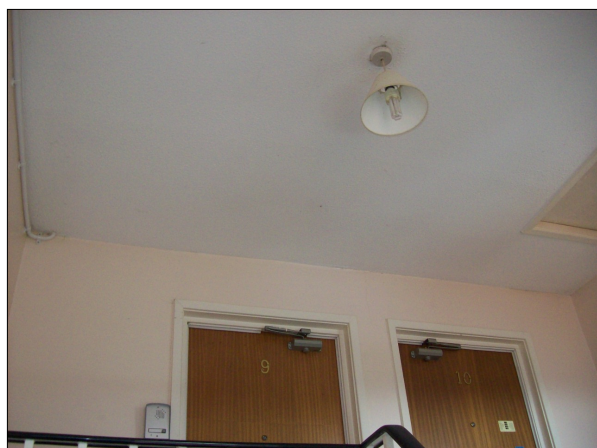
Asbestos Sample Record - 02a

Flats 7 - 10, 1st floor, Lobby & Stairwell

Inspection Dates:	10/04/2008 to 10/04/2008	Reference No.:	02a
Surveyor:	CT&MW	Survey/Inspection:	Survey
Component:	Textured coatings and plaster		
Asbestos?:	No		
Asbestos type(s):	N/A

Condition:	Good	Accessibility:	Low
Friability:	Low	Exposure:	Public
Surface:	Fully sealed	Amount:	10 m ²
Position:	Internal	RISK:	NONE

N.A.D.I.S textured coating to plasterboard ceiling.

Action required:	None		
Next action due date:	N/A	Approximate cost:
