## MANAGEMENT SURVEY WITH A TARGETED REFURBISHMENT INSPECTION

**Client: Wales & West Housing  
Site ID: PF /13/ LBF642**

**8 Lllys Bryn Felin Mill Street  
Tonyrefail  
Rhondda  
CF398AB**

**Issue Date: 18<sup>th</sup> December 2013**

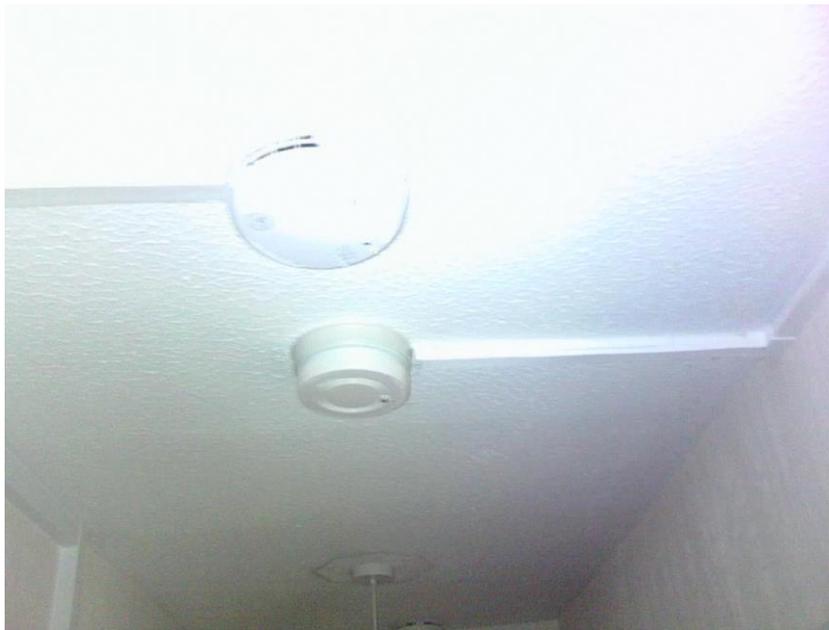
Site ID	Location ID	Building	Floor	Room / Area	Description
PF /13/ LBF642	D-50563/01	Flat	Ground floor	Hall	Stipple

Asbestos Type	Product Type	Amount	Extent of Damage	Surface Treatment	Action Assessment	Material Assessment
Non Asbestos	Textured Coating - Ceiling	N/A	N/A	N/A	N/A	0

**Comments:** No asbestos was detected in the sample taken from the material.

**Recommendations:** No further action is required.

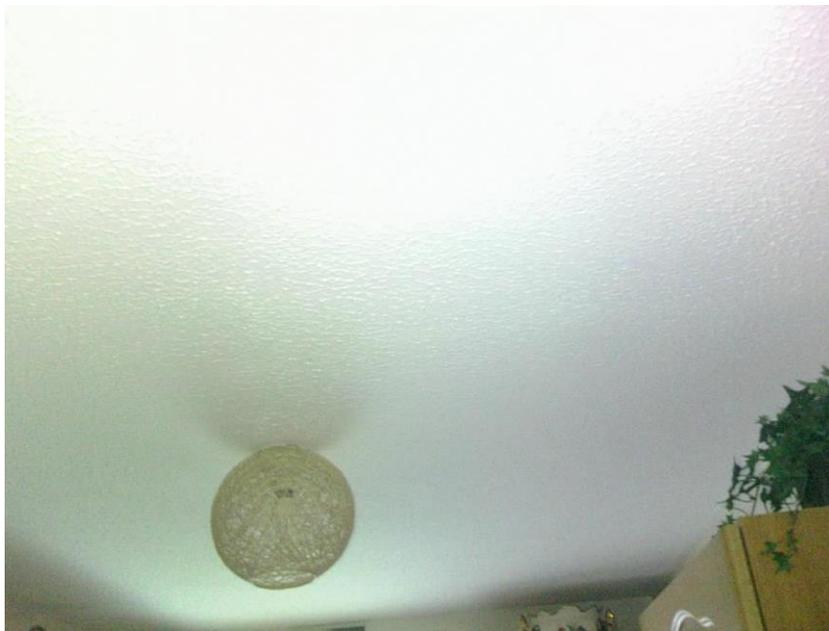
Site ID	Location ID	Building	Floor	Room / Area	Description
PF /13/ LBF642	D-50563/01A	Flat	Ground floor	Kitchen	Stipple

Asbestos Type	Product Type	Amount	Extent of Damage	Surface Treatment	Action Assessment	Material Assessment
Non Asbestos	Textured Coating - Ceiling	N/A	N/A	N/A	N/A	0

**Comments:** No asbestos was detected in the sample taken from the material.

**Recommendations:** No further action is required.

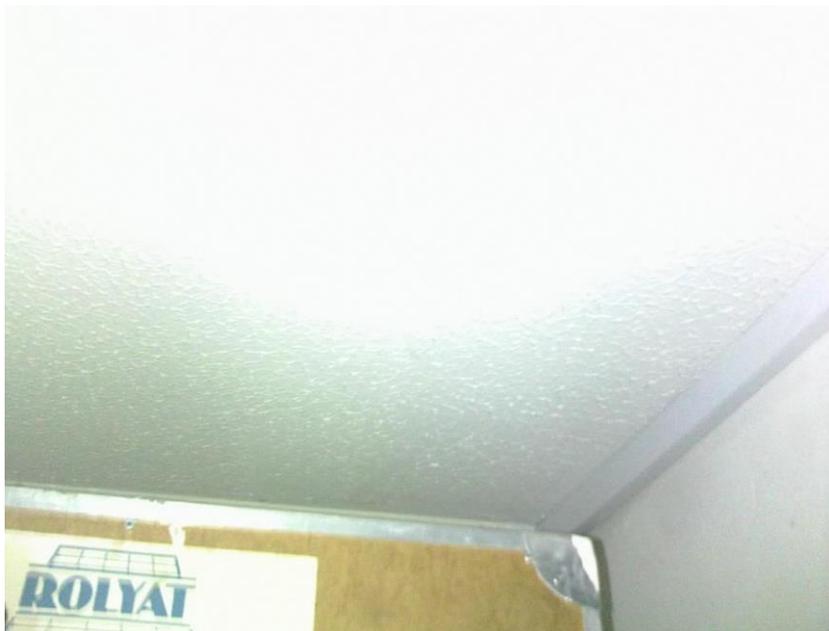
Site ID	Location ID	Building	Floor	Room / Area	Description
PF /13/ LBF642	D-50563/01B	Flat	Ground floor	Airing Cupboard	Stipple

Asbestos Type	Product Type	Amount	Extent of Damage	Surface Treatment	Action Assessment	Material Assessment
Non Asbestos	Textured Coating - Ceiling	N/A	N/A	N/A	N/A	0

**Comments:** No asbestos was detected in the sample taken from the material.

**Recommendations:** No further action is required.

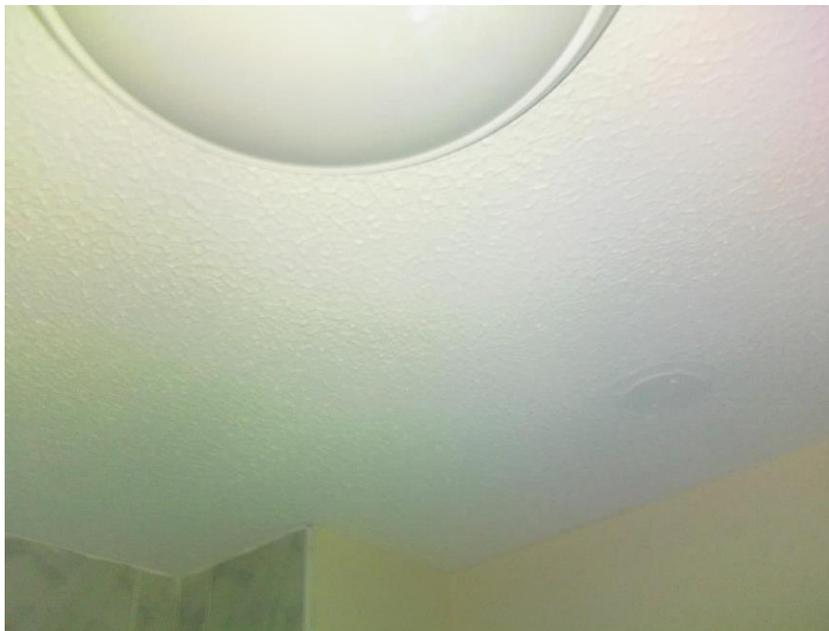
Site ID	Location ID	Building	Floor	Room / Area	Description
PF /13/ LBF642	D-50563/01C	Flat	Ground floor	Bathroom	Stipple

Asbestos Type	Product Type	Amount	Extent of Damage	Surface Treatment	Action Assessment	Material Assessment
Non Asbestos	Textured Coating - Ceiling	N/A	N/A	N/A	N/A	0

**Comments:** No asbestos was detected in the sample taken from the material.

**Recommendations:** No further action is required.

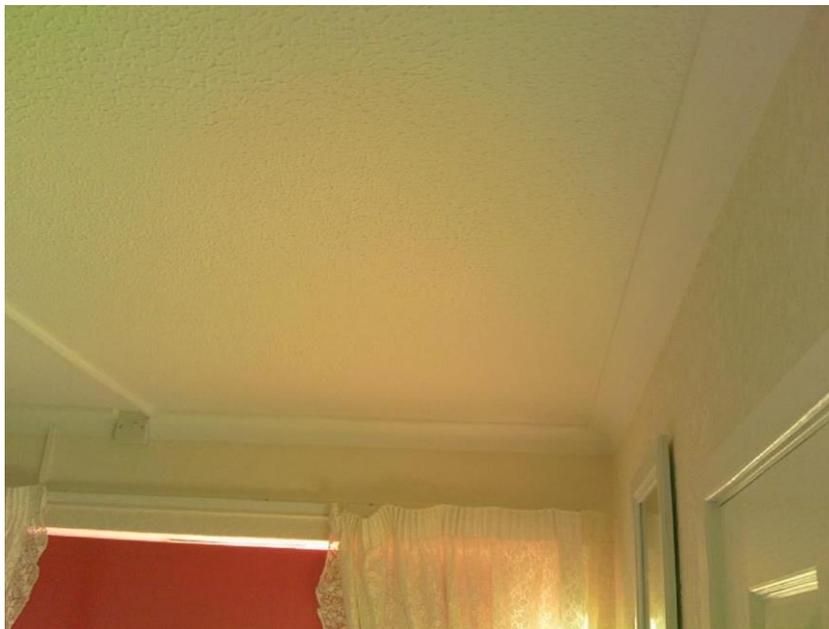
Site ID	Location ID	Building	Floor	Room / Area	Description
PF /13/ LBF642	D-50563/01D	Flat	Ground floor	Bedroom 1	Stipple

Asbestos Type	Product Type	Amount	Extent of Damage	Surface Treatment	Action Assessment	Material Assessment
Non Asbestos	Textured Coating - Ceiling	N/A	N/A	N/A	N/A	0

**Comments:** No asbestos was detected in the sample taken from the material.

**Recommendations:** No further action is required.

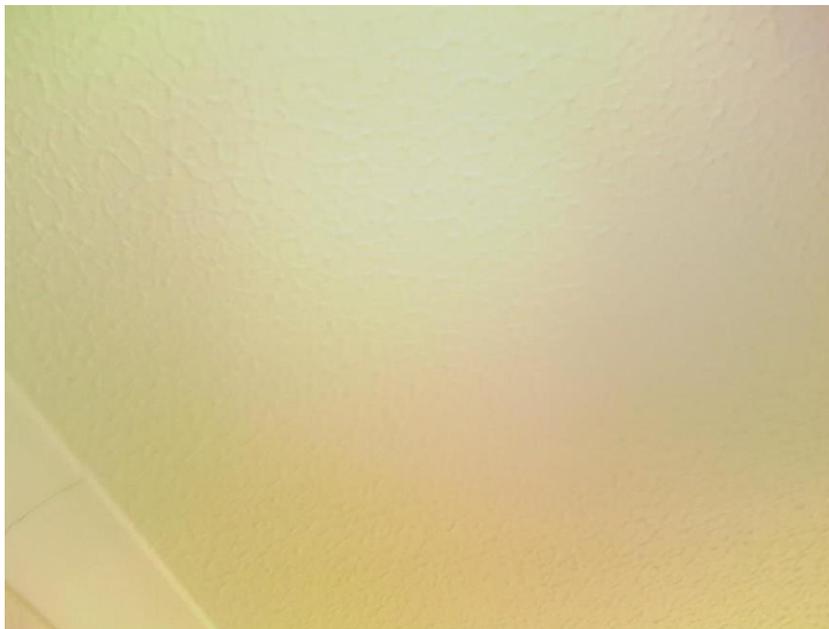
Site ID	Location ID	Building	Floor	Room / Area	Description
PF /13/ LBF642	D-50563/01E	Flat	Ground floor	Bedroom 2	Stipple

Asbestos Type	Product Type	Amount	Extent of Damage	Surface Treatment	Action Assessment	Material Assessment
Non Asbestos	Textured Coating - Ceiling	N/A	N/A	N/A	N/A	0

**Comments:** No asbestos was detected in the sample taken from the material.

**Recommendations:** No further action is required.

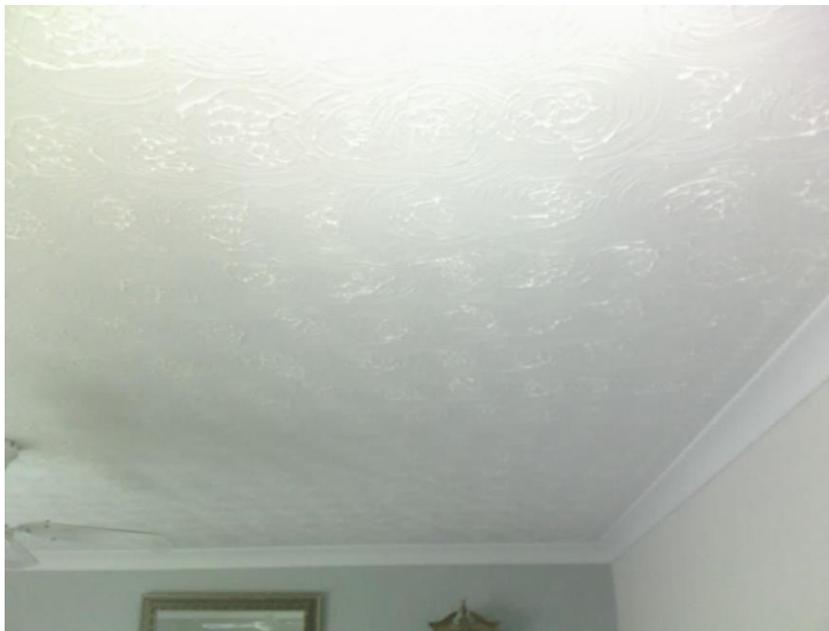
Site ID	Location ID	Building	Floor	Room / Area	Description
PF /13/ LBF642	D-50563/02	Flat	Ground floor	Lounge	Random pattern

Asbestos Type	Product Type	Amount	Extent of Damage	Surface Treatment	Action Assessment	Material Assessment
Non Asbestos	Textured Coating - Ceiling	N/A	N/A	N/A	N/A	0

**Comments:** No asbestos was detected in the sample taken from the material.

**Recommendations:** No further action is required.
