# **Asbestos Survey Report**

**Project Ref. No: M10538**

**Flat 1 Llys Bryn Felin**

**Full type 2 survey**

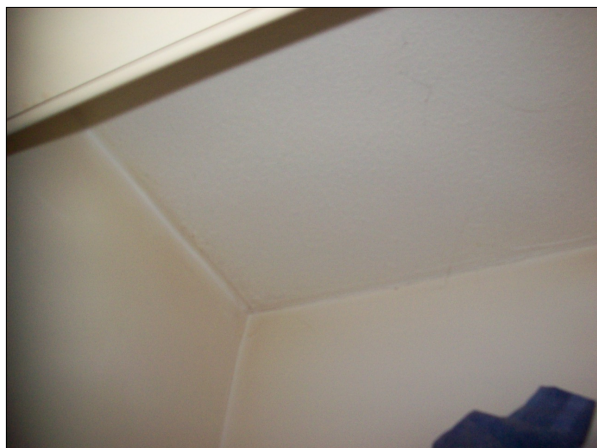
## Asbestos Sample Record - 01a

N.A.D.I.S textured coating to plasterboard ceiling.

| <b>Action required:</b> | None | | |

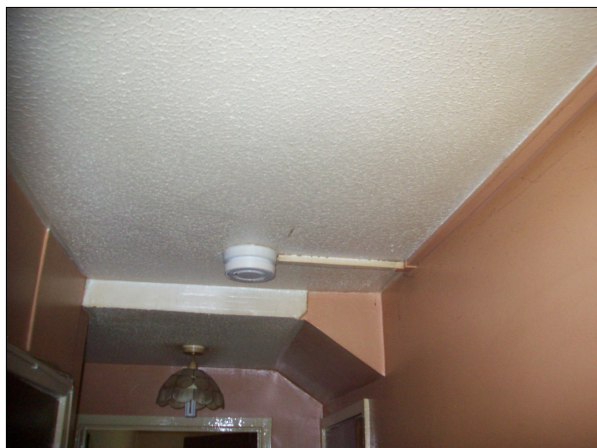
N.A.D.I.S textured coating to plasterboard ceiling.

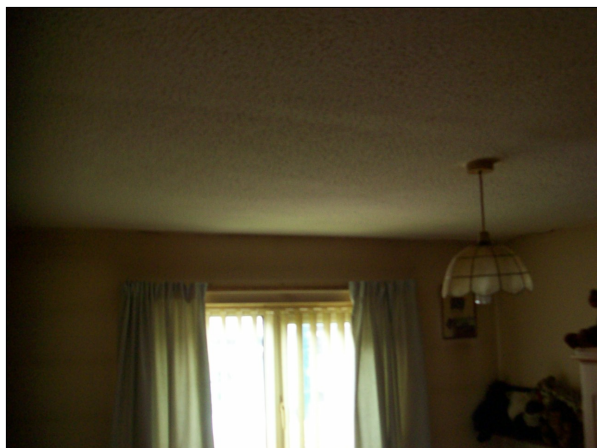
N.A.D.I.S textured coating to plasterboard ceiling.

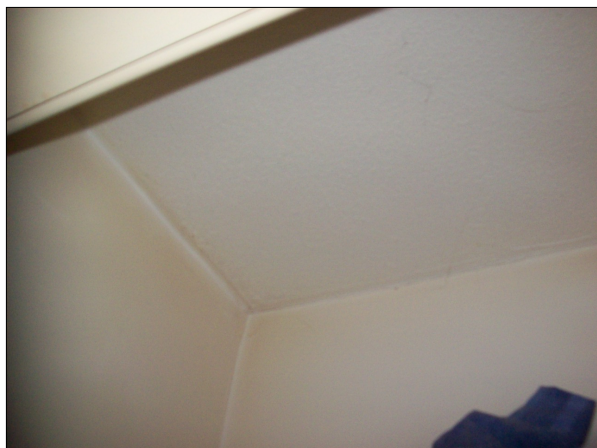
N.A.D.I.S textured coating to plasterboard ceiling.

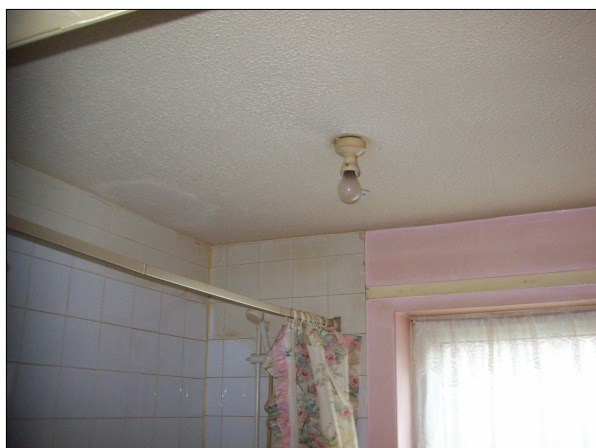
N.A.D.I.S textured coating to plasterboard ceiling.

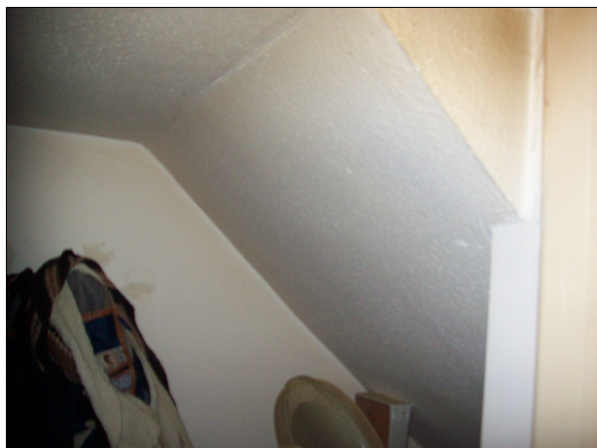
N.A.D.I.S textured coating to concrete ceiling.

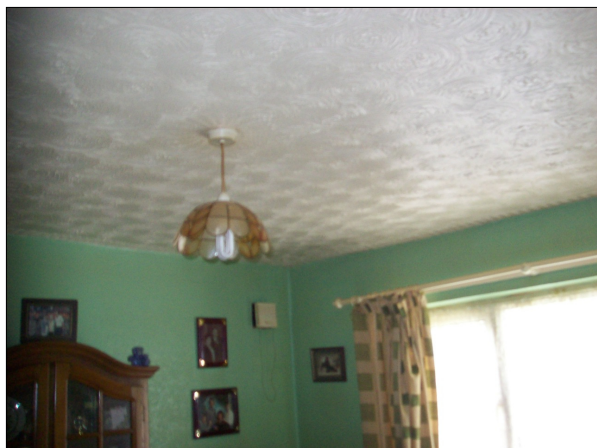
N.A.D.I.S textured coating to plasterboard ceiling.
