# **Asbestos Survey Report**

**Project Ref. No: M10538**

**Flat 9 Llys Bryn Felin**

**Full type 2 survey**

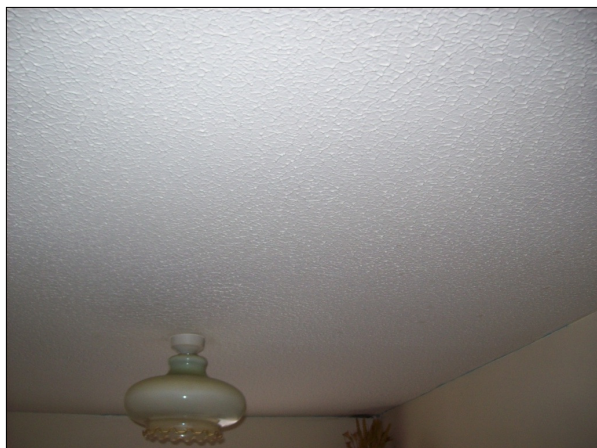
### Asbestos Sample Record - 01a

N.A.D.I.S textured coating to plasterboard ceiling.

| <b>Action required:</b> | None | | |

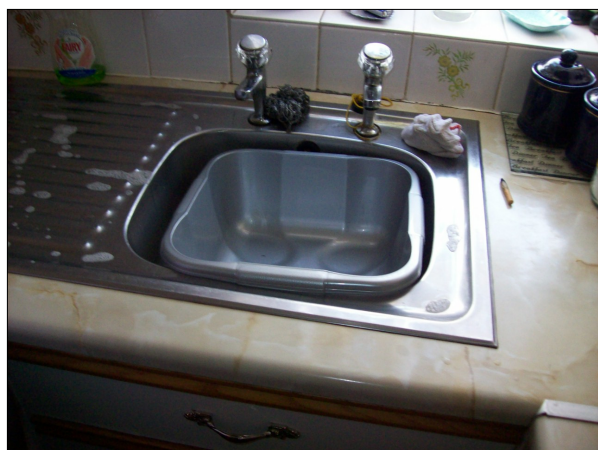
### Asbestos Sample Record - 02a

N.A.D.I.S bitumastic sink pad.

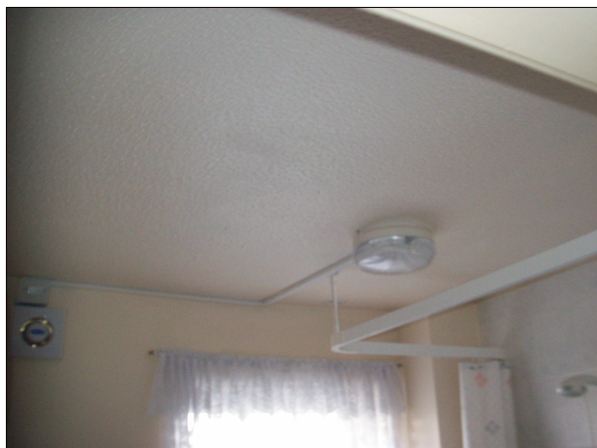
N.A.D.I.S textured coating to plasterboard ceiling.

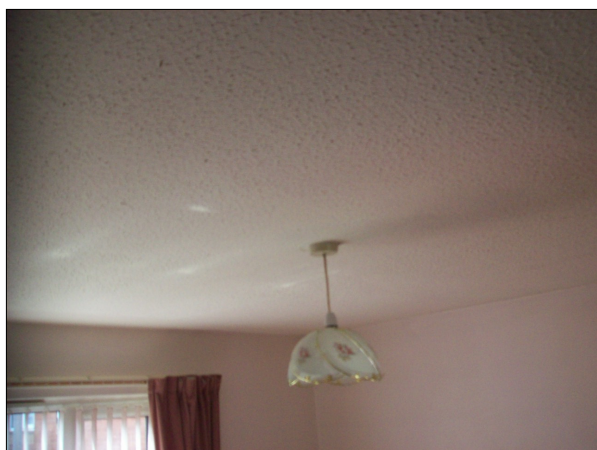
N.A.D.I.S textured coating to plasterboard ceiling.

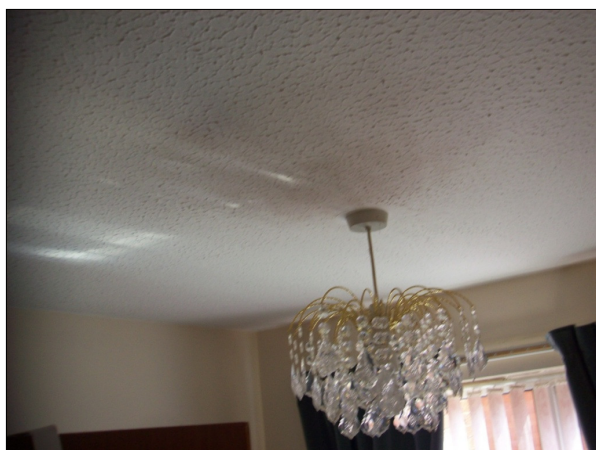
N.A.D.I.S textured coating to plasterboard ceiling.

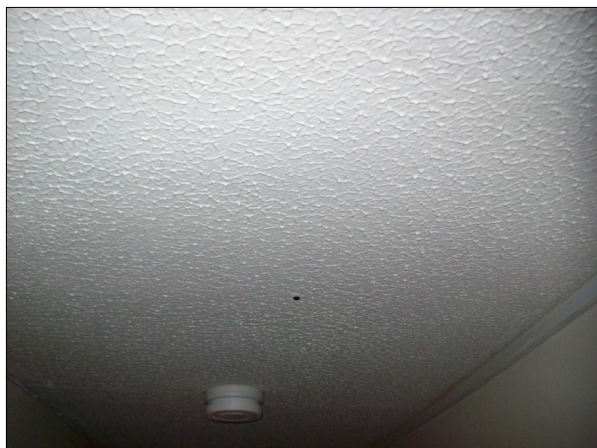
N.A.D.I.S textured coating to ceiling.

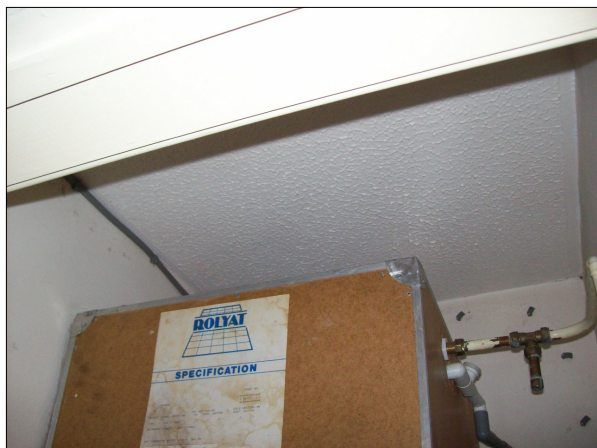
N.A.D.I.S textured coating to plasterboard ceiling.

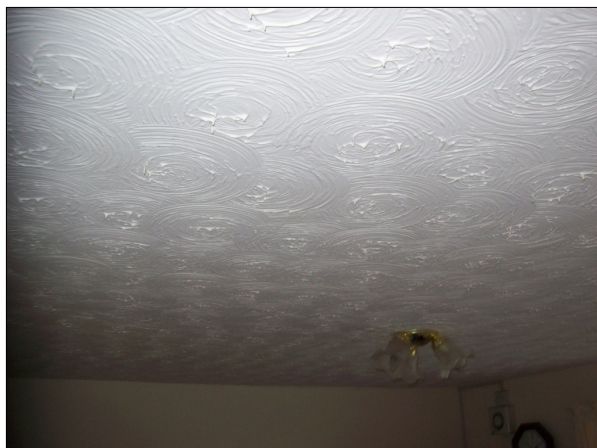
Visual inspection carried out in living room. Textured coating not sampled due to tenants occupying area. Small children & elderly people present.

| Position: | Internal | RISK: | <b>MINOR (5)</b> |

Presumed asbestos textured coating to plasterboard ceiling.

| <b>Remedial action:</b> | Investigate further | | |
| <b>Timescale:</b> | A.S.A.P. | <b>Approx. cost:</b> | N/A |
