## Management with Targeted Refurbishment Survey to Wet Room

10 Llys Glanrhondda  
High Street  
Treorchy  
Rhondda  
CF42 6NZ  
UPRN: 6060

| Type of survey: | Management Survey with part Refurbishment/Demolition (MA and PA) | | |
| Date of survey: | 10 Aug 2016 | | |

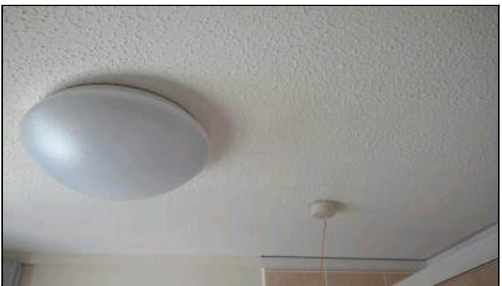
| | Survey Date: | Lead Surveyor | Survey Type | Floor | Analysis |
|---|---|---|---|---|---|
| | 10 Aug 2016 | Sebastian Lawniczak | Refurbishment and Demolition Survey | Ground | No Asbestos Detected (0) |
| | AE001710 (S) | Textured Coating (1) | Completely Sealed (0) | Good Condition (0) | Occasionally likely to be disturbed (1) |

| Normal Occupancy | Score | Likelihood of disturbance | Score | Exposure Potential | Score | Maintenance Activity | Score |
|---|---|---|---|---|---|---|---|
| Recommendation | No further action required | | | | | | |

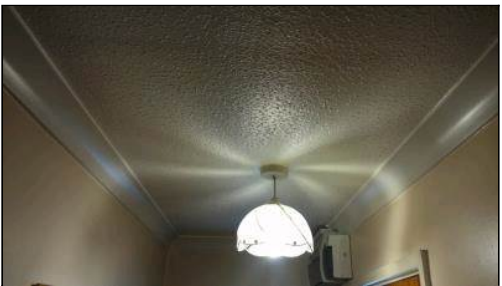
| | Survey Date: | Lead Surveyor | Survey Type | Floor | Analysis |
|---|---|---|---|---|---|
| | 10 Aug 2016 | Sebastian Lawniczak | Management Survey | Ground | No Asbestos Detected (0) |
| | As AE001710 (SP) | Textured Coating (1) | Completely Sealed (0) | Good Condition (0) | Occasionally likely to be disturbed (1) |

| Normal Occupancy | Score | Likelihood of disturbance | Score | Exposure Potential | Score | Maintenance Activity | Score |
|---|---|---|---|---|---|---|---|
| Recommendation | No further action required | | | | | | |

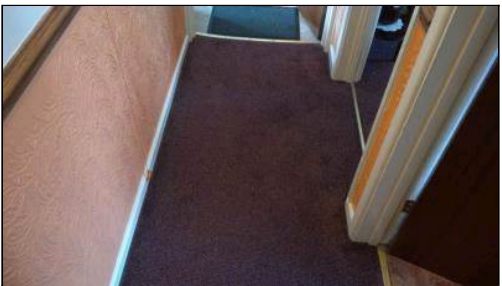
| | Survey Date: | Lead Surveyor | Survey Type | Floor | Analysis |
|---|---|---|---|---|---|
| | 10 Aug 2016 | Sebastian Lawniczak | Management Survey | Ground | No Asbestos Detected (0) |
| | AE001711 (S) | Reinforced Composite (1) | Completely Sealed (0) | Good Condition (0) | Usually inaccessible or unlikely to be disturbed (0) |

| Normal Occupancy | Score | Likelihood of disturbance | Score | Exposure Potential | Score | Maintenance Activity | Score |
|---|---|---|---|---|---|---|---|
| Recommendation | No further action required | | | | | | |

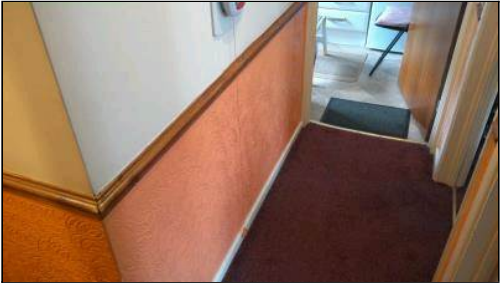
| | Survey Date: | Lead Surveyor | Survey Type | Floor | Analysis |
|---|---|---|---|---|---|
| | 10 Aug 2016 | Sebastian Lawniczak | Management Survey | Ground | No Asbestos Detected (0) |
| | AE001712 (S) | Textured Coating (1) | Completely Sealed (0) | Good Condition (0) | Easily disturbed (2) |

| Normal Occupancy | Score | Likelihood of disturbance | Score | Exposure Potential | Score | Maintenance Activity | Score |
|---|---|---|---|---|---|---|---|
| Recommendation | No further action required | | | | | | |

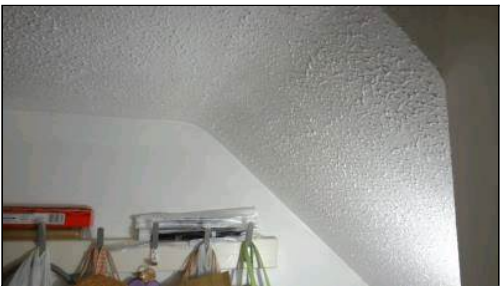
| | 10 Aug 2016 | Sebastian Lawniczak | Management Survey | Ground | No Asbestos Detected (0) |
| | As AE001710 (SP) | Textured Coating (1) | Completely Sealed (0) | Good Condition (0) | Occasionally likely to be disturbed (1) |

| Recommendation | No further action required | | | | | | |

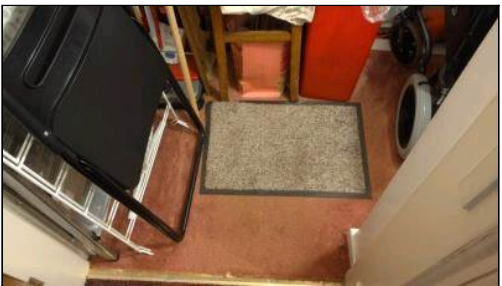
| | 10 Aug 2016 | Sebastian Lawniczak | Management Survey | Ground | No Asbestos Detected (0) |
| | As AE001711 (SP) | Reinforced Composite (1) | Completely Sealed (0) | Good Condition (0) | Usually inaccessible or unlikely to be disturbed (0) |

| Recommendation | No further action required | | | | | | |

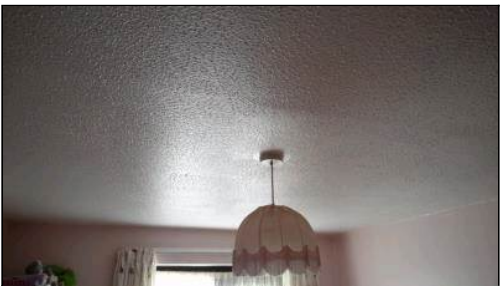
| | 10 Aug 2016 | Sebastian Lawniczak | Management Survey | Ground | No Asbestos Detected (0) |
| | As AE001710 (SP) | Textured Coating (1) | Completely Sealed (0) | Good Condition (0) | Occasionally likely to be disturbed (1) |

| Recommendation | No further action required | | | | | | |

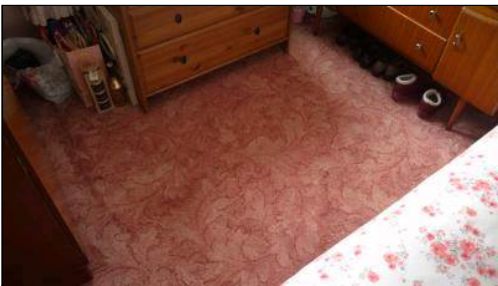
| | Survey Date: | Lead Surveyor | Survey Type | Floor | Analysis |
|---|---|---|---|---|---|
| | 10 Aug 2016 | Sebastian Lawniczak | Management Survey | Ground | No Asbestos Detected (0) |
| | As AE001711 (SP) | Reinforced Composite (1) | Completely Sealed (0) | Good Condition (0) | Usually inaccessible or unlikely to be disturbed (0) |

| Normal Occupancy | Score | Likelihood of disturbance | Score | Exposure Potential | Score | Maintenance Activity | Score |
|---|---|---|---|---|---|---|---|
| Recommendation | No further action required | | | | | | |

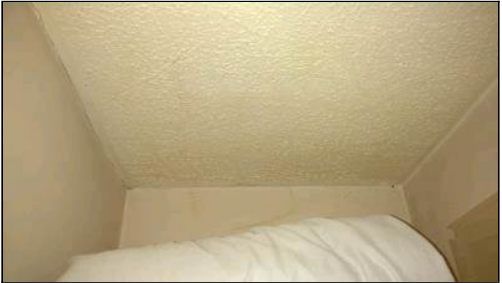
| | 10 Aug 2016 | Sebastian Lawniczak | Management Survey | Ground | No Asbestos Detected (0) |
| | As AE001710 (SP) | Textured Coating (1) | Completely Sealed (0) | Good Condition (0) | Occasionally likely to be disturbed (1) |

| Recommendation | No further action required | | | | | | |

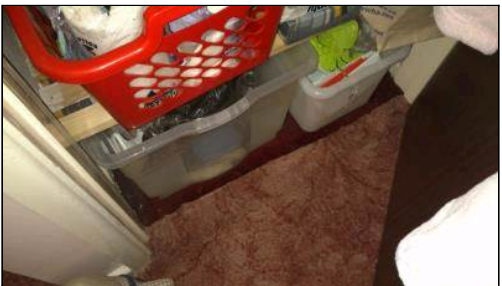
| | 10 Aug 2016 | Sebastian Lawniczak | Management Survey | Ground | No Asbestos Detected (0) |
| | As AE001711 (SP) | Reinforced Composite (1) | Completely Sealed (0) | Good Condition (0) | Usually inaccessible or unlikely to be disturbed (0) |

| Recommendation | No further action required | | | | | | |

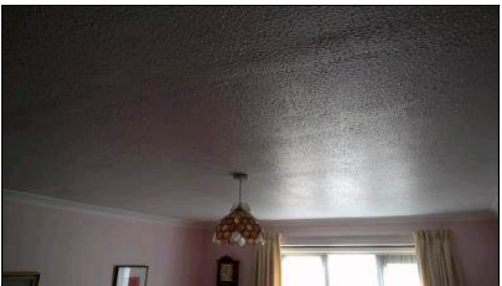
| | Survey Date: | Lead Surveyor | Survey Type | Floor | Analysis |
|---|---|---|---|---|---|
| | 10 Aug 2016 | Sebastian Lawniczak | Management Survey | Ground | No Asbestos Detected (0) |
| | As AE001710 (SP) | Textured Coating (1) | Completely Sealed (0) | Good Condition (0) | Occasionally likely to be disturbed (1) |

| Normal Occupancy | Score | Likelihood of disturbance | Score | Exposure Potential | Score | Maintenance Activity | Score |
|---|---|---|---|---|---|---|---|
| Recommendation | No further action required | | | | | | |

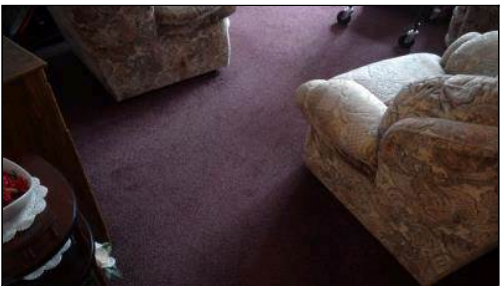
| | Survey Date: | Lead Surveyor | Survey Type | Floor | Analysis |
|---|---|---|---|---|---|
| | 10 Aug 2016 | Sebastian Lawniczak | Management Survey | Ground | No Asbestos Detected (0) |
| | As AE001711 (SP) | Reinforced Composite (1) | Completely Sealed (0) | Good Condition (0) | Usually inaccessible or unlikely to be disturbed (0) |

| Normal Occupancy | Score | Likelihood of disturbance | Score | Exposure Potential | Score | Maintenance Activity | Score |
|---|---|---|---|---|---|---|---|
| Recommendation | No further action required | | | | | | |

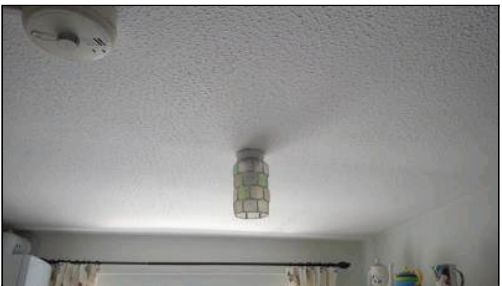
| | 10 Aug 2016 | Sebastian Lawniczak | Management Survey | Ground | No Asbestos Detected (0) |
| | AE001713 (S) | Textured Coating (1) | Completely Sealed (0) | Good Condition (0) | Occasionally likely to be disturbed (1) |

| Recommendation | No further action required | | | | | | |
