- 1.1. Following discussions with Mr Les Adams of Pectel (Wales) Limited, Unit 6, Stadium Close, Cardiff, CF11 8TS, Manestream Ltd, Unit 7 Olympic Business Centre, Paycocke Road, Basildon, Essex, SS14 3EX were requested to undertake a Type II inspection of asbestos containing materials in:

**No 11
Llys Glanrhondda
High Street
Treorchy
CF42 6NY**

- 1.5. Accreditation Details – see APPENDIX 4.
- 1.6. This survey was carried out by Byron Phillips on 11th July 2005 in accordance with Guidance Note **MDHS 100** *Surveying, sampling and assessment of asbestos-containing materials*

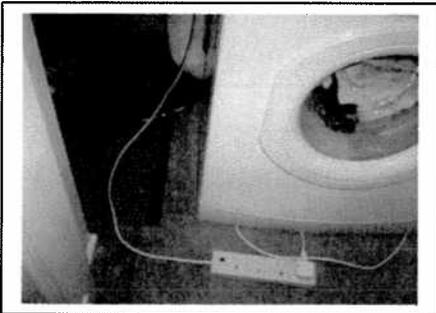
Sample No. 50711BP010
Location G002
Description Beige Floor tile

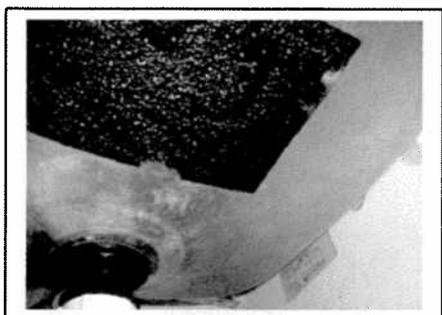
Sample No. 50711BP012
Location G004
Description Sink pad

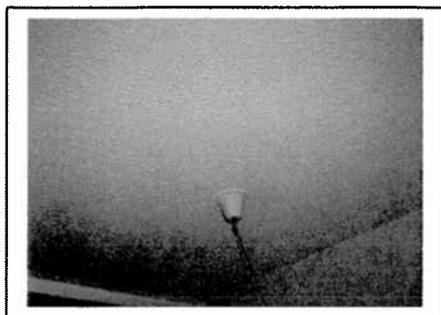
Sample No. 50711BP014
Location G007
Description Textured Coating To Ceiling

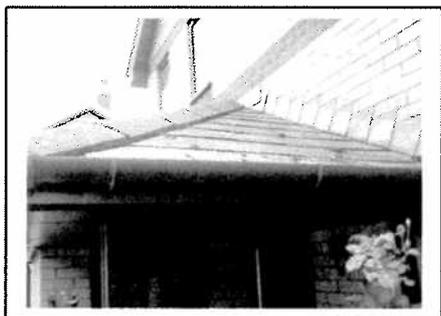
Sample No. 50711BP015
Location External
Description Cement tile
