**WALES & WEST HOUSING  
ASSOCIATION  
3 ALEXANDRA GATE  
FFORDD PENGAM  
TREMORFA  
CARDIFF  
CF24 2UD**

**PROJECT NO: J096753**

**DATE: JUNE 2013**

**ASBESTOS MANAGEMENT SURVEY WITH REFURBISHMENT SURVEY TO  
SPECIFIED AREAS OF  
2 LLYS GLANRHONDDA, HIGH STREET, TREORCHY, RHONDDA, CF42 6NZ**

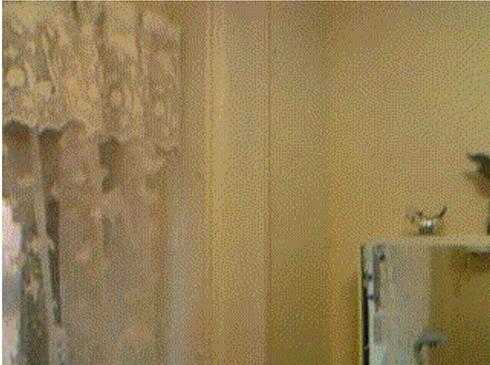
<b>FLOOR/LOCATION:</b>	Ground Floor Bathroom (007)

<b>DESCRIPTION:</b>	Presumed asbestos cement soil pipe within fixed timber riser boxing - unable to inspect the area due to tenant refusal	
<b>RECOMMENDATIONS:</b>	Conduct further investigation prior to relevant maintenance / refurbishment works	
<b>EXTENT:</b>	<10m <sup>2</sup> or <10m pipe run	
<b>SAMPLE REF:</b>	Presumed	
<b>RESULT:</b>	Presumed Crocidolite (or unknown)
