## Management with Targeted Refurbishment Survey to Shower Room

4 Llys Glanrhondda  
High Street  
Treorchy  
Rhondda  
CF42 6NZ  
UPRN: 6054

| Type of survey: | Management Survey with part Refurbishment/Demolition (MA and PA) | | |
| Date of survey: | 10 Aug 2016 | | |

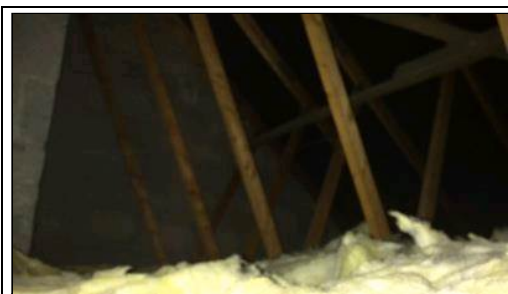
| Survey Date: | Lead Surveyor | Survey Type | Floor | Analysis |
|---|---|---|---|---|
| 10 Aug 2016 | Sebastian Lawniczak | Management Survey | Roof | N/A |

| Normal Occupancy | Score | Likelihood of disturbance | Score | Exposure Potential | Score | Maintenance Activity | Score |
|---|---|---|---|---|---|---|---|
| Recommendation | No further action required | | | | | | |

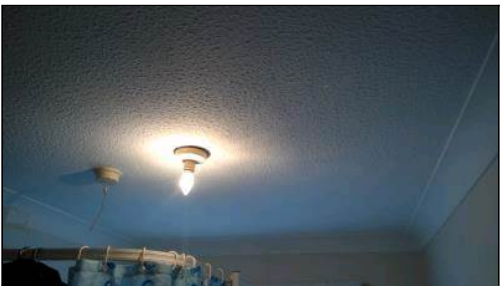
| | Survey Date: | Lead Surveyor | Survey Type | Floor | Analysis |
|---|---|---|---|---|---|
| | 10 Aug 2016 | Sebastian Lawniczak | Refurbishment and Demolition Survey | 1st | No Asbestos Detected (0) |
| | AE001702 (S) | Textured Coating (1) | Completely Sealed (0) | Good Condition (0) | Occasionally likely to be disturbed (1) |

| Normal Occupancy | Score | Likelihood of disturbance | Score | Exposure Potential | Score | Maintenance Activity | Score |
|---|---|---|---|---|---|---|---|
| Recommendation | No further action required | | | | | | |

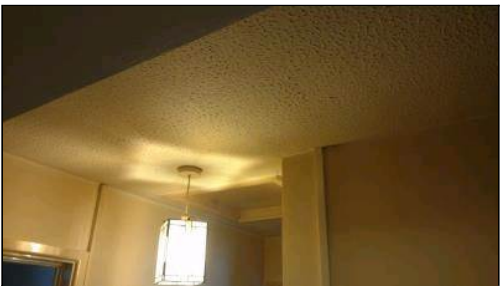
| | 10 Aug 2016 | Sebastian Lawniczak | Management Survey | 1st | No Asbestos Detected (0) |
| | As AE001702 (SP) | Textured Coating (1) | Completely Sealed (0) | Good Condition (0) | Occasionally likely to be disturbed (1) |

| Recommendation | No further action required | | | | | | |

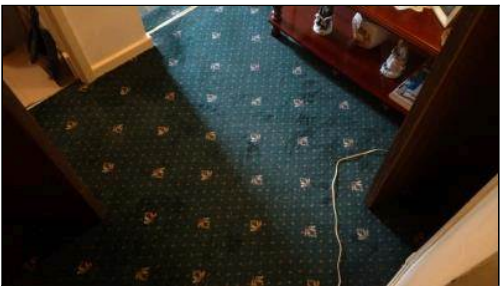
| | Survey Date: | Lead Surveyor | Survey Type | Floor | Analysis |
|---|---|---|---|---|---|
| | 10 Aug 2016 | Sebastian Lawniczak | Management Survey | 1st | No Asbestos Detected (0) |
| | AE001703 (S) | Reinforced Composite (1) | Completely Sealed (0) | Good Condition (0) | Usually inaccessible or unlikely to be disturbed (0) |

| Normal Occupancy | Score | Likelihood of disturbance | Score | Exposure Potential | Score | Maintenance Activity | Score |
|---|---|---|---|---|---|---|---|
| Recommendation | No further action required | | | | | | |

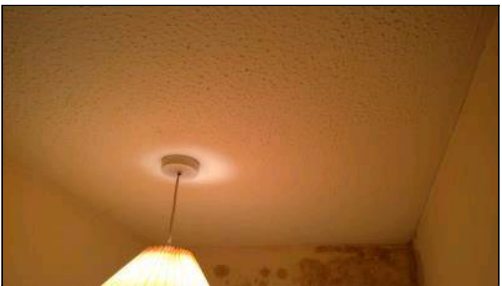
| | 10 Aug 2016 | Sebastian Lawniczak | Management Survey | 1st | No Asbestos Detected (0) |
| | As AE001702 (SP) | Textured Coating (1) | Completely Sealed (0) | Good Condition (0) | Occasionally likely to be disturbed (1) |

| Recommendation | No further action required | | | | | | |

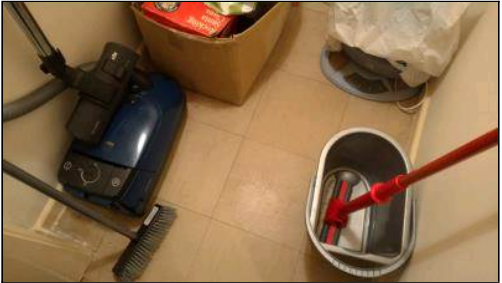
| | Survey Date: | Lead Surveyor | Survey Type | Floor | Analysis |
|---|---|---|---|---|---|
| | 10 Aug 2016 | Sebastian Lawniczak | Management Survey | 1st | No Asbestos Detected (0) |
| | As AE001703 (SP) | Reinforced Composite (1) | Completely Sealed (0) | Good Condition (0) | Routinely disturbed (3) |

| Normal Occupancy | Score | Likelihood of disturbance | Score | Exposure Potential | Score | Maintenance Activity | Score |
|---|---|---|---|---|---|---|---|
| Recommendation | No further action required | | | | | | |

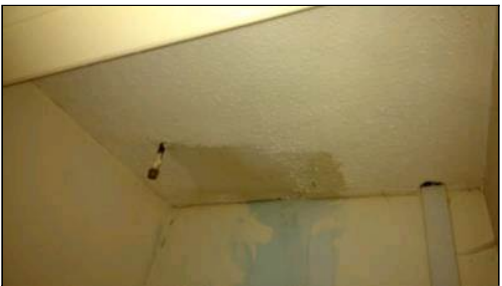
| | 10 Aug 2016 | Sebastian Lawniczak | Management Survey | 1st | No Asbestos Detected (0) |
| | As AE001702 (SP) | Textured Coating (1) | Completely Sealed (0) | Good Condition (0) | Occasionally likely to be disturbed (1) |

| Recommendation | No further action required | | | | | | |

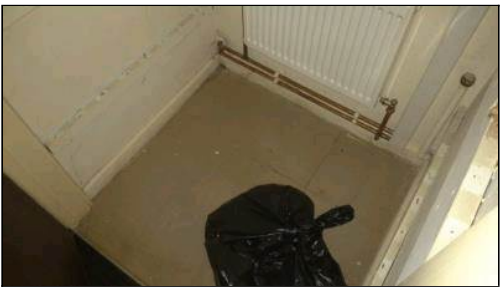
| | Survey Date: | Lead Surveyor | Survey Type | Floor | Analysis |
|---|---|---|---|---|---|
| | 10 Aug 2016 | Sebastian Lawniczak | Management Survey | 1st | No Asbestos Detected (0) |
| | As AE001703 (SP) | Reinforced Composite (1) | Completely Sealed (0) | Good Condition (0) | Routinely disturbed (3) |

| Normal Occupancy | Score | Likelihood of disturbance | Score | Exposure Potential | Score | Maintenance Activity | Score |
|---|---|---|---|---|---|---|---|
| Recommendation | No further action required | | | | | | |

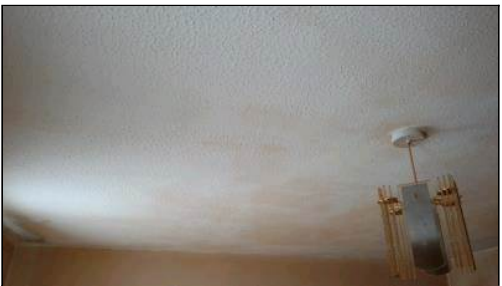
| | Survey Date: | Lead Surveyor | Survey Type | Floor | Analysis |
|---|---|---|---|---|---|
| | 10 Aug 2016 | Sebastian Lawniczak | Management Survey | 1st | No Asbestos Detected (0) |
| | As AE001702 (SP) | Textured Coating (1) | Completely Sealed (0) | Low Damage (1) | Occasionally likely to be disturbed (1) |

| Normal Occupancy | Score | Likelihood of disturbance | Score | Exposure Potential | Score | Maintenance Activity | Score |
|---|---|---|---|---|---|---|---|
| Recommendation | No further action required | | | | | | |

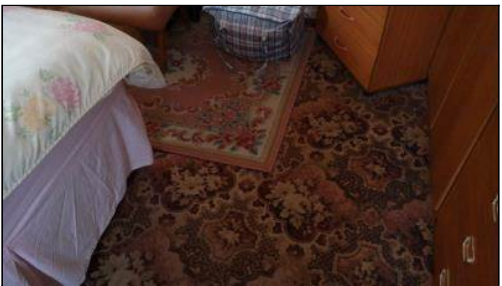
| | Survey Date: | Lead Surveyor | Survey Type | Floor | Analysis |
|---|---|---|---|---|---|
| | 10 Aug 2016 | Sebastian Lawniczak | Management Survey | 1st | No Asbestos Detected (0) |
| | As AE001703 (SP) | Reinforced Composite (1) | Completely Sealed (0) | Good Condition (0) | Usually inaccessible or unlikely to be disturbed (0) |

| Normal Occupancy | Score | Likelihood of disturbance | Score | Exposure Potential | Score | Maintenance Activity | Score |
|---|---|---|---|---|---|---|---|
| Recommendation | No further action required | | | | | | |

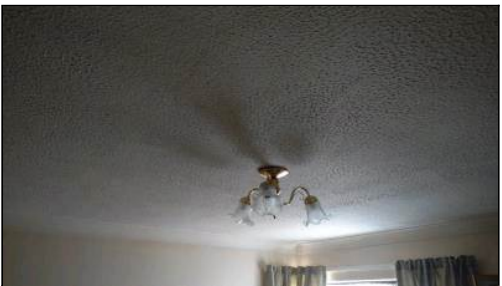
| | 10 Aug 2016 | Sebastian Lawniczak | Management Survey | 1st | No Asbestos Detected (0) |
| | As AE001702 (SP) | Textured Coating (1) | Completely Sealed (0) | Good Condition (0) | Occasionally likely to be disturbed (1) |

| Recommendation | No further action required | | | | | | |

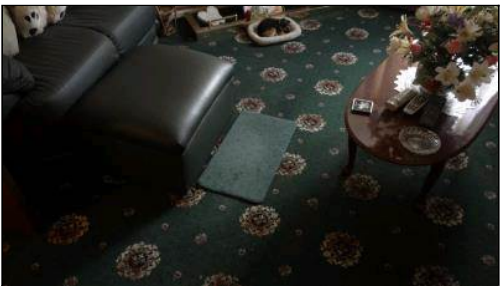
| | Survey Date: | Lead Surveyor | Survey Type | Floor | Analysis |
|---|---|---|---|---|---|
| | 10 Aug 2016 | Sebastian Lawniczak | Management Survey | 1st | No Asbestos Detected (0) |
| | As AE001703 (SP) | Reinforced Composite (1) | Completely Sealed (0) | Good Condition (0) | Usually inaccessible or unlikely to be disturbed (0) |

| Normal Occupancy | Score | Likelihood of disturbance | Score | Exposure Potential | Score | Maintenance Activity | Score |
|---|---|---|---|---|---|---|---|
| Recommendation | No further action required | | | | | | |

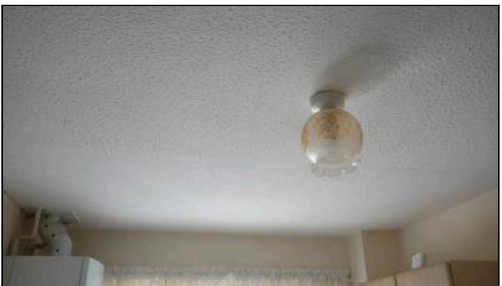
| | Survey Date: | Lead Surveyor | Survey Type | Floor | Analysis |
|---|---|---|---|---|---|
| | 10 Aug 2016 | Sebastian Lawniczak | Management Survey | 1st | No Asbestos Detected (0) |
| | AE001704 (S) | Textured Coating (1) | Completely Sealed (0) | Good Condition (0) | Occasionally likely to be disturbed (1) |

| Normal Occupancy | Score | Likelihood of disturbance | Score | Exposure Potential | Score | Maintenance Activity | Score |
|---|---|---|---|---|---|---|---|
| Recommendation | No further action required | | | | | | |

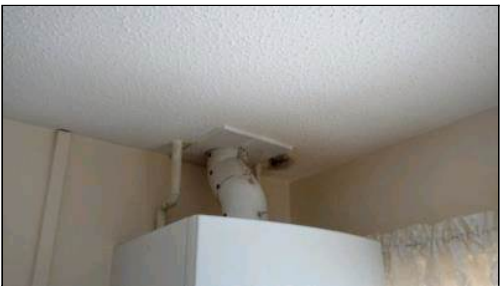
| | Survey Date: | Lead Surveyor | Survey Type | Floor | Analysis |
|---|---|---|---|---|---|
| | 10 Aug 2016 | Sebastian Lawniczak | Management Survey | 1st | No Asbestos Detected (0) |
| | AE001705 (S) | Asbestos Insulating Board (2) | Unsealed (2) | Low Damage (1) | Usually inaccessible or unlikely to be disturbed (0) |

| Normal Occupancy | Score | Likelihood of disturbance | Score | Exposure Potential | Score | Maintenance Activity | Score |
|---|---|---|---|---|---|---|---|
| Recommendation | No further action required | | | | | | |

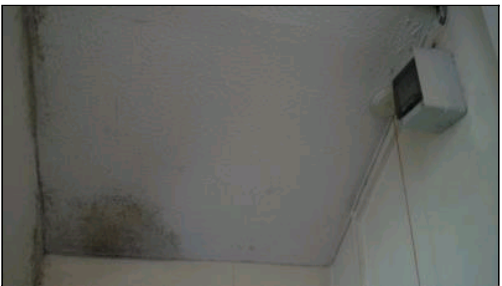
| | Survey Date: | Lead Surveyor | Survey Type | Floor | Analysis |
|---|---|---|---|---|---|
| | 10 Aug 2016 | Sebastian Lawniczak | Management Survey | Ground | No Asbestos Detected (0) |
| | As AE001704 (SP) | Textured Coating (1) | Completely Sealed (0) | Low Damage (1) | Occasionally likely to be disturbed (1) |

| Normal Occupancy | Score | Likelihood of disturbance | Score | Exposure Potential | Score | Maintenance Activity | Score |
|---|---|---|---|---|---|---|---|
| Recommendation | No further action required | | | | | | |

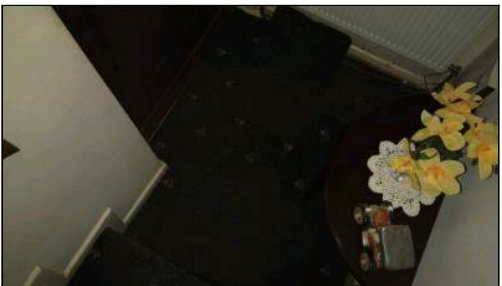
| | Survey Date: | Lead Surveyor | Survey Type | Floor | Analysis |
|---|---|---|---|---|---|
| | 10 Aug 2016 | Sebastian Lawniczak | Management Survey | Ground | No Asbestos Detected (0) |
| | As AE001703 (SP) | Reinforced Composite (1) | Completely Sealed (0) | Good Condition (0) | Usually inaccessible or unlikely to be disturbed (0) |

| Normal Occupancy | Score | Likelihood of disturbance | Score | Exposure Potential | Score | Maintenance Activity | Score |
|---|---|---|---|---|---|---|---|
| Recommendation | No further action required | | | | | | |
