## Management with Targeted Refurbishment Survey to Bathroom

9 Llys Glanrhondda  
High Street  
Treorchy  
Rhondda  
CF42 6NZ  
UPRN: 6059

| Type of survey: | Management Survey with part Refurbishment/Demolition (MA and PA) | | |
| Date of survey: | 10 Aug 2016 | | |

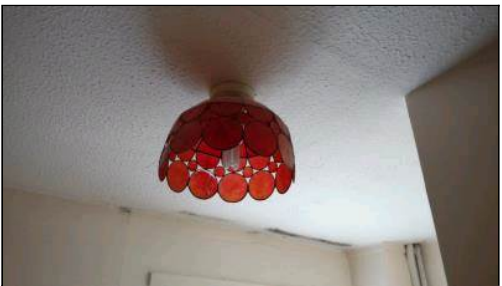
| | 10 Aug 2016 | Sebastian Lawniczak | Refurbishment and Demolition Survey | 1st | No Asbestos Detected (0) |
| | AE001706 (S) | Textured Coating (1) | Completely Sealed (0) | Low Damage (1) | Occasionally likely to be disturbed (1) |

| Recommendation | No further action required | | | | | | |

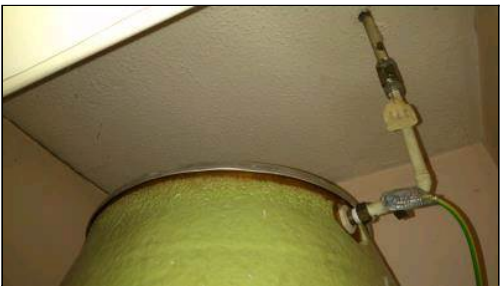
| | Survey Date: | Lead Surveyor | Survey Type | Floor | Analysis |
|---|---|---|---|---|---|
| | 10 Aug 2016 | Sebastian Lawniczak | Management Survey | 1st | No Asbestos Detected (0) |
| | As AE001706 (SP) | Textured Coating (1) | Completely Sealed (0) | Low Damage (1) | Occasionally likely to be disturbed (1) |

| Normal Occupancy | Score | Likelihood of disturbance | Score | Exposure Potential | Score | Maintenance Activity | Score |
|---|---|---|---|---|---|---|---|
| Recommendation | No further action required | | | | | | |

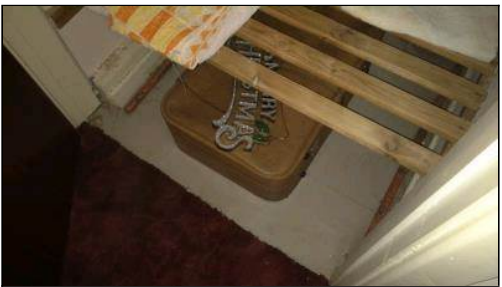
| | Survey Date: | Lead Surveyor | Survey Type | Floor | Analysis |
|---|---|---|---|---|---|
| | 10 Aug 2016 | Sebastian Lawniczak | Management Survey | 1st | No Asbestos Detected (0) |
| | As AE001707 (SP) | Reinforced Composite (1) | Completely Sealed (0) | Good Condition (0) | Routinely disturbed (3) |

| Normal Occupancy | Score | Likelihood of disturbance | Score | Exposure Potential | Score | Maintenance Activity | Score |
|---|---|---|---|---|---|---|---|
| Recommendation | No further action required | | | | | | |

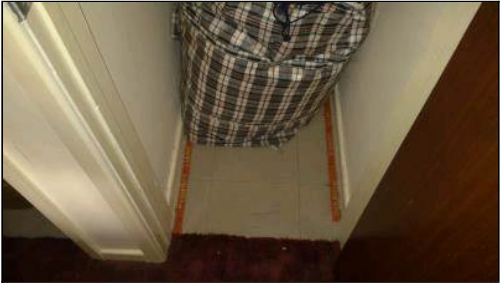
| | 10 Aug 2016 | Sebastian Lawniczak | Management Survey | 1st | No Asbestos Detected (0) |
| | As AE001707 (SP) | Reinforced Composite (1) | Completely Sealed (0) | Good Condition (0) | Routinely disturbed (3) |

| Recommendation | No further action required | | | | | | |

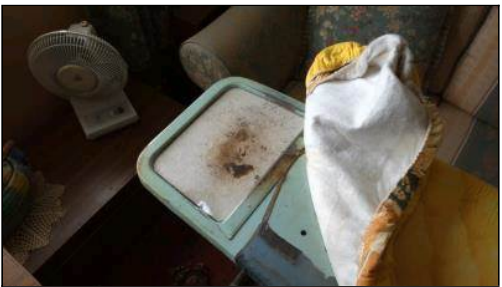
| Building | Floor | Room | Description | Material | Risk assessment Score | Recommendations |
|---|---|---|---|---|---|---|
| Block 1-16. Flat 9. | 1st | Living Room 107 | Cement panel to ironing board | Asbestos Cement | VERY LOW (4 / 9) | Manage and re-inspect |

| Building | Floor | Location /Room | S,P,SP,AS<br>Sample<br>No | Product Type | Condition | Surface<br>Treatment | Asbestos Type | Quantity | Accessibility | Material<br>Score | Priority<br>Score | Total PA<br>risk<br>assessment<br>score | Recommendation |
|---|---|---|---|---|---|---|---|---|---|---|---|---|---|
| Block 1-16.<br>Flat 9. | 1st | Living Room 107, Cement panel<br>to ironing board | S<br>AE001708 | Asbestos<br>Cement | Low<br>Damage | Surface Sealed | Chrysotile | <1m <sup>2</sup> | Easily disturbed | 4 | 5 | 9 | Manage and re-<br>inspect |

| | Survey Date: | Lead Surveyor | Survey Type | Floor | Analysis |
|---|---|---|---|---|---|
| | 10 Aug 2016 | Sebastian Lawniczak | Management Survey | 1st | Chrysotile (1) |
| | AE001708 (S) | Asbestos Cement (1) | Surface Sealed (1) | Low Damage (1) | Easily disturbed (2) |

| Normal Occupancy | Score | Likelihood of disturbance | Score | Exposure Potential | Score | Maintenance Activity | Score |
|---|---|---|---|---|---|---|---|
| Recommendation | Manage and re-inspect | | | | | | |
