Date: August, 2005  
Report Ref: R9925.113.5.08.001 AN

Pectel (Wales) Limited  
Llys Hebron  
Pentre  
CF41 7AD

## TYPE II ASBESTOS SURVEY

**Communal Areas**  
**Liys Hebron**  
**Pentre**  
**CF41 7AD**

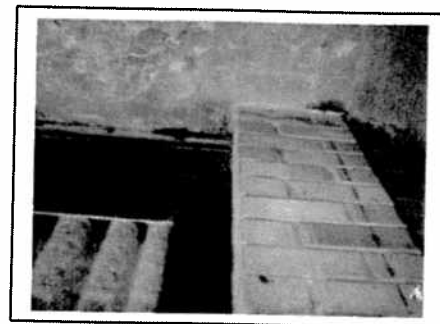
| Sample Number | Sample Description | Content |
|---|---|---|
| 50725CB014 | External, Within walls, damp proof course | No Asbestos<br>Detected |

| Sample No. | 50725CB014 |
| Location | External |
