Management with Targeted Refurbishment Survey to Bathroom

1 Llys Hebron
Pentre
Rhondda
CF41 7AD
UPRN: 6431

1 Llys Hebron
Pentre
Rhondda
CF41 7AD

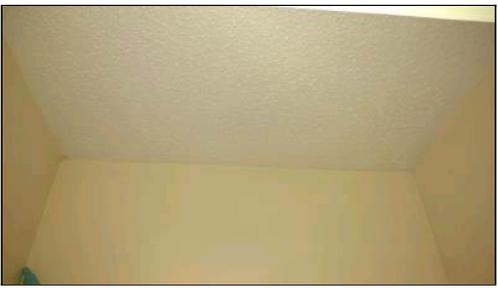
Survey Date:	Lead Surveyor	Survey Type	Floor	Analysis
	27 Jul 2016	Sebastian Lawniczak	Management Survey	Z-Sub	No Asbestos Detected (0)
	Building	Room	Item	Quantity	
	Block 1-7. Flat 1.	Store Cupboard Z102	Textured coating to fixed plasterboard ceiling	1m ²	
	Sample No (S,SP,P,As)	Product Type	Surface Treatment	Condition	Accessibility
As AE001629 (SP)	Textured Coating (1)	Completely Sealed (0)	Good Condition (0)	Occasionally likely to be disturbed (1)

Normal Occupancy	Score	Likelihood of disturbance	Score	Exposure Potential	Score	Maintenance Activity	Score
Main type of activity	N/A	Location	N/A	Number of occupants	N/A	Type of Maintenance	N/A
		Accessibility	N/A	Frequency of use	N/A	Frequency of maintenance	N/A
		Amount	N/A	Average Time	N/A		
Average Score	N/A	Average Score	N/A	Average Score	N/A	Average Score	N/A
Average of Priority	N/A						
Material Assessment Score	N/A						
Recommendation	No further action required						
Surveyor comments	N/A

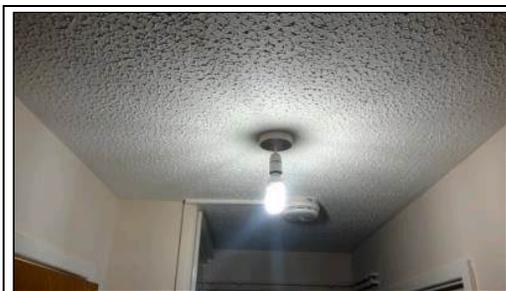
Survey Date:	Lead Surveyor	Survey Type	Floor	Analysis
27 Jul 2016	Sebastian Lawniczak	Management Survey	Z-Sub	No Asbestos Detected (0)
Building	Room	Item	Quantity	
Block 1-7. Flat 1.	Hallway Z103	Textured coating to fixed plasterboard ceiling	3m ²	
Sample No (S,SP,P,As)	Product Type	Surface Treatment	Condition	Accessibility
As AE001629 (SP)	Textured Coating (1)	Completely Sealed (0)	Good Condition (0)	Occasionally likely to be disturbed (1)

Normal Occupancy	Score	Likelihood of disturbance	Score	Exposure Potential	Score	Maintenance Activity	Score
Main type of activity	N/A	Location	N/A	Number of occupants	N/A	Type of Maintenance	N/A
		Accessibility	N/A	Frequency of use	N/A	Frequency of maintenance	N/A
		Amount	N/A	Average Time	N/A		
Average Score	N/A	Average Score	N/A	Average Score	N/A	Average Score	N/A
Average of Priority	N/A						
Material Assessment Score	N/A						
Recommendation	No further action required						
Surveyor comments	N/A

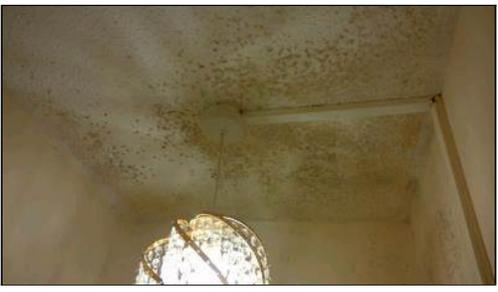
Survey Date:	Lead Surveyor	Survey Type	Floor	Analysis
	27 Jul 2016	Sebastian Lawniczak	Management Survey	Z-Sub	No Asbestos Detected (0)
	Building	Room	Item	Quantity	
	Block 1-7. Flat 1.	Entrance Hall Z104	Textured coating to concrete ceiling	1m ²	
	Sample No (S,SP,P,As)	Product Type	Surface Treatment	Condition	Accessibility
	As AE001629 (SP)	Textured Coating (1)	Completely Sealed (0)	Low Damage (1)	Occasionally likely to be disturbed (1)

Normal Occupancy	Score	Likelihood of disturbance	Score	Exposure Potential	Score	Maintenance Activity	Score
Main type of activity	N/A	Location	N/A	Number of occupants	N/A	Type of Maintenance	N/A
		Accessibility	N/A	Frequency of use	N/A	Frequency of maintenance	N/A
		Amount	N/A	Average Time	N/A		
Average Score	N/A	Average Score	N/A	Average Score	N/A	Average Score	N/A
Average of Priority	N/A						
Material Assessment Score	N/A						
Recommendation	No further action required						
Surveyor comments	N/A

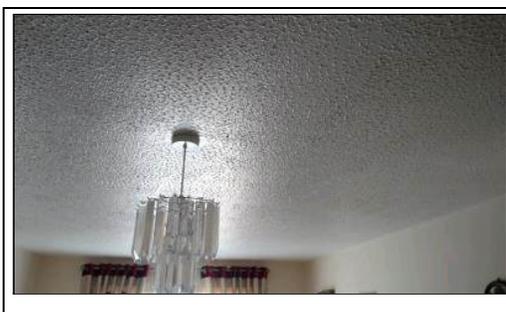
Survey Date:	Lead Surveyor	Survey Type	Floor	Analysis
27 Jul 2016	Sebastian Lawniczak	Management Survey	Z-Sub	No Asbestos Detected (0)
Building	Room	Item	Quantity	
Block 1-7. Flat 1.	Living Room Z106	Textured coating to fixed plasterboard ceiling	12m ²	
Sample No (S,SP,P,As)	Product Type	Surface Treatment	Condition	Accessibility
As AE001629 (SP)	Textured Coating (1)	Completely Sealed (0)	Good Condition (0)	Occasionally likely to be disturbed (1)

Normal Occupancy	Score	Likelihood of disturbance	Score	Exposure Potential	Score	Maintenance Activity	Score
Main type of activity	N/A	Location	N/A	Number of occupants	N/A	Type of Maintenance	N/A
		Accessibility	N/A	Frequency of use	N/A	Frequency of maintenance	N/A
		Amount	N/A	Average Time	N/A		
Average Score	N/A	Average Score	N/A	Average Score	N/A	Average Score	N/A
Average of Priority	N/A						
Material Assessment Score	N/A						
Recommendation	No further action required						
Surveyor comments	N/A

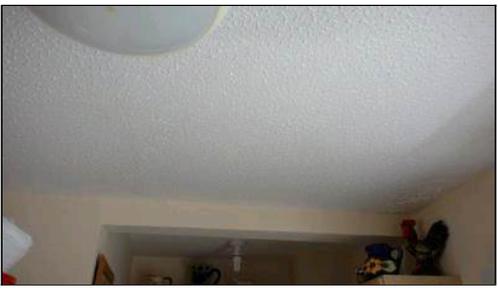
Survey Date:	Lead Surveyor	Survey Type	Floor	Analysis
	27 Jul 2016	Sebastian Lawniczak	Management Survey	Z-Sub	No Asbestos Detected (0)
	Building	Room	Item	Quantity	
	Block 1-7. Flat 1.	Kitchen Z107	Textured coating to fixed plasterboard ceiling	5m ²	
	Sample No (S,SP,P,As)	Product Type	Surface Treatment	Condition	Accessibility
As AE001629 (SP)	Textured Coating (1)	Completely Sealed (0)	Good Condition (0)	Occasionally likely to be disturbed (1)

Normal Occupancy	Score	Likelihood of disturbance	Score	Exposure Potential	Score	Maintenance Activity	Score
Main type of activity	N/A	Location	N/A	Number of occupants	N/A	Type of Maintenance	N/A
		Accessibility	N/A	Frequency of use	N/A	Frequency of maintenance	N/A
		Amount	N/A	Average Time	N/A		
Average Score	N/A	Average Score	N/A	Average Score	N/A	Average Score	N/A
Average of Priority	N/A						
Material Assessment Score	N/A						
Recommendation	No further action required						
Surveyor comments	N/A
