MANAGEMENT SURVEY

**Client: Wales & West Housing
Site ID: PF /13 LH628**

**3 Llys Hebron
Pentre Rhondda
CF417AD**

Information based upon D.M.W. Survey **D-50559** Survey Date **17 Dec 2013**.

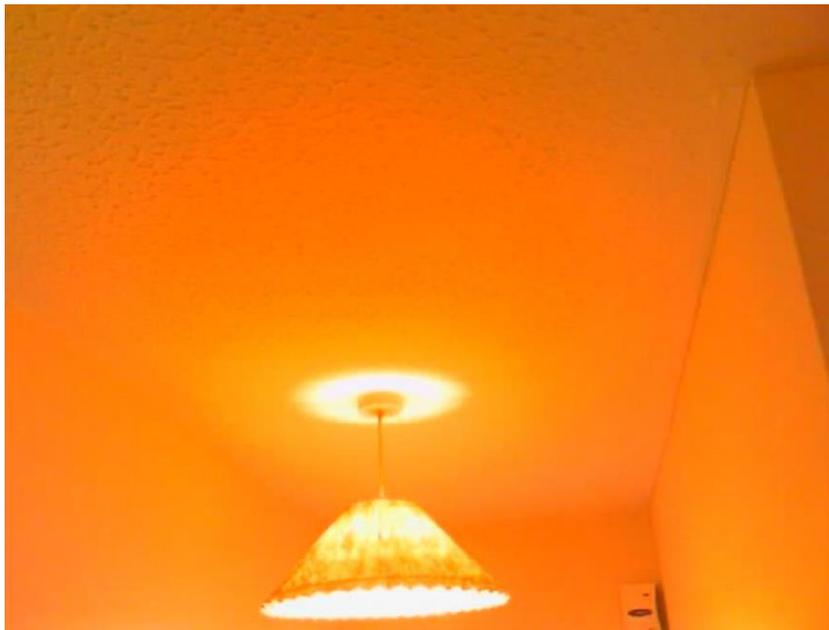
Site ID	Location ID	Building	Floor	Room / Area	Description
PF /13 LH628	D-50559/01	Flat	Ground floor	Hall	Ceiling

Asbestos Type	Product Type	Amount	Extent of Damage	Surface Treatment	Action Assessment	Material Assessment
Non Asbestos	Textured Coating - Ceiling	N/A	N/A	N/A	N/A	0

Comments: No asbestos was detected in the sample taken from the material.

Recommendations: No further action is required.

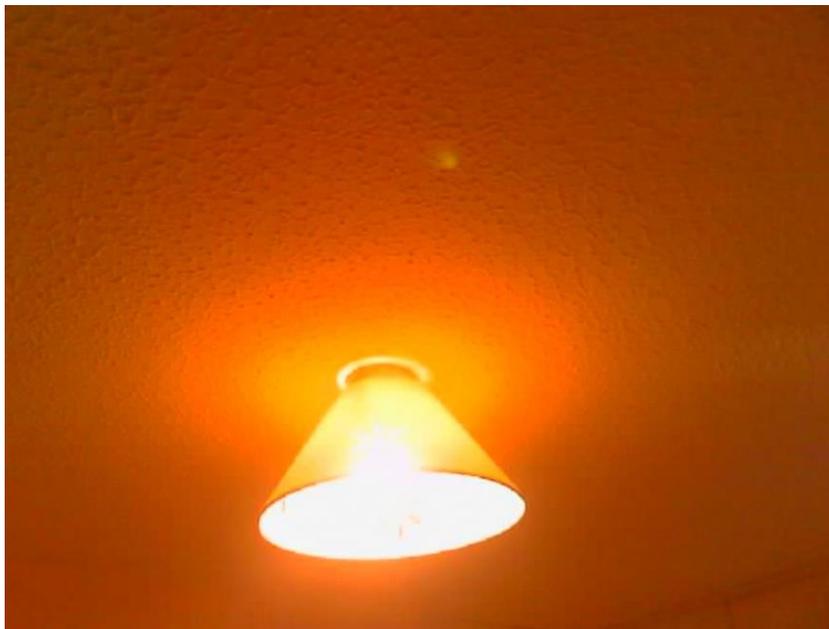
Site ID	Location ID	Building	Floor	Room / Area	Description
PF /13 LH628	D-50559/01A	Flat	Ground floor	Shower room	Ceiling

Asbestos Type	Product Type	Amount	Extent of Damage	Surface Treatment	Action Assessment	Material Assessment
Non Asbestos	Textured Coating - Ceiling	N/A	N/A	N/A	N/A	0

Comments: No asbestos was detected in the sample taken from the material.

Recommendations: No further action is required.

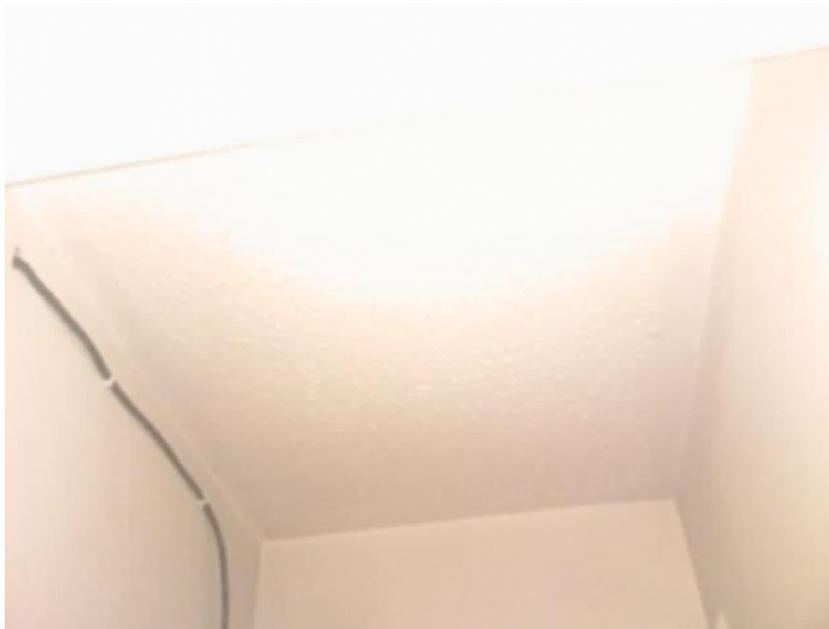
Site ID	Location ID	Building	Floor	Room / Area	Description
PF /13 LH628	D-50559/01B	Flat	Ground floor	Boiler cupboard	Ceiling

Asbestos Type	Product Type	Amount	Extent of Damage	Surface Treatment	Action Assessment	Material Assessment
Non Asbestos	Textured Coating - Ceiling	N/A	N/A	N/A	N/A	0

Comments: No asbestos was detected in the sample taken from the material.

Recommendations: No further action is required.

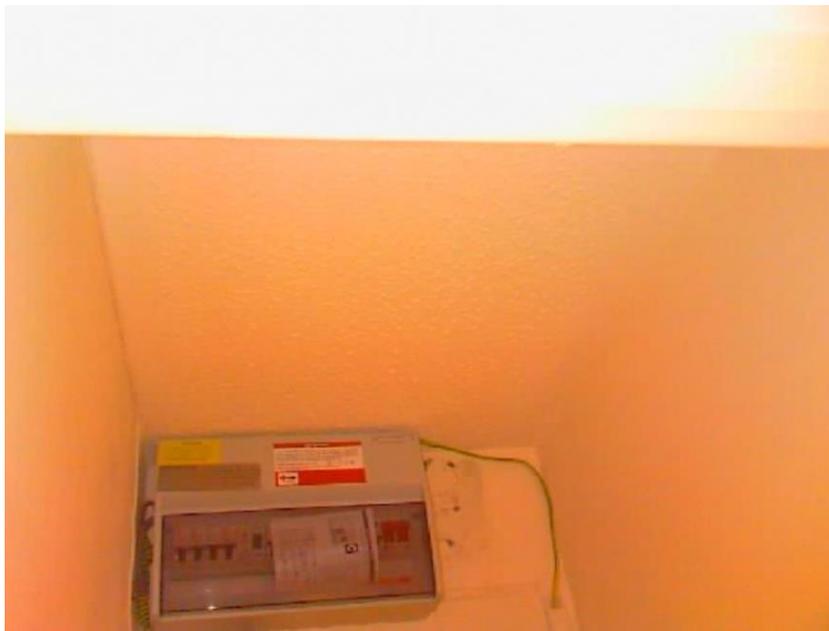
Site ID	Location ID	Building	Floor	Room / Area	Description
PF /13 LH628	D-50559/01C	Flat	Ground floor	Cupboard 1	Ceiling

Asbestos Type	Product Type	Amount	Extent of Damage	Surface Treatment	Action Assessment	Material Assessment
Non Asbestos	Textured Coating - Ceiling	N/A	N/A	N/A	N/A	0

Comments: No asbestos was detected in the sample taken from the material.

Recommendations: No further action is required.

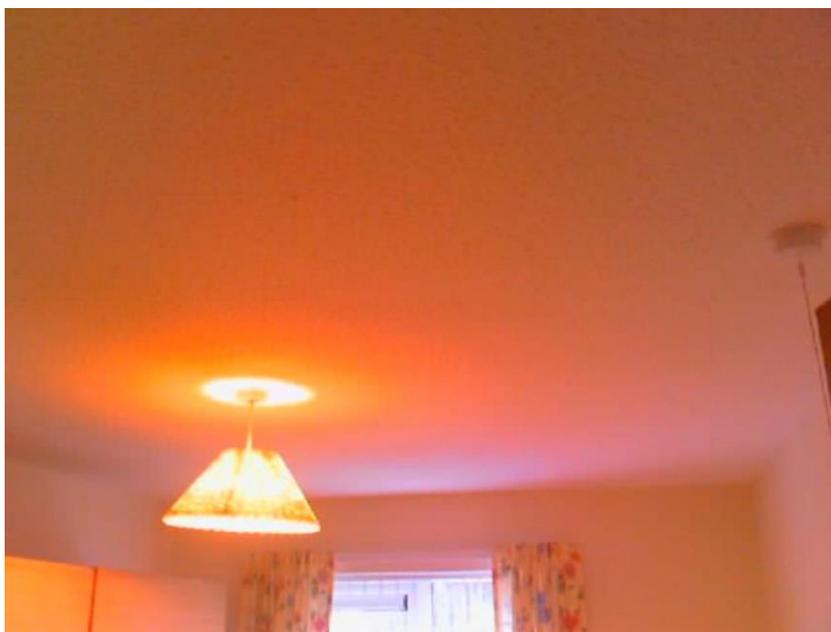
Site ID	Location ID	Building	Floor	Room / Area	Description
PF /13 LH628	D-50559/01D	Flat	Ground floor	Bedroom 1	Ceiling

Asbestos Type	Product Type	Amount	Extent of Damage	Surface Treatment	Action Assessment	Material Assessment
Non Asbestos	Textured Coating - Ceiling	N/A	N/A	N/A	N/A	0

Comments: No asbestos was detected in the sample taken from the material.

Recommendations: No further action is required.

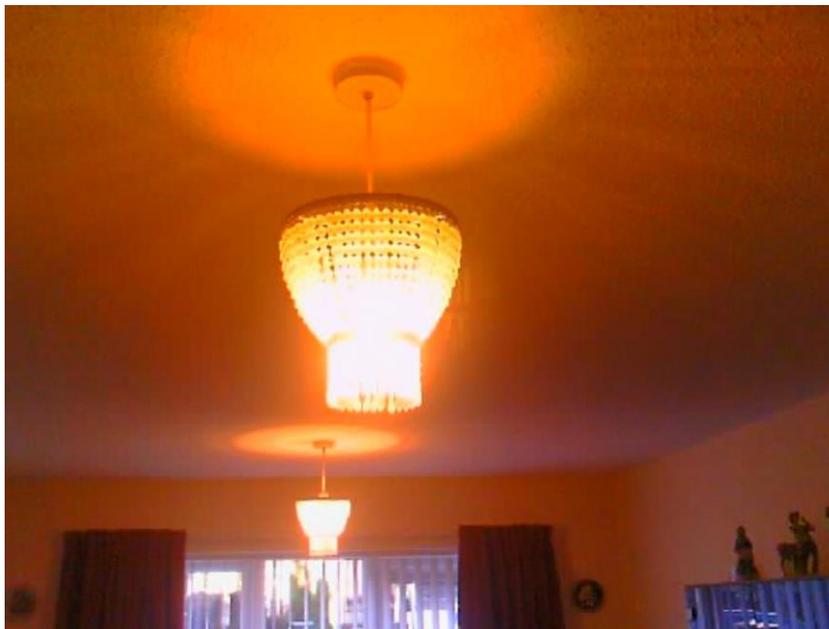
Site ID	Location ID	Building	Floor	Room / Area	Description
PF /13 LH628	D-50559/01E	Flat	Ground floor	Lounge	Ceiling

Asbestos Type	Product Type	Amount	Extent of Damage	Surface Treatment	Action Assessment	Material Assessment
Non Asbestos	Textured Coating - Ceiling	N/A	N/A	N/A	N/A	0

Comments: No asbestos was detected in the sample taken from the material.

Recommendations: No further action is required.

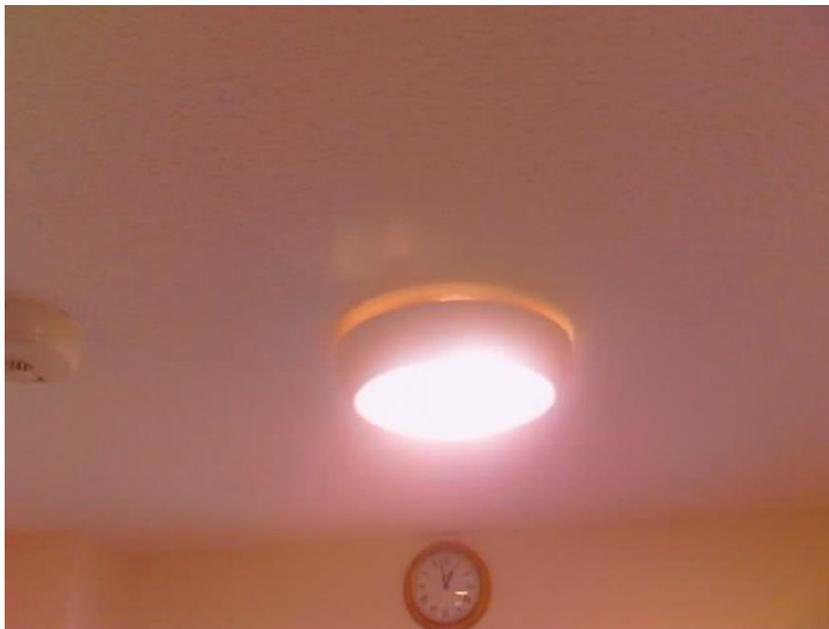
Site ID	Location ID	Building	Floor	Room / Area	Description
PF /13 LH628	D-50559/01F	Flat	Ground floor	Kitchen	Ceiling

Asbestos Type	Product Type	Amount	Extent of Damage	Surface Treatment	Action Assessment	Material Assessment
Non Asbestos	Textured Coating - Ceiling	N/A	N/A	N/A	N/A	0

Comments: No asbestos was detected in the sample taken from the material.

Recommendations: No further action is required.

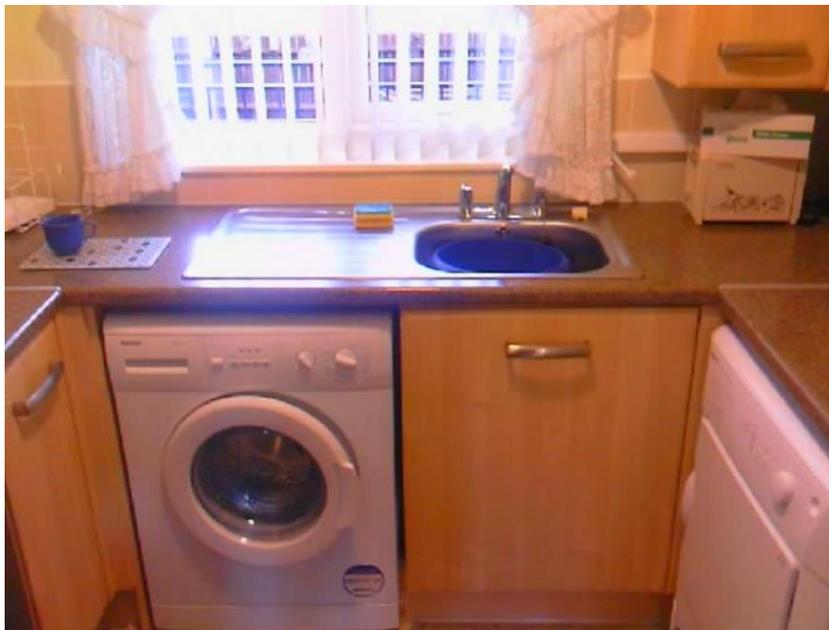
Site ID	Location ID	Building	Floor	Room / Area	Description
PF /13 LH628	D-50559/02	Flat	Ground floor	Kitchen	Sinkpadx1

Asbestos Type	Product Type	Amount	Extent of Damage	Surface Treatment	Action Assessment	Material Assessment
Non Asbestos	Bitumen	N/A	N/A	N/A	N/A	0

Comments: No asbestos was detected in the sample taken from the material.

Recommendations: No further action is required.
