Date: August, 2005
Report Ref: R9925.112.5.08.001_NH

MANESTREAM LTD

**Flat 5, Llys Hebron
Church Street
Ton Pentre, Pentre, CF41 5AD**

TYPE II ASBESTOS SURVEY

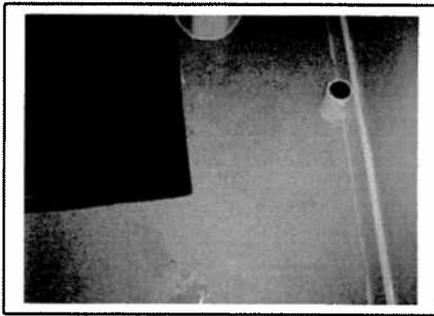
Sample No. 50725CB008
Location F003
Description Beige Vinyl Flooring

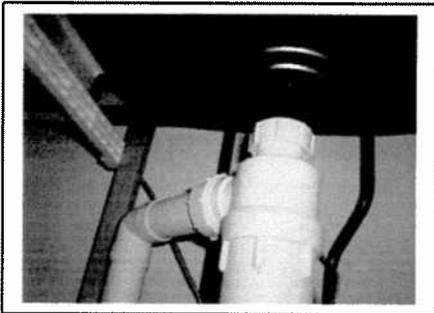
Sample No. 50725CB009
Location F007
Description Sink Pad

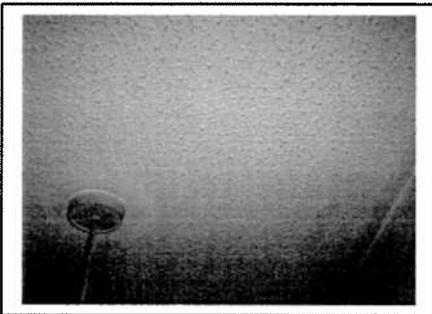
Sample No. AS50725CB027
Location F005
Description Textured Coating to Ceiling

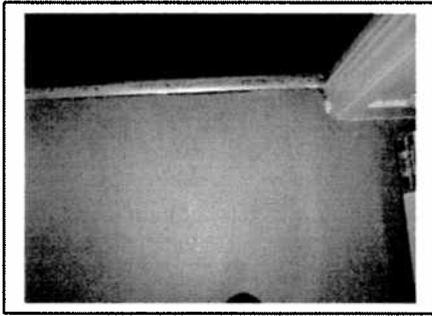
Sample No. AS50725CB008
Location F007
Description Beige Vinyl Flooring

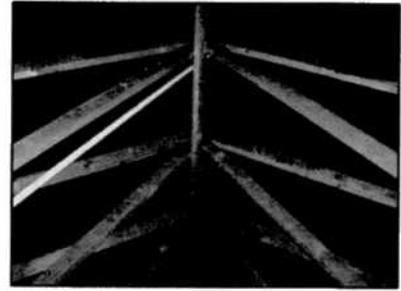
PHOTO Number: 50725CBV002

SAMPLE NO	LOCATION	DESCRIPTION	TYPE OF ASBESTOS	GUIDE EXTENT	Material Risk Category	Total Score (MRA + Priority Risk Assessment)	Category	RECOMMENDED ACTION	For CLIENT USE			Completed On / Re-inspection Due (if applicable)
									Date Actioned	Authorised By	Work Undertaken By	
50725CBV002	R001	Roof Felt	Presumed to contain Crocidolite	50m2	Very Low	9	3	Gain Access

Sample Description:
Roof Felt

3. Surface treatment	Composite/ Enclosed & Unsealed cement/ Unsealed AIB/ Unsealed friable	0-3	0
4. Asbestos Type	Chrysotile/ Amphibole (excluding Crocidolite)/ Crocidolite	1-3	3
Material Assessment Score		4	
Material Risk Category		Very Low

14. Frequency of maintenance	Unlikely/ <1yr/ >1yr/ >1per month	0-3	
Priority Assessment Score		5	
Total		9

The Roof Felt in Attic Space R001 (Sample No: 50725CBV002) is presumed to contain Crocidolite (blue asbestos). This material is sealed beneath plastic covering. Manestream Ltd recommends that this material is labelled before being incorporated into an Asbestos Management Plan and is inspected at regular intervals. If, at any time, this presumed asbestos-containing material is to be removed then sampling should be carried out to determine the presence of asbestos. If proved positive, under Regulation 6 of The Control of Asbestos at Work Regulations, providing the exposure does not exceed the stated action levels/ control limits then the work will not be notifiable to the HSE. If a general contractor is to be used for this work then a detailed method statement must be provided including all relevant risk assessments. The asbestos-containing material must then be disposed of by a licensed carrier of asbestos waste to a licensed tip.
