## Management with Targeted Refurbishment Survey to Bathroom

6 Llys Hebron  
Pentre  
Rhondda  
CF41 7AD  
UPRN: 6436

| Date of survey: | 10 Aug 2016 | | |

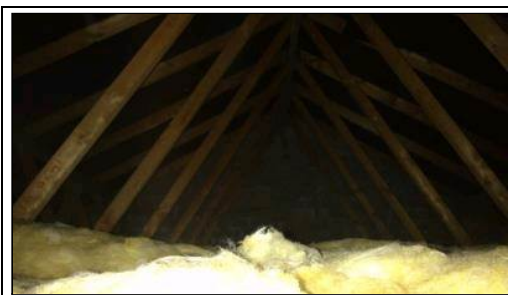
| Survey Date: | Lead Surveyor | Survey Type | Floor | Analysis |
|---|---|---|---|---|
| 10 Aug 2016 | Sebastian Lawniczak | Management Survey | Roof | N/A |

| Normal Occupancy | Score | Likelihood of disturbance | Score | Exposure Potential | Score | Maintenance Activity | Score |
|---|---|---|---|---|---|---|---|
| Recommendation | No further action required | | | | | | |

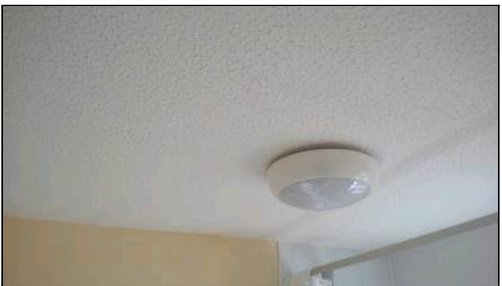
| | Survey Date: | Lead Surveyor | Survey Type | Floor | Analysis |
|---|---|---|---|---|---|
| | 10 Aug 2016 | Sebastian Lawniczak | Refurbishment and Demolition Survey | 1st | No Asbestos Detected (0) |
| | AE001714 (S) | Textured Coating (1) | Completely Sealed (0) | Good Condition (0) | Occasionally likely to be disturbed (1) |

| Normal Occupancy | Score | Likelihood of disturbance | Score | Exposure Potential | Score | Maintenance Activity | Score |
|---|---|---|---|---|---|---|---|
| Recommendation | No further action required | | | | | | |

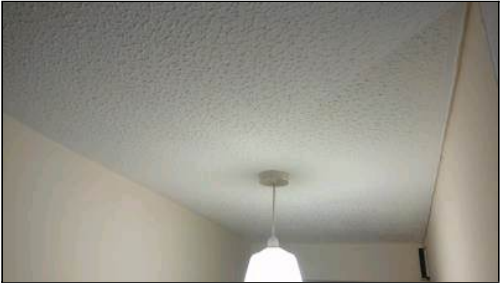
| | Survey Date: | Lead Surveyor | Survey Type | Floor | Analysis |
|---|---|---|---|---|---|
| | 10 Aug 2016 | Sebastian Lawniczak | Management Survey | 1st | No Asbestos Detected (0) |
| | As AE001714 (SP) | Textured Coating (1) | Completely Sealed (0) | Good Condition (0) | Occasionally likely to be disturbed (1) |

| Normal Occupancy | Score | Likelihood of disturbance | Score | Exposure Potential | Score | Maintenance Activity | Score |
|---|---|---|---|---|---|---|---|
| Recommendation | No further action required | | | | | | |

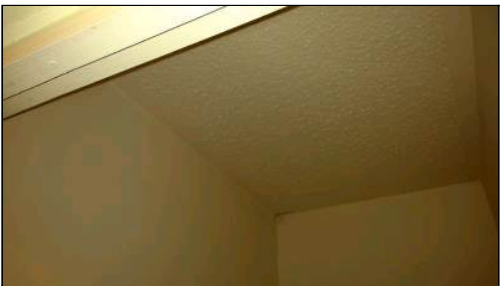
| | 10 Aug 2016 | Sebastian Lawniczak | Management Survey | 1st | No Asbestos Detected (0) |
| | As AE001714 (SP) | Textured Coating (1) | Completely Sealed (0) | Good Condition (0) | Occasionally likely to be disturbed (1) |

| Recommendation | No further action required | | | | | | |

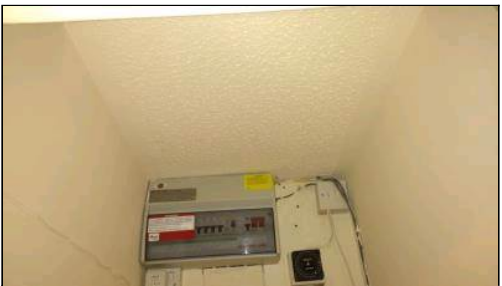
| | 10 Aug 2016 | Sebastian Lawniczak | Management Survey | 1st | No Asbestos Detected (0) |
| | As AE001714 (SP) | Textured Coating (1) | Completely Sealed (0) | Good Condition (0) | Occasionally likely to be disturbed (1) |

| Recommendation | No further action required | | | | | | |

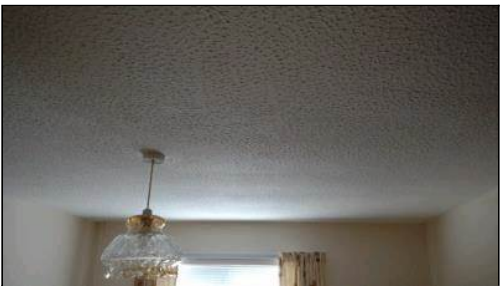
| | 10 Aug 2016 | Sebastian Lawniczak | Management Survey | 1st | No Asbestos Detected (0) |
| | As AE001714 (SP) | Textured Coating (1) | Completely Sealed (0) | Good Condition (0) | Occasionally likely to be disturbed (1) |

| Recommendation | No further action required | | | | | | |

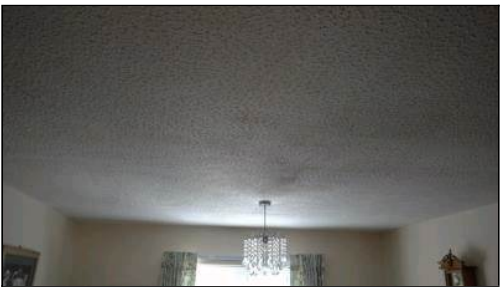
| | 10 Aug 2016 | Sebastian Lawniczak | Management Survey | 1st | No Asbestos Detected (0) |
| | As AE001714 (SP) | Textured Coating (1) | Completely Sealed (0) | Good Condition (0) | Occasionally likely to be disturbed (1) |

| Recommendation | No further action required | | | | | | |

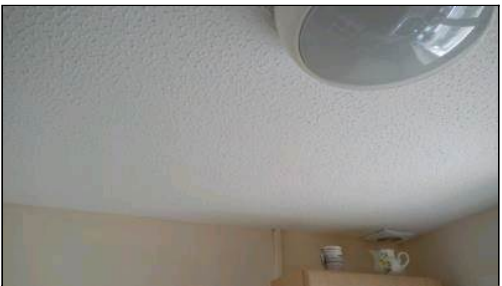
| | Survey Date: | Lead Surveyor | Survey Type | Floor | Analysis |
|---|---|---|---|---|---|
| | 10 Aug 2016 | Sebastian Lawniczak | Management Survey | 1st | No Asbestos Detected (0) |
| | As AE001714 (SP) | Textured Coating (1) | Completely Sealed (0) | Good Condition (0) | Occasionally likely to be disturbed (1) |

| Normal Occupancy | Score | Likelihood of disturbance | Score | Exposure Potential | Score | Maintenance Activity | Score |
|---|---|---|---|---|---|---|---|
| Recommendation | No further action required | | | | | | |

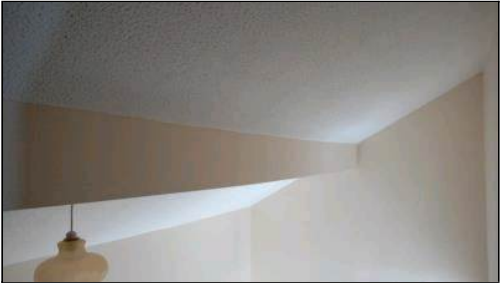
| | 10 Aug 2016 | Sebastian Lawniczak | Management Survey | 1st | No Asbestos Detected (0) |
| | AE001715 (S) | Textured Coating (1) | Completely Sealed (0) | Good Condition (0) | Occasionally likely to be disturbed (1) |

| Recommendation | No further action required | | | | | | |
