Management with Targeted Refurbishment Survey to Bathroom

1 Llys Nazareth
Llewellyn Street
Pentre
Rhondda
CF41 7BS
UPRN: 5455

1.0 Executive summary:

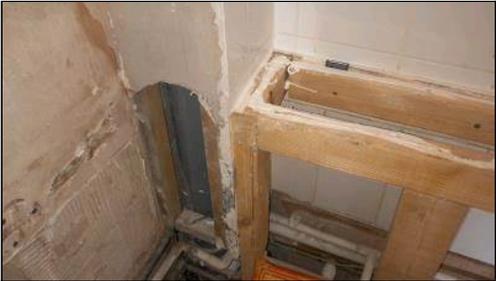
Survey Date:	Lead Surveyor	Survey Type	Floor	Analysis
	30 Mar 2017	Ben Coleman	Refurbishment and Demolition Survey	Ground	No Asbestos Detected (0)
	Building	Room	Item	Quantity	
	Block 1-20, Flat 1	Bathroom G01	Insulating board panels to boxing.	2m ²	
	Sample No (S,SP,P,As)	Product Type	Surface Treatment	Condition	Accessibility
AI002587 (S)	Insulating Board (0)	Unsealed (2)	Medium Damage (2)	Easily disturbed (2)

Normal Occupancy	Score	Likelihood of disturbance	Score	Exposure Potential	Score	Maintenance Activity	Score
Main type of activity	N/A	Location	N/A	Number of occupants	N/A	Type of Maintenance	N/A
		Accessibility	N/A	Frequency of use	N/A	Frequency of maintenance	N/A
		Amount	N/A	Average Time	N/A		
Average Score	N/A	Average Score	N/A	Average Score	N/A	Average Score	N/A
Average of Priority	N/A						
Material Assessment Score	N/A						
Recommendation	No further action required						
Surveyor comments	N/A

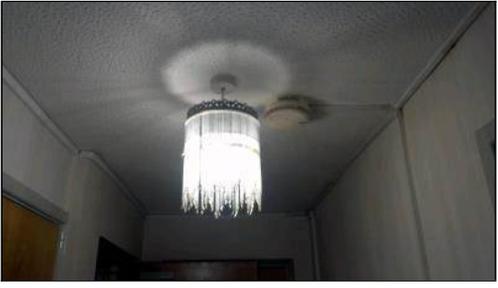
Survey Date:	Lead Surveyor	Survey Type	Floor	Analysis
	30 Mar 2017	Ben Coleman	Management Survey	Ground	No Asbestos Detected (0)
	Building	Room	Item	Quantity	
	Block 1-20, Flat 1	Hall G02	Textured coating to plasterboard ceiling	3m ²	
	Sample No (S,SP,P,As)	Product Type	Surface Treatment	Condition	Accessibility
	As AI002588 (SP)	Textured Coating (1)	Completely Sealed (0)	Good Condition (0)	Occasionally likely to be disturbed (1)

Normal Occupancy	Score	Likelihood of disturbance	Score	Exposure Potential	Score	Maintenance Activity	Score
Main type of activity	N/A	Location	N/A	Number of occupants	N/A	Type of Maintenance	N/A
		Accessibility	N/A	Frequency of use	N/A	Frequency of maintenance	N/A
		Amount	N/A	Average Time	N/A		
Average Score	N/A	Average Score	N/A	Average Score	N/A	Average Score	N/A
Average of Priority	N/A						
Material Assessment Score	N/A						
Recommendation	No further action required						
Surveyor comments	N/A

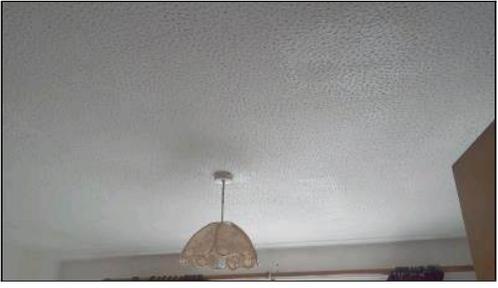
Survey Date:	Lead Surveyor	Survey Type	Floor	Analysis
	30 Mar 2017	Ben Coleman	Management Survey	Ground	No Asbestos Detected (0)
	Building	Room	Item	Quantity	
	Block 1-20, Flat 1	Bedroom 2 G06	Textured coating to plasterboard ceiling.	8m ²	
	Sample No (S,SP,P,As)	Product Type	Surface Treatment	Condition	Accessibility
	As AI002588 (SP)	Textured Coating (1)	Completely Sealed (0)	Good Condition (0)	Occasionally likely to be disturbed (1)

Normal Occupancy	Score	Likelihood of disturbance	Score	Exposure Potential	Score	Maintenance Activity	Score
Main type of activity	N/A	Location	N/A	Number of occupants	N/A	Type of Maintenance	N/A
		Accessibility	N/A	Frequency of use	N/A	Frequency of maintenance	N/A
		Amount	N/A	Average Time	N/A		
Average Score	N/A	Average Score	N/A	Average Score	N/A	Average Score	N/A
Average of Priority	N/A						
Material Assessment Score	N/A						
Recommendation	No further action required						
Surveyor comments	N/A

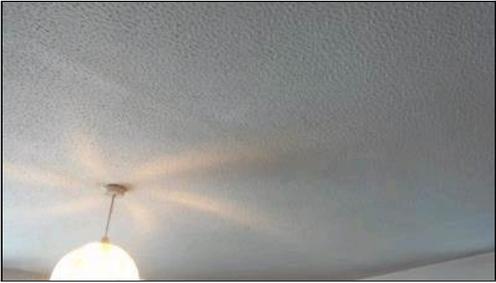
Survey Date:	Lead Surveyor	Survey Type	Floor	Analysis
	30 Mar 2017	Ben Coleman	Management Survey	Ground	
	Building	Room	Item	Quantity	
	Block 1-20, Flat 1	Living Room G07	Textured coating to plasterboard ceiling	16m ²	
	Sample No (S,SP,P,As)	Product Type	Surface Treatment	Condition	Accessibility
As AI002588 (SP)	Textured Coating (1)	Completely Sealed (0)	Good Condition (0)	Occasionally likely to be disturbed (1)

Normal Occupancy	Score	Likelihood of disturbance	Score	Exposure Potential	Score	Maintenance Activity	Score
Main type of activity	N/A	Location	N/A	Number of occupants	N/A	Type of Maintenance	N/A
		Accessibility	N/A	Frequency of use	N/A	Frequency of maintenance	N/A
		Amount	N/A	Average Time	N/A		
Average Score	N/A	Average Score	N/A	Average Score	N/A	Average Score	N/A
Average of Priority	N/A						
Material Assessment Score	N/A						
Recommendation	No further action required						
Surveyor comments	N/A
