Management Survey

10 Llys Nazareth
Llewellyn Street
Pentre
Rhondda
CF41 7BS
UPRN: 5464

Report issue date:	28 Sep 2015

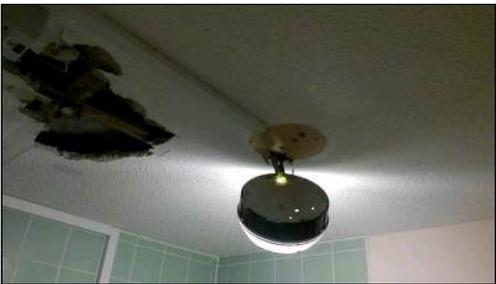
Survey Date:	Lead Surveyor	Survey Type	Floor	Analysis
	16 Sep 2015	Sebastian Lawniczak	Management Survey	1st	No Asbestos Detected (0)
	Building	Room	Item	Quantity	
	Main Flat.	Shower Room 101	Textured coating to plasterboard ceiling	3m ²	
	Sample No (S,SP,P,As)	Product Type	Surface Treatment	Condition	Accessibility
	AD001566 (S)	Textured Coating (1)	Completely Sealed (0)	Medium Damage (2)	Occasionally likely to be disturbed (1)

Normal Occupancy	Score	Likelihood of disturbance	Score	Exposure Potential	Score	Maintenance Activity	Score
Main type of activity	N/A	Location	N/A	Number of occupants	N/A	Type of Maintenance	N/A
		Accessibility	N/A	Frequency of use	N/A	Frequency of maintenance	N/A
		Amount	N/A	Average Time	N/A		
Average Score	N/A	Average Score	N/A	Average Score	N/A	Average Score	N/A
Average of Priority	N/A						
Material Assessment Score	N/A						
Recommendation	No further action required						
Surveyor comments	N/A

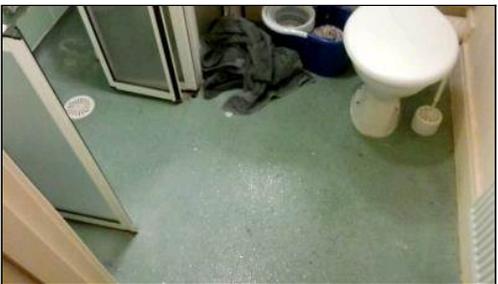
Survey Date:	Lead Surveyor	Survey Type	Floor	Analysis
	16 Sep 2015	Sebastian Lawniczak	Management Survey	1st	Chrysotile (1)
	Building	Room	Item	Quantity	
	Main Flat.	Shower Room 101	Strongly presumed vinyl floor tiles and bitumen adhesive to concrete floor beneath fixed non-suspect vinyl flooring	2m ²	
	Sample No (S,SP,P,As)	Product Type	Surface Treatment	Condition	Accessibility
	Visual (SP)	Reinforced Composite (1)	Completely Sealed (0)	Good Condition (0)	Usually inaccessible or unlikely to be disturbed (0)

Normal Occupancy	Score	Likelihood of disturbance	Score	Exposure Potential	Score	Maintenance Activity	Score
Main type of activity	1	Location	2	Number of occupants	1	Type of Maintenance	0
		Accessibility	0	Frequency of use	3	Frequency of maintenance	0
		Amount	1	Average Time	0		
Average Score	1	Average Score	1	Average Score	2	Average Score	0
Average of Priority	4						
Material Assessment Score	2						
Recommendation	E - Inspection required						
Surveyor comments	No inspection possible without undue damage to fixed flooring.

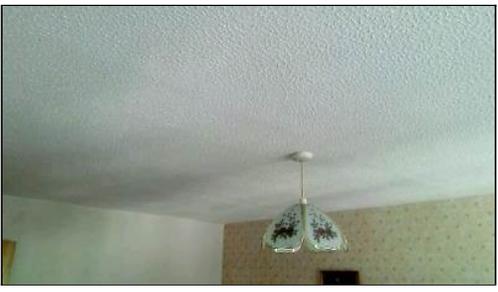
Survey Date:	Lead Surveyor	Survey Type	Floor	Analysis
	16 Sep 2015	Sebastian Lawniczak	Management Survey	1st	No Asbestos Detected (0)
	Building	Room	Item	Quantity	
	Main Flat.	Lounge 102	Textured coating to plasterboard ceiling	12m ²	
	Sample No (S,SP,P,As)	Product Type	Surface Treatment	Condition	Accessibility
	As AD001566 (SP)	Textured Coating (1)	Completely Sealed (0)	Good Condition (0)	Occasionally likely to be disturbed (1)

Normal Occupancy	Score	Likelihood of disturbance	Score	Exposure Potential	Score	Maintenance Activity	Score
Main type of activity	N/A	Location	N/A	Number of occupants	N/A	Type of Maintenance	N/A
		Accessibility	N/A	Frequency of use	N/A	Frequency of maintenance	N/A
		Amount	N/A	Average Time	N/A		
Average Score	N/A	Average Score	N/A	Average Score	N/A	Average Score	N/A
Average of Priority	N/A						
Material Assessment Score	N/A						
Recommendation	No further action required						
Surveyor comments	N/A

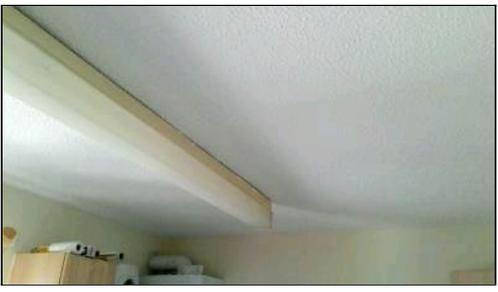
Survey Date:	Lead Surveyor	Survey Type	Floor	Analysis
	16 Sep 2015	Sebastian Lawniczak	Management Survey	1st	No Asbestos Detected (0)
	Building	Room	Item	Quantity	
	Main Flat.	Kitchen 103	Textured coating to plasterboard ceiling	6m ²	
	Sample No (S,SP,P,As)	Product Type	Surface Treatment	Condition	Accessibility
As AD001566 (SP)	Textured Coating (1)	Completely Sealed (0)	Good Condition (0)	Occasionally likely to be disturbed (1)

Normal Occupancy	Score	Likelihood of disturbance	Score	Exposure Potential	Score	Maintenance Activity	Score
Main type of activity	N/A	Location	N/A	Number of occupants	N/A	Type of Maintenance	N/A
		Accessibility	N/A	Frequency of use	N/A	Frequency of maintenance	N/A
		Amount	N/A	Average Time	N/A		
Average Score	N/A	Average Score	N/A	Average Score	N/A	Average Score	N/A
Average of Priority	N/A						
Material Assessment Score	N/A						
Recommendation	No further action required						
Surveyor comments	N/A

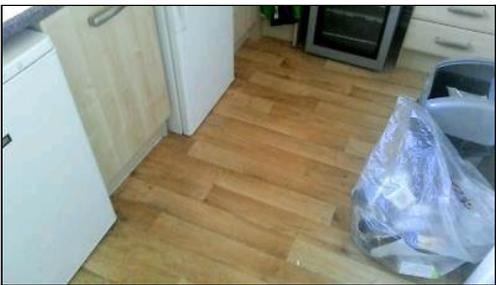
Survey Date:	Lead Surveyor	Survey Type	Floor	Analysis
	16 Sep 2015	Sebastian Lawniczak	Management Survey	1st	Chrysotile (1)
	Building	Room	Item	Quantity	
	Main Flat.	Kitchen 103	Strongly presumed vinyl floor tiles and bitumen adhesive to concrete floor beneath fixed non-suspect timber-effect laminate flooring	6m ²	
	Sample No (S,SP,P,As)	Product Type	Surface Treatment	Condition	Accessibility
Visual (SP)	Reinforced Composite (1)	Completely Sealed (0)	Good Condition (0)	Usually inaccessible or unlikely to be disturbed (0)

Normal Occupancy	Score	Likelihood of disturbance	Score	Exposure Potential	Score	Maintenance Activity	Score
Main type of activity	1	Location	2	Number of occupants	1	Type of Maintenance	0
		Accessibility	0	Frequency of use	3	Frequency of maintenance	0
		Amount	1	Average Time	1		
Average Score	1	Average Score	1	Average Score	2	Average Score	0
Average of Priority	4						
Material Assessment Score	2						
Recommendation	E - Inspection required						
Surveyor comments	No inspection possible without undue damage to fixed flooring.

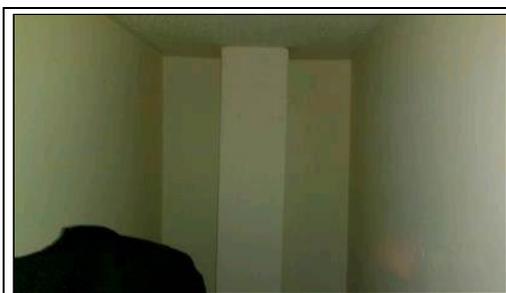
Survey Date:	Lead Surveyor	Survey Type	Floor	Analysis
16 Sep 2015	Sebastian Lawniczak	Management Survey	1st	No Asbestos Detected (0)
Building	Room	Item	Quantity	
Main Flat.	Store Cupboard 104	Insulating board forming riser boxing to back wall	2m ²	
Sample No (S,SP,P,As)	Product Type	Surface Treatment	Condition	Accessibility
AD001568 (S)	Insulation board (2)	Surface Sealed (1)	Good Condition (0)	Easily disturbed (2)

Normal Occupancy	Score	Likelihood of disturbance	Score	Exposure Potential	Score	Maintenance Activity	Score
Main type of activity	N/A	Location	N/A	Number of occupants	N/A	Type of Maintenance	N/A
		Accessibility	N/A	Frequency of use	N/A	Frequency of maintenance	N/A
		Amount	N/A	Average Time	N/A		
Average Score	N/A	Average Score	N/A	Average Score	N/A	Average Score	N/A
Average of Priority	N/A						
Material Assessment Score	N/A						
Recommendation	No further action required						
Surveyor comments	N/A

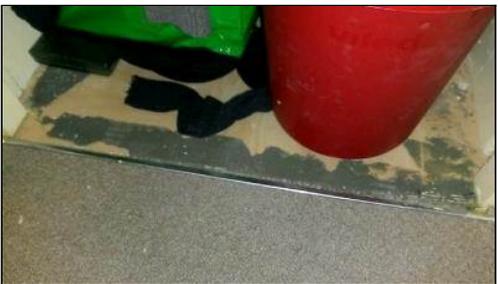
Survey Date:	Lead Surveyor	Survey Type	Floor	Analysis
	16 Sep 2015	Sebastian Lawniczak	Management Survey	1st	
	Building	Room	Item	Quantity	
	Main Flat.	Store Cupboard 104	Beige vinyl tiles to timber floor	2m ²	
	Sample No (S,SP,P,As)	Product Type	Surface Treatment	Condition	Accessibility
	AD001569 (S)	Vinyl floor tiles (1)	Completely Sealed (0)	Good Condition (0)	Routinely disturbed (3)

Normal Occupancy	Score	Likelihood of disturbance	Score	Exposure Potential	Score	Maintenance Activity	Score
Main type of activity	N/A	Location	N/A	Number of occupants	N/A	Type of Maintenance	N/A
		Accessibility	N/A	Frequency of use	N/A	Frequency of maintenance	N/A
		Amount	N/A	Average Time	N/A		
Average Score	N/A	Average Score	N/A	Average Score	N/A	Average Score	N/A
Average of Priority	N/A						
Material Assessment Score	N/A						
Recommendation	No further action required						
Surveyor comments	N/A

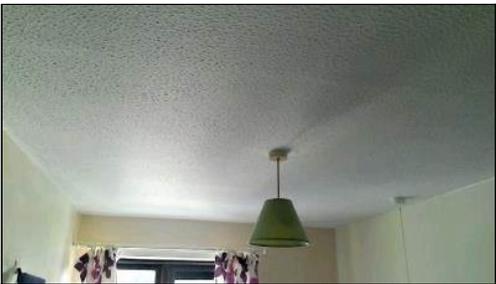
Survey Date:	Lead Surveyor	Survey Type	Floor	Analysis
	16 Sep 2015	Sebastian Lawniczak	Management Survey	1st	No Asbestos Detected (0)
	Building	Room	Item	Quantity	
	Main Flat.	Bedroom 105	Textured coating to plasterboard ceiling	8m ²	
	Sample No (S,SP,P,As)	Product Type	Surface Treatment	Condition	Accessibility
As AD001567 (SP)	Textured Coating (1)	Completely Sealed (0)	Good Condition (0)	Occasionally likely to be disturbed (1)

Normal Occupancy	Score	Likelihood of disturbance	Score	Exposure Potential	Score	Maintenance Activity	Score
Main type of activity	N/A	Location	N/A	Number of occupants	N/A	Type of Maintenance	N/A
		Accessibility	N/A	Frequency of use	N/A	Frequency of maintenance	N/A
		Amount	N/A	Average Time	N/A		
Average Score	N/A	Average Score	N/A	Average Score	N/A	Average Score	N/A
Average of Priority	N/A						
Material Assessment Score	N/A						
Recommendation	No further action required						
Surveyor comments	N/A

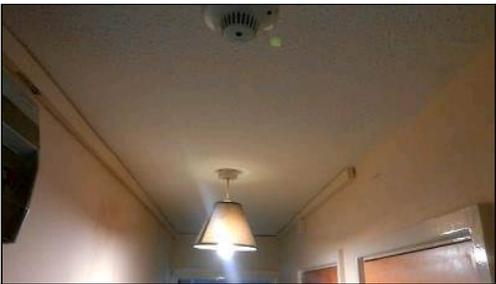
Survey Date:	Lead Surveyor	Survey Type	Floor	Analysis
	16 Sep 2015	Sebastian Lawniczak	Management Survey	1st	No Asbestos Detected (0)
	Building	Room	Item	Quantity	
	Main Flat.	Hallway 106	Textured coating to plasterboard ceiling	4m ²	
	Sample No (S,SP,P,As)	Product Type	Surface Treatment	Condition	Accessibility
As AD001567 (SP)	Textured Coating (1)	Completely Sealed (0)	Good Condition (0)	Occasionally likely to be disturbed (1)

Normal Occupancy	Score	Likelihood of disturbance	Score	Exposure Potential	Score	Maintenance Activity	Score
Main type of activity	N/A	Location	N/A	Number of occupants	N/A	Type of Maintenance	N/A
		Accessibility	N/A	Frequency of use	N/A	Frequency of maintenance	N/A
		Amount	N/A	Average Time	N/A		
Average Score	N/A	Average Score	N/A	Average Score	N/A	Average Score	N/A
Average of Priority	N/A						
Material Assessment Score	N/A						
Recommendation	No further action required						
Surveyor comments	N/A
