Date: July 2005
Report Ref: R9925.116.5.07.001_FH

Pectel (Wales) Ltd
18 Llys Nazareth,
Llwewllyn Street,
Pentre
CF41 7BS

TYPE II ASBESTOS SURVEY

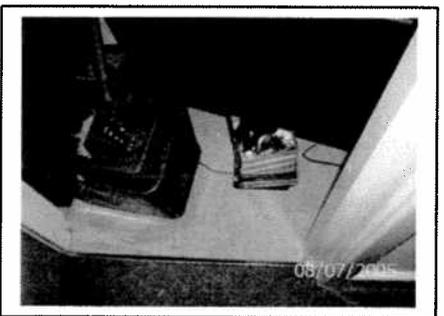
Sample No. 50708CB031
Location G002
Description Beige Floor Tile & Bitumen Adhesive

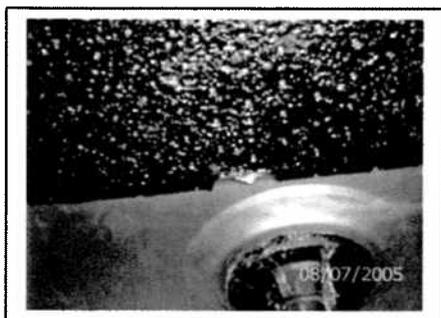
Sample No. 50708CB032

Description Sink Pad

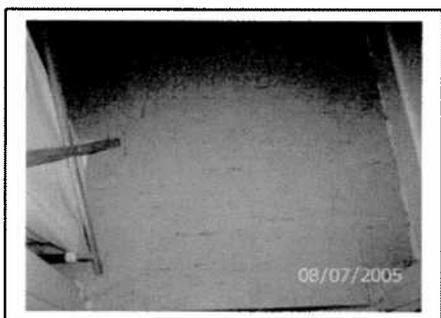
Sample No. AS50708CB031

Description Beige Floor Tile & Bitumen Adhesive
